## 8.0 ANALYSIS OF UPPER RESERVOIR BARRIERS

### 8.1 OVERTOPPING ANALYSIS

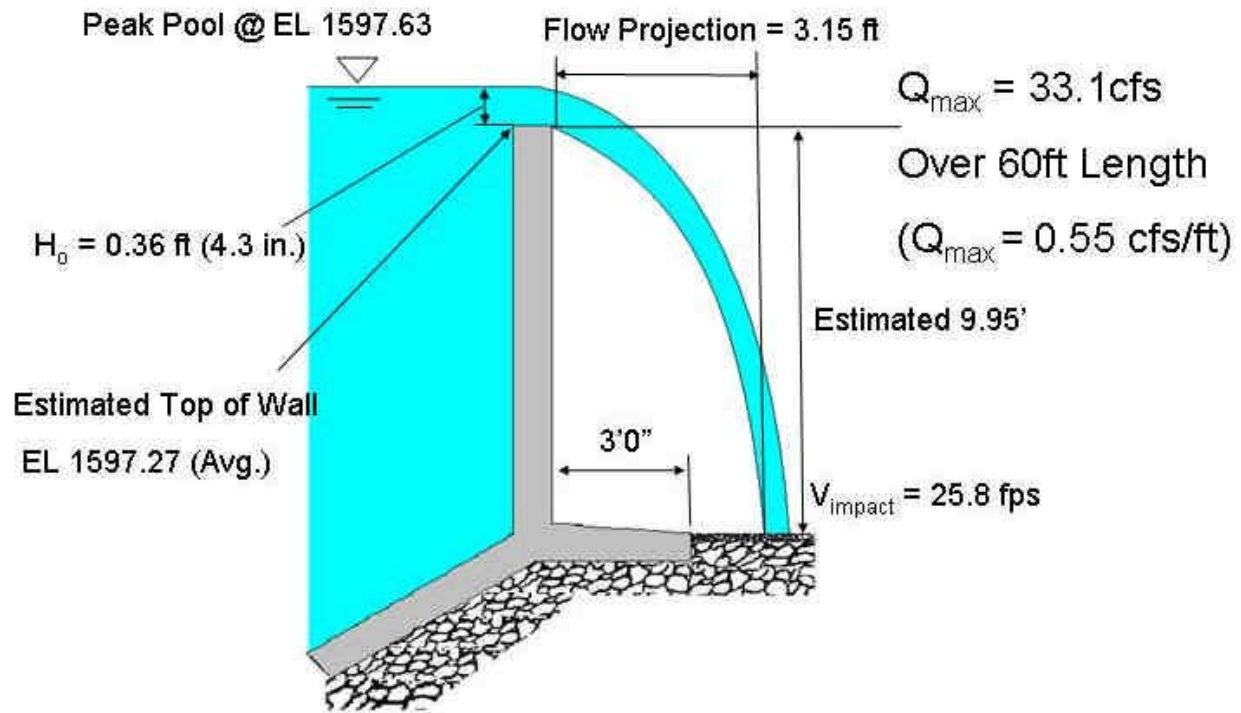
FIGURE 8-4

The total flow over Wall Segment 72 (78 feet long) having an average top Elevation of 1597.10 is 80.1 cfs, or 1.03 cfs/ft. This is slightly greater than at the Breach Area but over a more concentrated zone. In the southwest corner as shown on **Figure 8-4** for Parapet Wall Segment 48, the flow is estimated to be 33.1 cfs over a length of 60 feet or about 0.55 cfs per foot. These

flows caused Parapet Wall Segment Nos. 72 and 48 to be undermined as illustrated below on *Figure 8-5* and *Figure 8-6* respectively.

WEIR FLOW PROJECTION – WALL SEGMENT 48

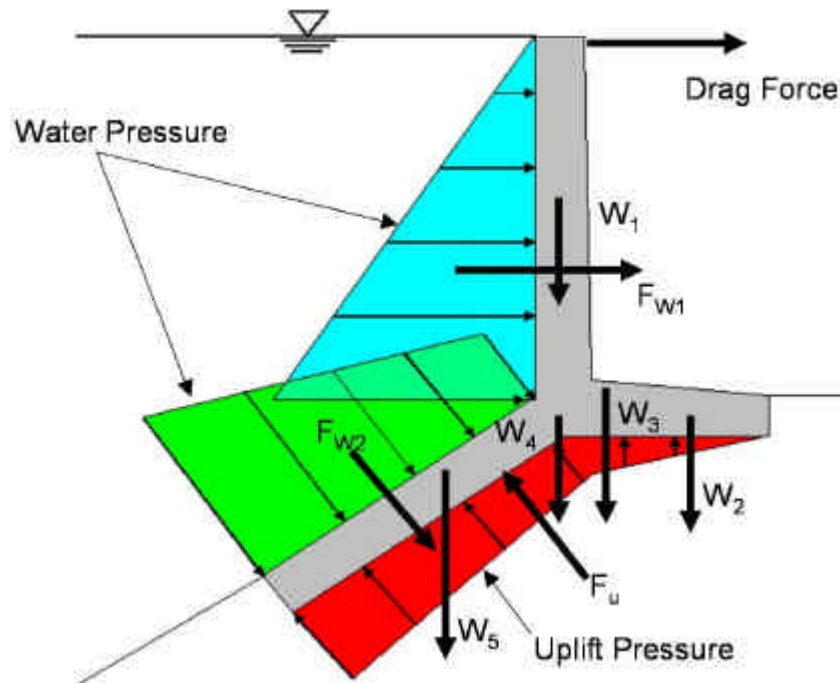
**FIGURE 8-8**  
**OVERTURNING ANALYSIS WITH NO UNDERMINING**

The forces considered for this analysis are illustrated below on **Figure 8-8** with the results shown on **Figure 8-9**. The results indicate that the Wall was stable against overturning for all practical purposes under the given water level and so long as no undermining had developed.

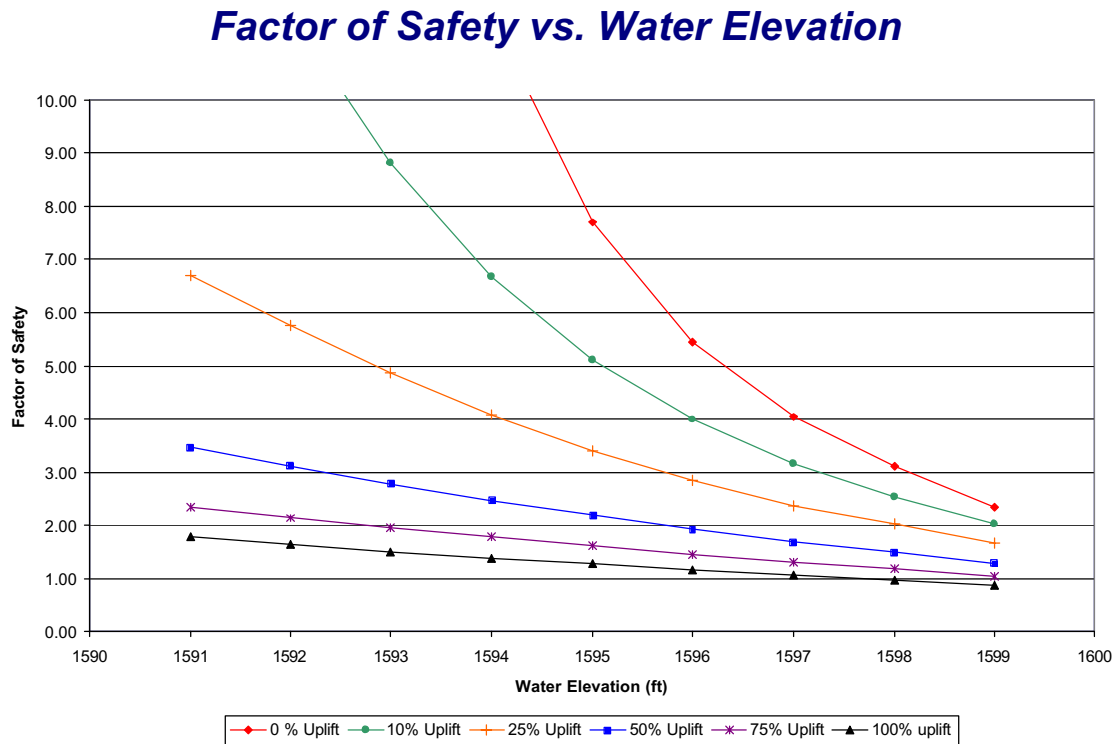
**FIGURE 8-9**

### OVERTURNING STABILITY ANALYSIS RESULTS

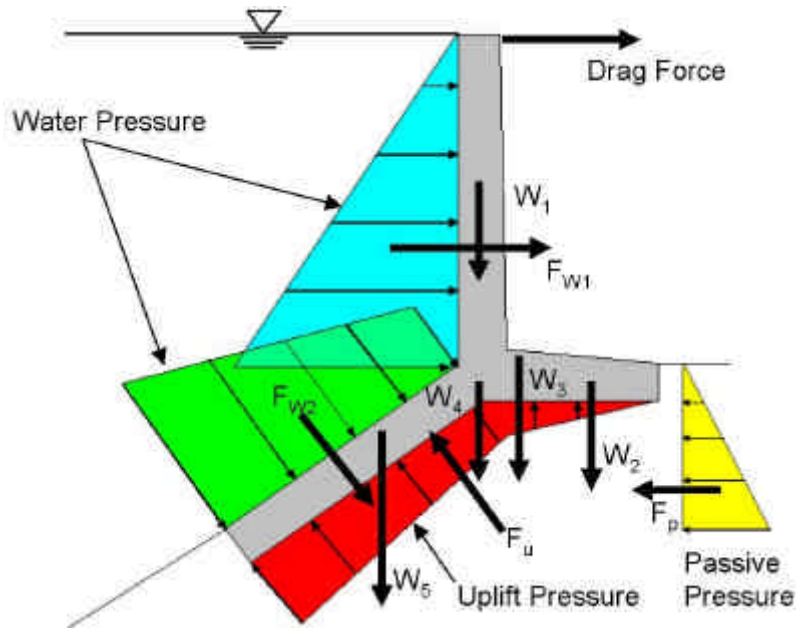
**FIGURE 8-10**

The forces considered for the sliding analysis are illustrated below on **Figure 8-10** with the results shown on **Figure 8-11**. The results indicate that the Wall was stable against sliding for all practical purposes under the given water level and so long as no undermining had developed.

**SLIDING ANALYSIS WITH NO UNDERMINING**

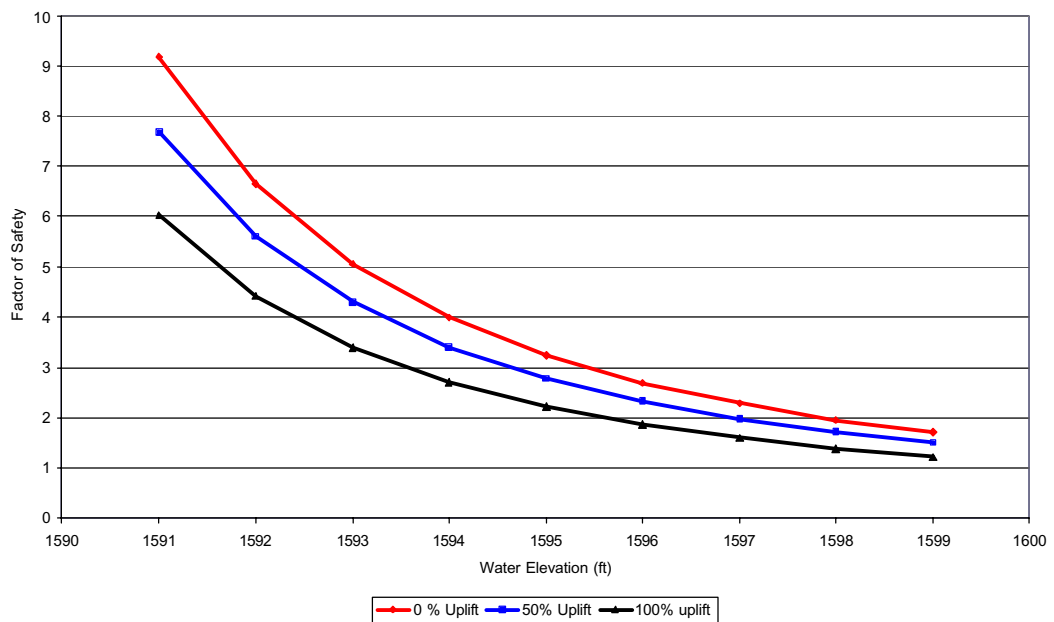
**FIGURE 8-11**

**SLIDING ANALYSIS RESULTS**

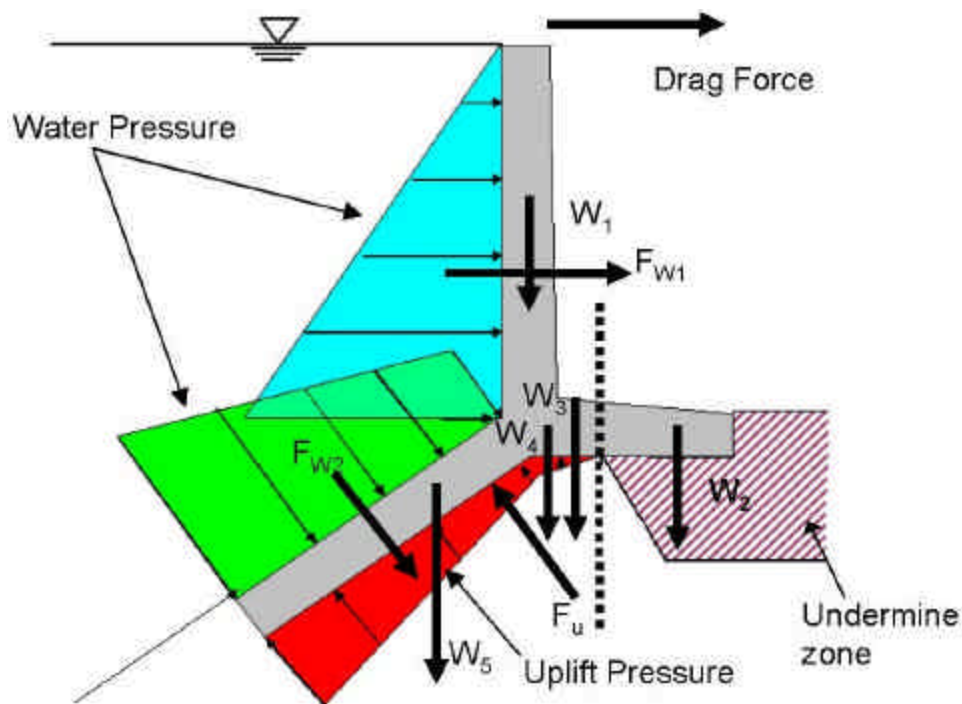
**FIGURE 8-12**

The forces considered for this analysis are illustrated below on **Figure 8-12** with the results shown on **Figure 8-13**. The results indicate that the Wall becomes unstable when undercutting penetrates about three feet under the wall. This analysis is two dimensional, and therefore for the Wall segment to actually fail, the entire 60 feet long Wall Segment would have to be undermined to this degree. We observe that Wall Segment 72 shown on **Figure 8-5** was probably “saved” by three dimensional action and the Wall Segments 44 to 56 shown on **Figure 8-6** were not undermined enough to result in an unstable situation.

**NEW OVERTURNING ANALYSIS WITH UNDERMINING**

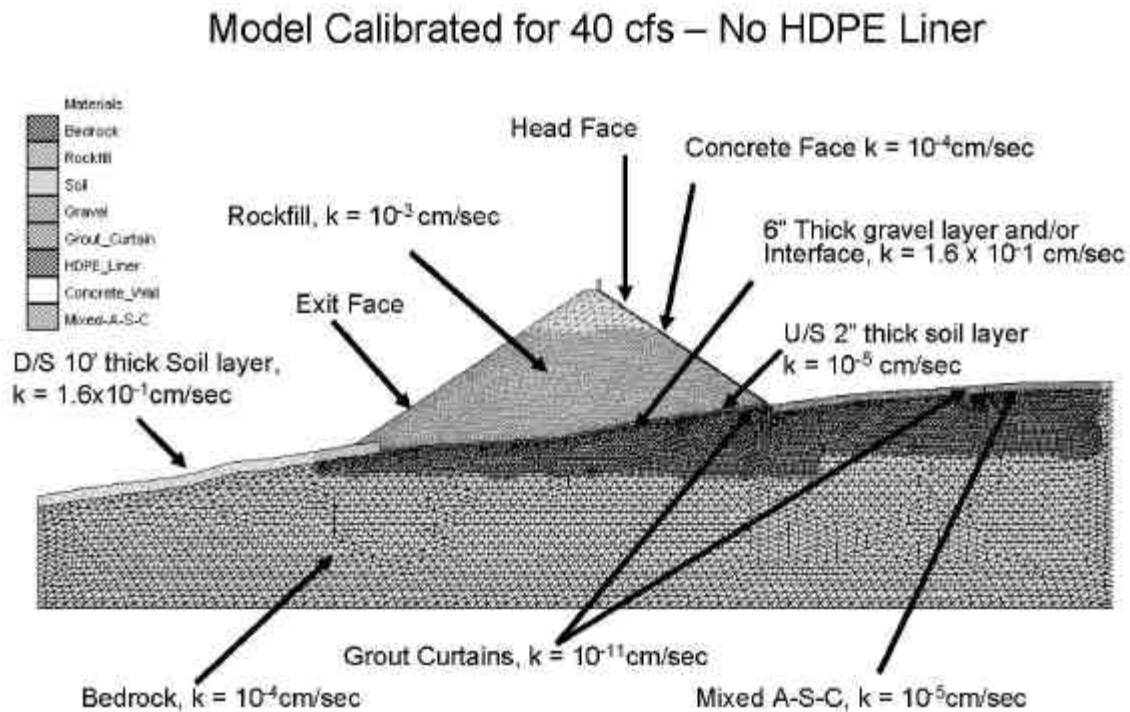
**FIGURE 8-15**

reported by AmerenUE. We then adjusted slightly our estimates to affect a reasonable match between our estimate of seepage and AmerenUE's values. The model used for this calibration model is shown on **Figure 8-15** and the phreatic surface and flow net is shown on **Figure 8-16**. Calculations are provided in **Appendix F**.

### **CALIBRATION MODEL**

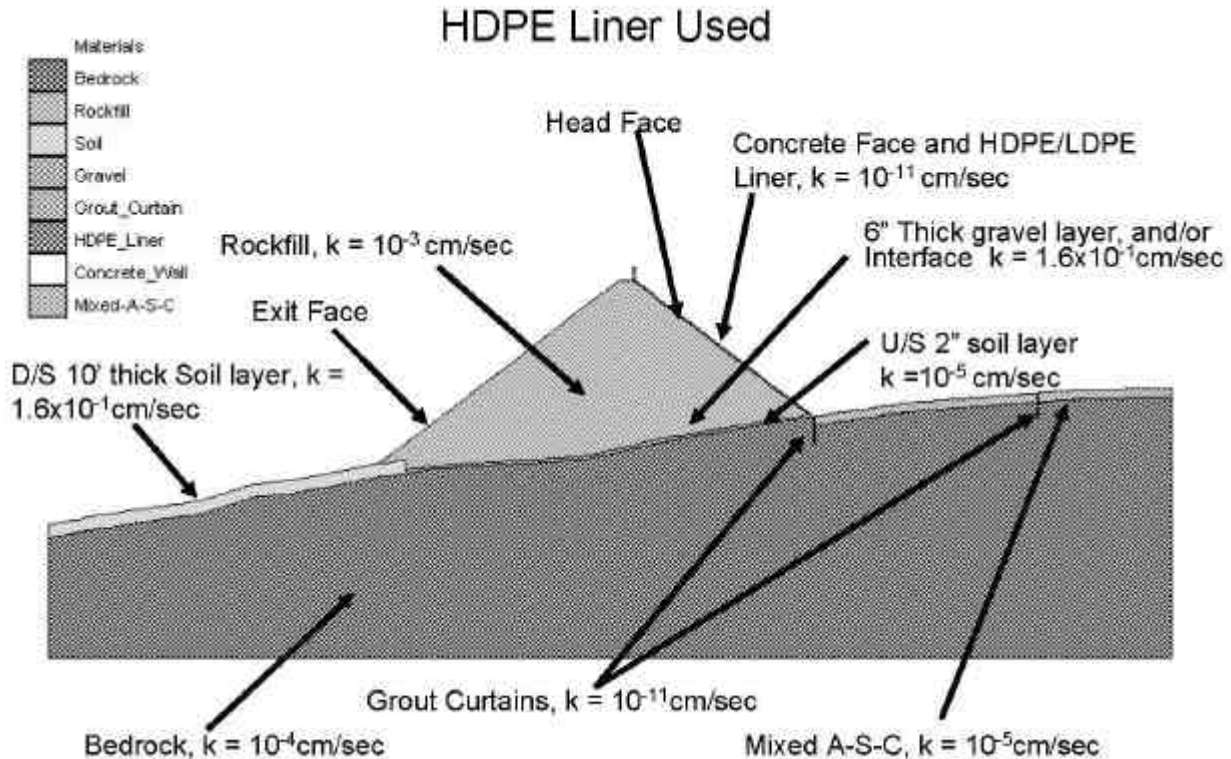
**FIGURE 8-17**

After calibrating the model shown on **Figure 8-15** and adding the HDPE Liner on the upstream face of the Dike, we performed a series of seepage analysis runs on the “Best Estimate” Model developed on **Figure 8-15** and modified to include the HDPE/LDPE Liner as shown in **Figure 8-17**. The resulting flow net shown on **Figure 8-18** indicates that the Liner significantly changed

the flow regime, dropping the phreatic surface to the level of the interface. This change increases the factor of safety for wedge failures along the interface significantly.

**BEST ESTIMATE SEEPAGE MODEL WITH LINER**

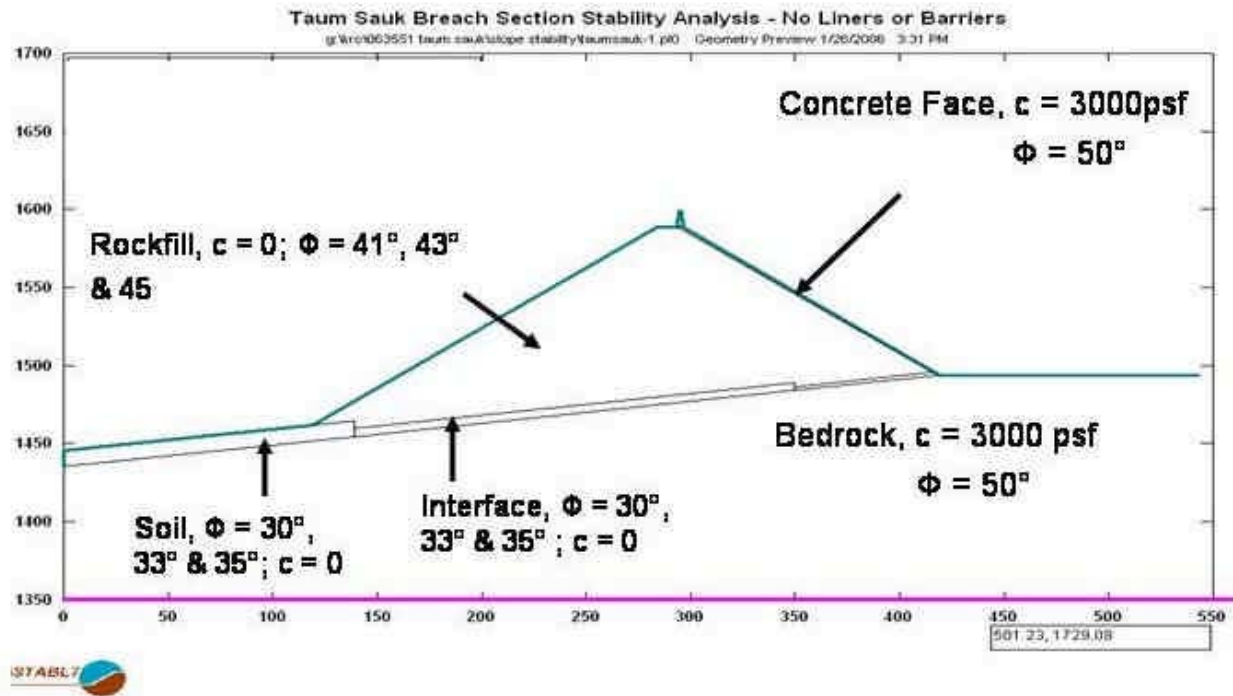
**FIGURE 8-21**

*Figure 8-21* below indicates the properties selected for the Best Estimate Cases and the parametric runs and *Table 8-2* describes the basis for selection

**SLOPE STABILITY ANALYSIS – MATERIAL PROPERTIES**
