5.200 BCRSD, Rollingwood Plat #1
Boone County
#MO-0038792

LETTER OF WARNING RESPONSE REQUIRED

Missouri Department of Natural Resources
Northeast Regional Office
Report of Inspection
BCRSD, Rollingwood Plat #1
Boone County
#MO-0038792
May 13, 2016

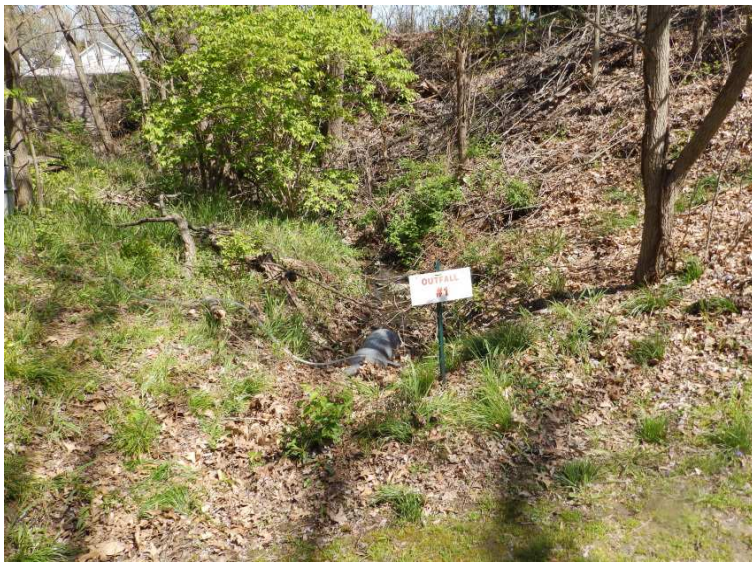
Photo #: 01
By: Michael Heaton
Facility: BCRSD, Rollingwood Plat #1
Permit: #MO-0038792
Location: Boone County

Description: Outfall location. The outfall location was the start of the tributary. A sign was present marking the outfall location.

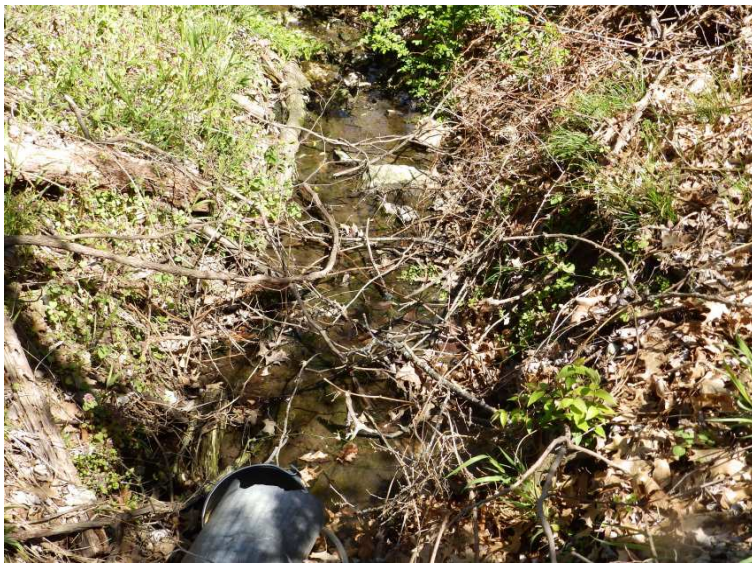
Photo #: 02
By: Michael Heaton
Facility: BCRSD, Rollingwood Plat #1
Permit: #MO-0038792
Location: Boone County

Description: Start of the tributary.

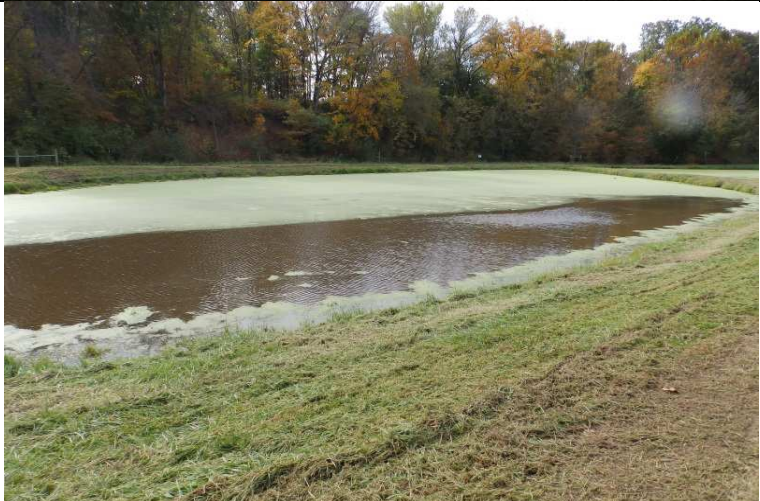
Photograph #: 3
Taken by: Leland Maize
Entity: BCRSD South Route K Wastewater Treatment Facility
Permit: #MO-0087173
Location: Boone County
Description: Tertiary cell of the lagoon system.
Date Taken: October 20, 2016
Program: WPC Unit

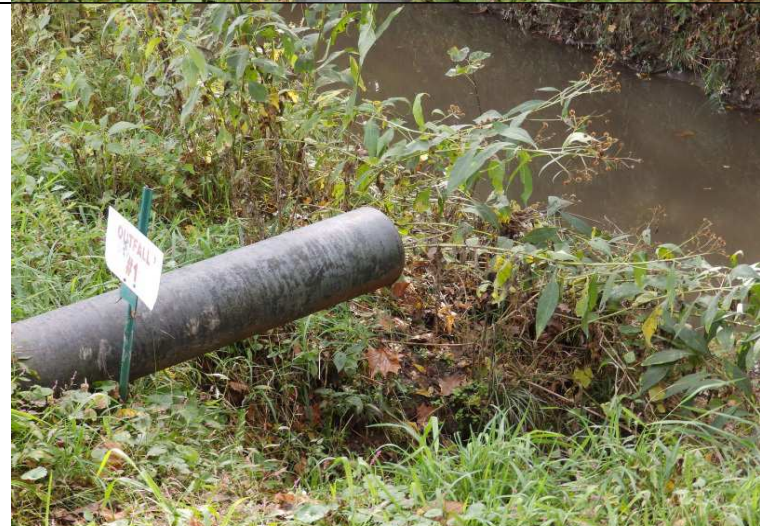
any damage to the lagoon berms or any signs of leaks. Each of the lagoon cells had greater than two feet of storage remaining at the time of the inspection. I observed Outfall #001 was marked in the field with a sign, but was not discharging during the inspection (Photo #4 and #5). I observed the receiving stream both upstream and downstream from Outfall #001. I did not observe any impact from Outfall #001 on the receiving stream.

Photograph #: 5
Taken by: Leland Maize
Entity: BCRSD South Route K Wastewater Treatment Facility
Permit: #MO-0087173
Location: Boone County
Description: Outfall #001 not discharging during the inspection.
Date Taken: October 20, 2016
Program: WPC Unit

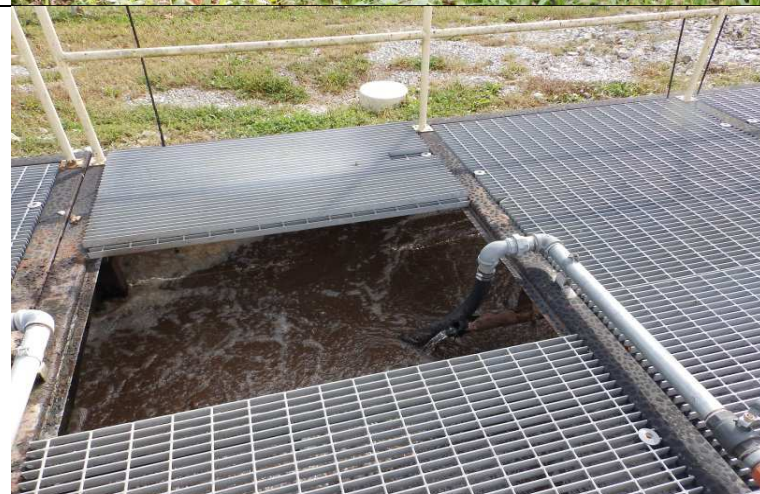
Outfall #002 discharges effluent from an extended aeration mechanical plant (Photo #6). Sludge from the mechanical plant is taken to a permitted wastewater treatment facility. The mechanical plant consists of an extended aeration basin, clarifier, and sludge storage. During the inspection, the aerators were functioning in the aeration basin and no dead areas were observed. The water in the aeration basin was light brown in color and had an earthy odor. The water in the clarifier appeared clear at the time of the inspection. I observed Outfall #002. The outfall was marked in the field with a sign and was discharging. I collected samples of the effluent from Outfall #002 for water quality field monitoring and laboratory analyses. I observed the receiving stream both upstream and downstream from Outfall #002. I did not observe any impact from Outfall #002 on the receiving stream.

Photograph #: 6
Taken by: Leland Maize
Entity: BCRSD South Route K Wastewater Treatment Facility
Permit: #MO-0087173
Location: Boone County
Description: Aeration basin in the mechanical plant. The aerators were functioning during the inspection.
Date Taken: October 20, 2016
Program: WPC Unit

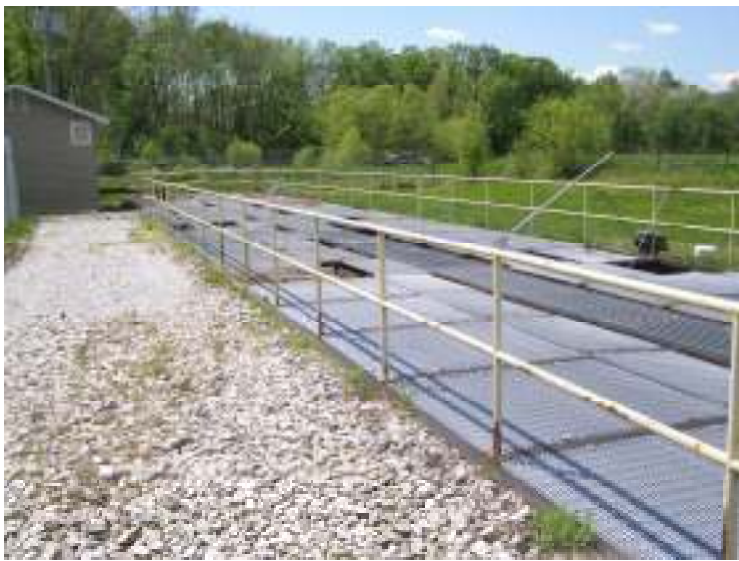
Photo #: 1
By: Stephen Moss
Facility: BCSD, South Route K Waste Water Treatment Facility
Permit: #MO-0087173
Location: Boone County

Description: View of the extended aeration plant.

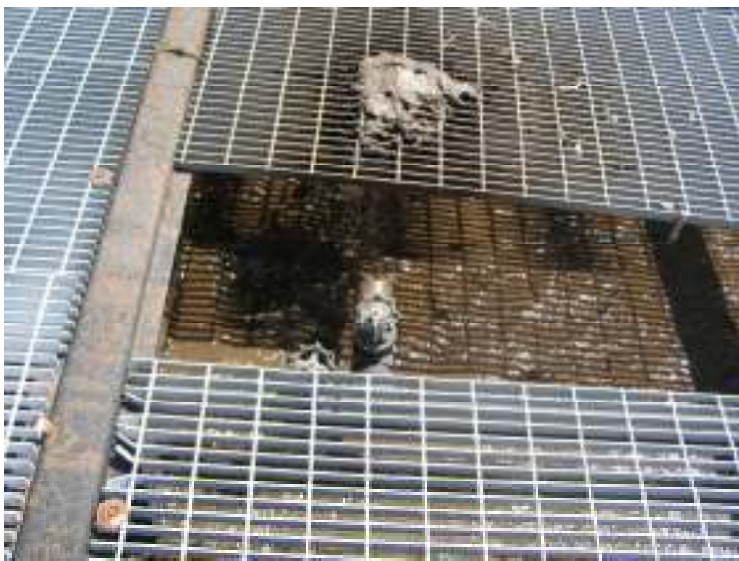
Photo #: 2
By: Stephen Moss
Facility: BCSD, South Route K Waste Water Treatment Facility
Permit: #MO-0087173
Location: Boone County

Description: View of the extended aeration plant

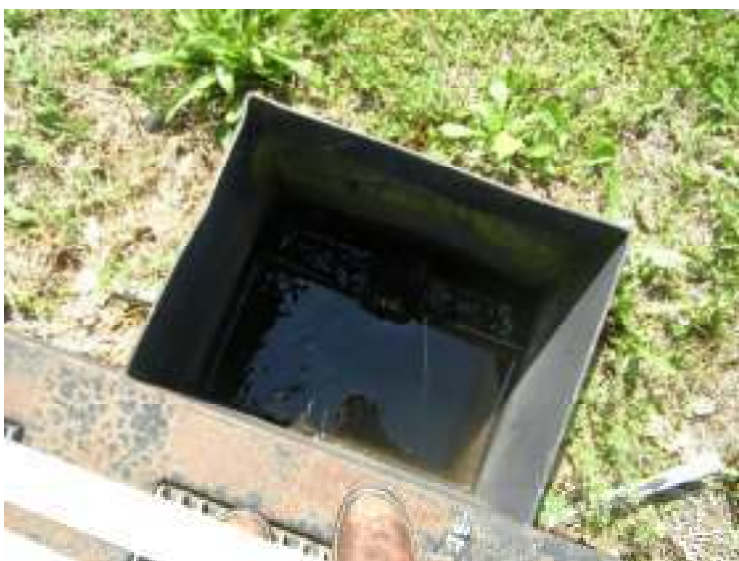
Photo #: 3
By: Stephen Moss
Facility: BCSD, South Route K Waste Water Treatment Facility
Permit: #MO-0087173
Location: Boone County

Description: View of the V-notch weir structure.

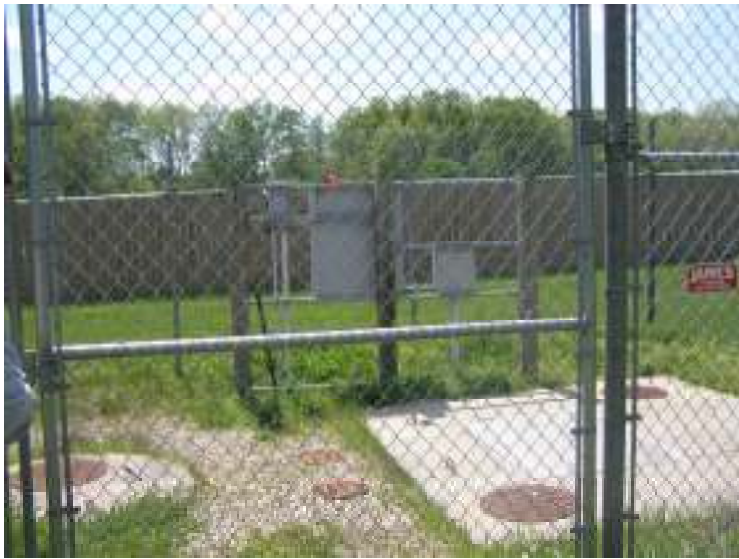
Photo #: 4
By: Stephen Moss
Facility: BCSD, South Route K Waste Water Treatment Facility
Permit: #MO-0087173
Location: Boone County

Description: View of the lift station.

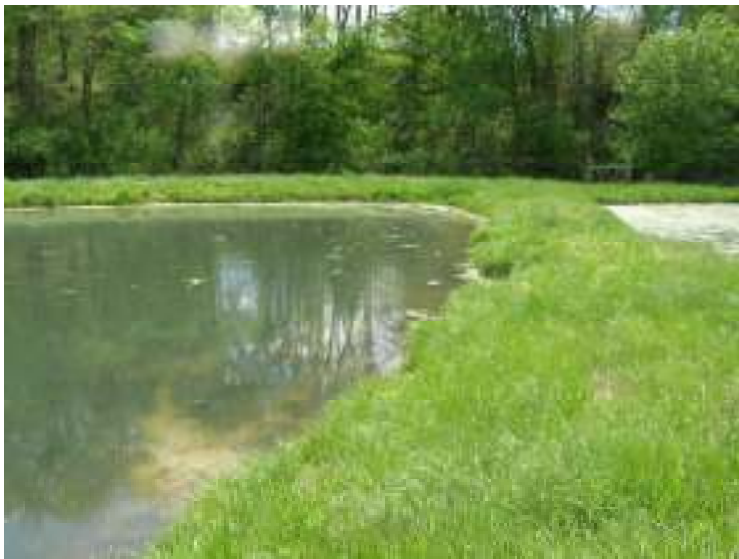
Photo #: 5
By: Stephen Moss
Facility: BCSD, South Route K Waste Water Treatment Facility
Permit: #MO-0087173
Location: Boone County

Description: View of the damaged lagoon berms on the third cell.

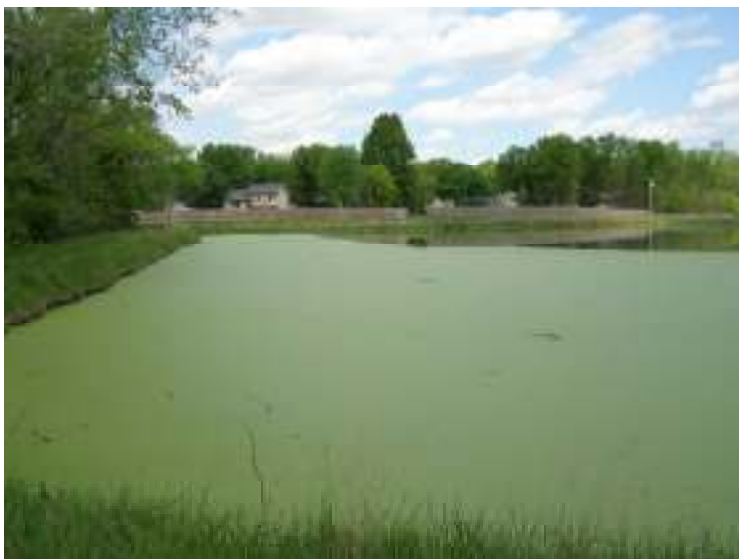
Photo #: 6
By: Stephen Moss
Facility: BCSD, South Route K Waste Water Treatment Facility
Permit: #MO-0087173
Location: Boone County

Description: View of the second cell of the lagoon.

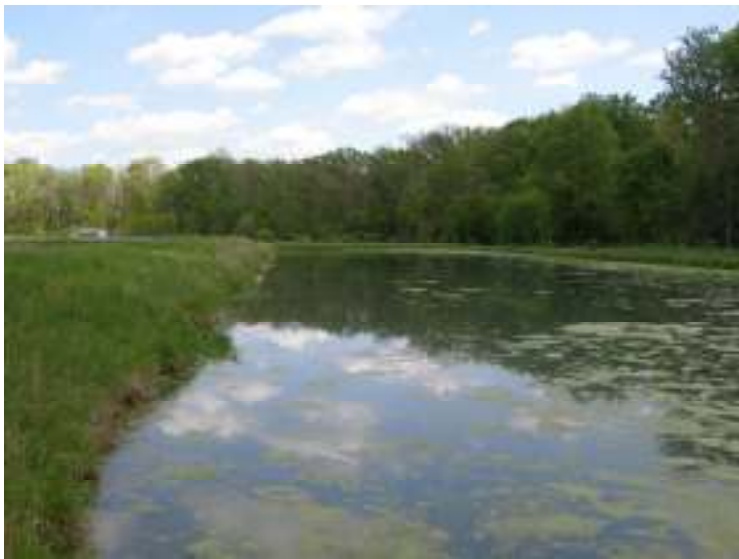
Photo #: 7
 By: Stephen Moss
 Facility: BCSD, South Route K Waste Water Treatment Facility
 Permit: #MO-0087173
 Location: Boone County

Description: View of the fourth cell of the lagoon.

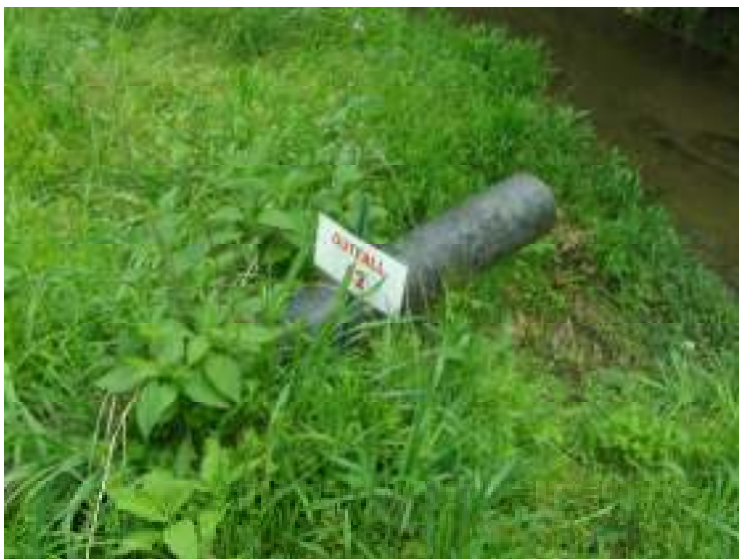
Photo #: 8
 By: Stephen Moss
 Facility: BCSD, South Route K Waste Water Treatment Facility
 Permit: #MO-0087173
 Location: Boone County

Description: View of Outfall #001 that is marked Outfall #002.

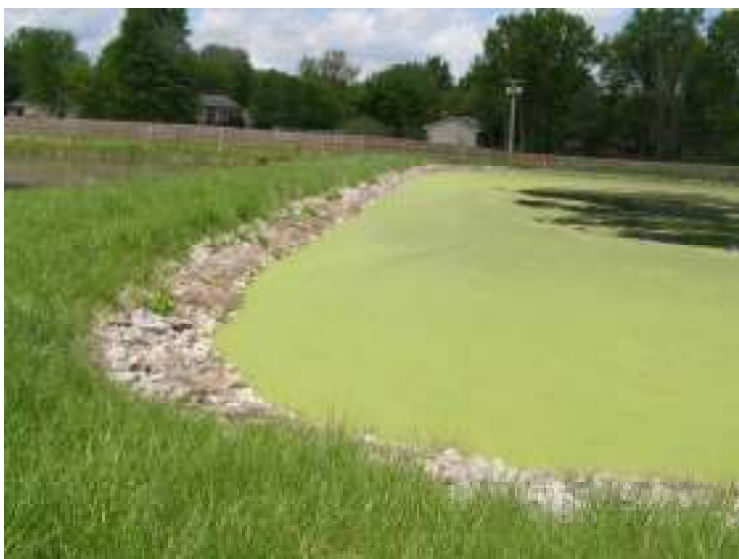
Photo #: 9
 By: Stephen Moss
 Facility: BCSD, South Route K Waste Water Treatment Facility
 Permit: #MO-0087173
 Location: Boone County

Description: View of the first cell of the lagoon.

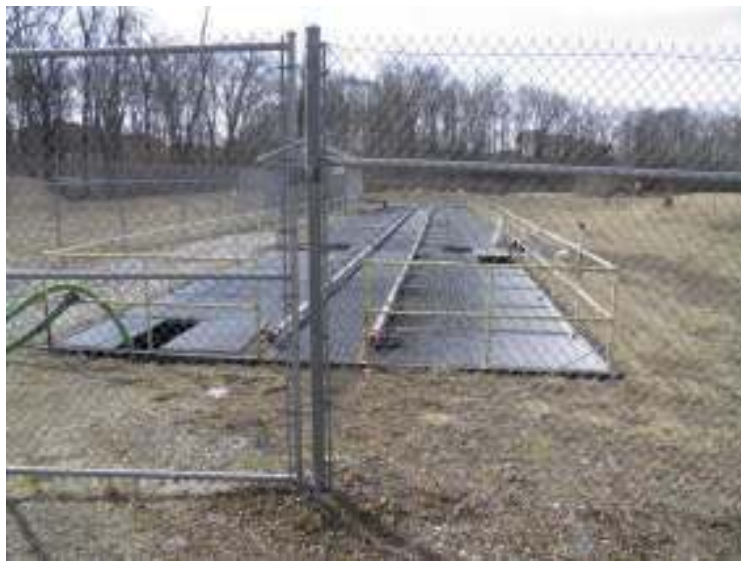
Photo #: 1
By: Mike Smith
Facility: BCSD - South Route K WWTF
Permit: #MO-0087173
Location: Boone County

Description: View of the extended aeration plant. Lock observed on gate to prevent unauthorized access. Perimeter fence was in good condition with signs observed posted on all sides.

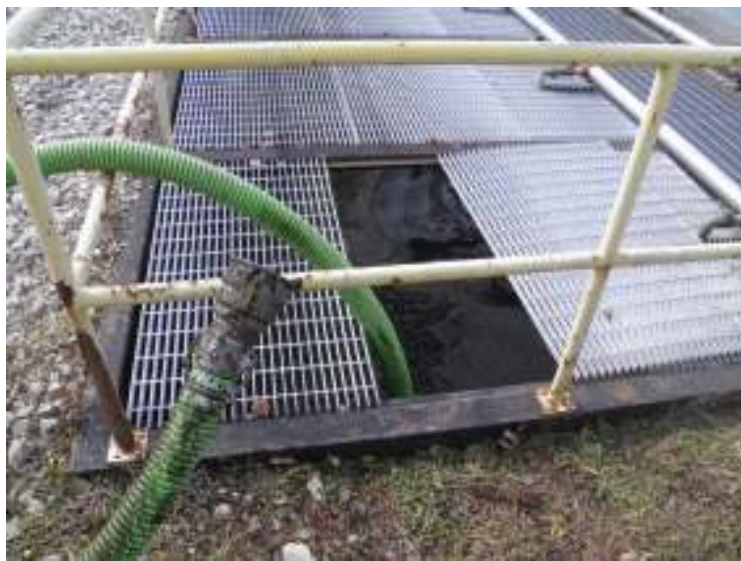
Photo #: 2
By: Mike Smith
Facility: BCSD - South Route K WWTF
Permit: #MO-0087173
Location: Boone County

Description: View of the sludge holding tanks. Hose observed that had been used to pump sludge from the facility the day of the inspection, according to Mr. Cooksey.

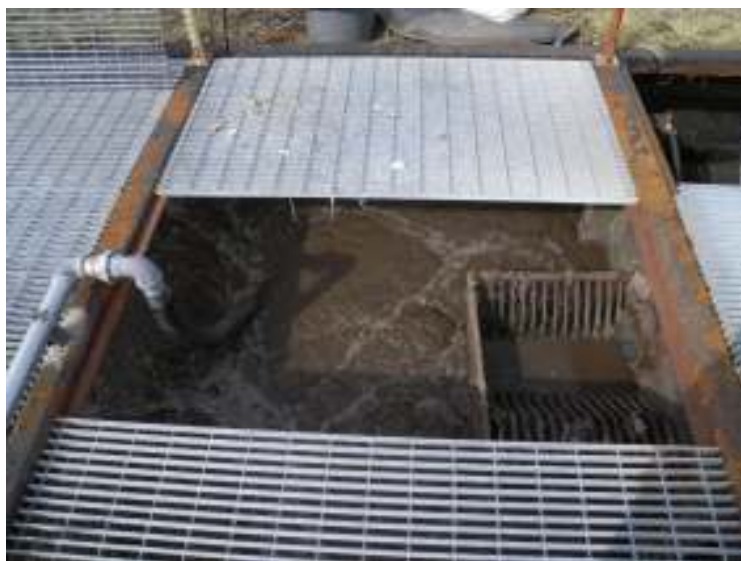
Photo #: 3
By: Mike Smith
Facility: BCSD - South Route K WWTF
Permit: #MO-0087173
Location: Boone County

Mr. Smith then observed the facility's aeration chambers (Photo #3). Aeration was occurring at the time of the inspection. The wastewater appeared brown in color, with minimal foaming observed. Mr. Smith then observed the facility's clarifiers (Photo #4). The water in the clarifiers appeared clear, with no concerns noted.

Description: View of aeration chamber. Aeration occurring at the time of the inspection. Wastewater appeared brown in color.

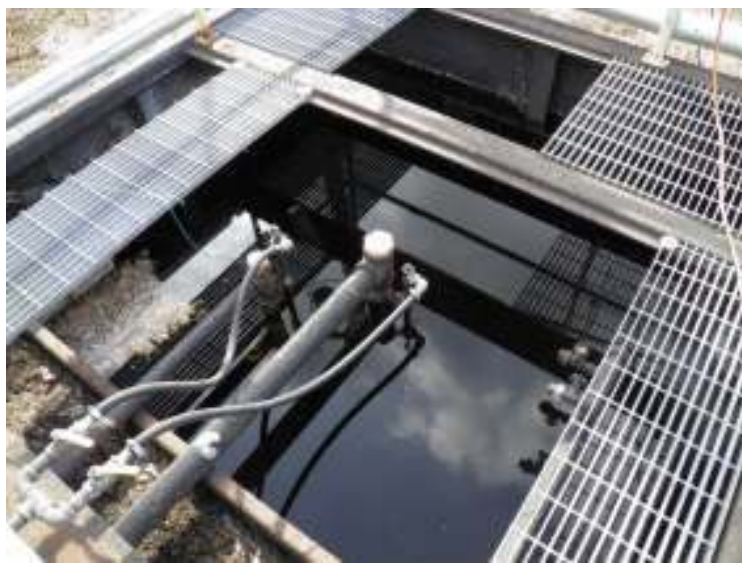
Photo #: 4
By: Mike Smith
Facility: BCSD - South Route K WWTF
Permit: #MO-0087173
Location: Boone County

Description: View of facility clarifier. Water in the clarifier appeared clear. No concerns noted.

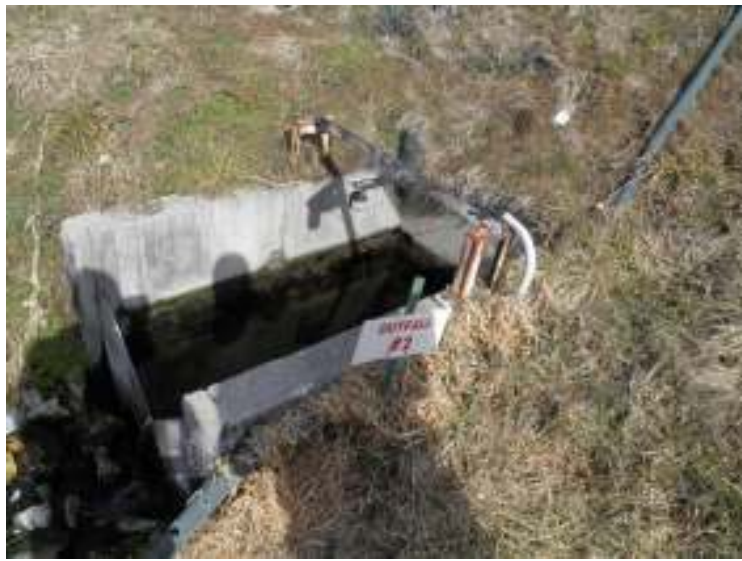
Photo #: 5
By: Mike Smith
Facility: BCSD - South Route K WWTF
Permit: #MO-0087173
Location: Boone County

Mr. Sublet then arrived at the facility. Mr. Smith observed Outfall #002. A sign marking the outfall location was observed (Photo #5). Effluent was discharging from the v-notch weir at the time of the inspection. The effluent appeared clear and no odor was detected in the area. Mr. Smith observed the unnamed tributary below the facility's outfall location (Photo #6). No evidence of a sludge discharge was observed in the tributary. Mr. Smith continued downstream and observed the location where the tributary enters a larger tributary to Little Boone Femme Creek. The water in the larger tributary appeared clear at the time of the inspection (Photo #7). No impact from the facility was observed in the tributary.

Description: View of sign marking Outfall #002. Effluent discharging from the v-notch weir. Effluent appeared clear with no odor detected.

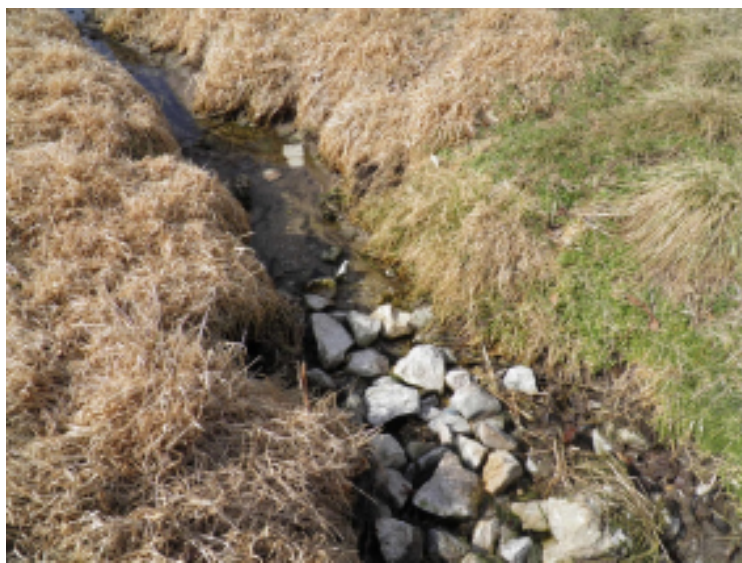
Photo #: 6
By: Mike Smith
Facility: BCSD - South Route K WWTF
Permit: #MO-0087173
Location: Boone County

Description: View directly downstream of the facility's outfall location. No concerns noted.

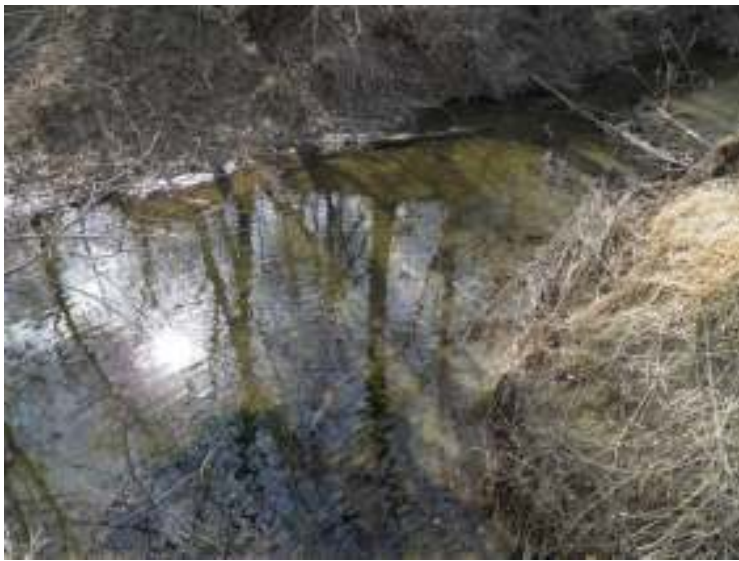
Photo #: 7
By: Mike Smith
Facility: BCSD - South Route K WWTF
Permit: #MO-0087173
Location: Boone County

Description: View of where the small tributary observed in Photo #6 enters a larger tributary to Little Boone Femme Creek. Water in the tributary appeared clear with no impacts from the facility observed.

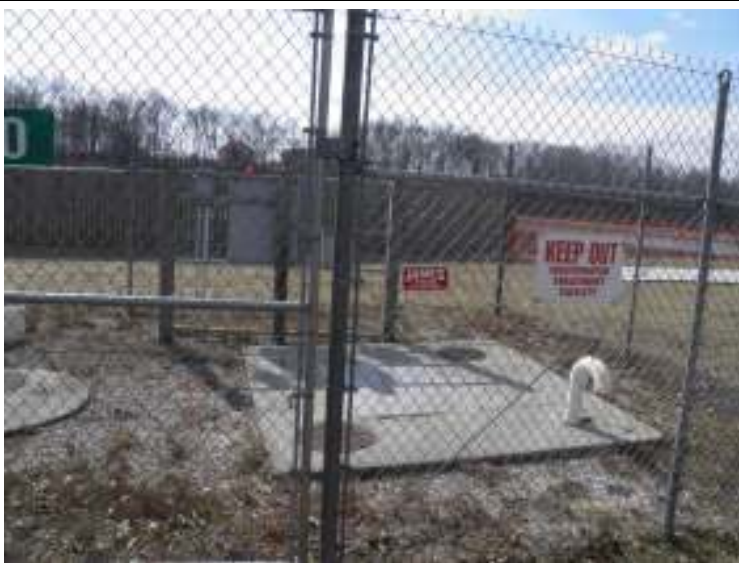
Photo #: 8
By: Mike Smith
Facility: BCSD - South Route K WWTF
Permit: #MO-0087173
Location: Boone County

Mr. Smith then made observations of the lift station just prior to the treatment plant and lagoon system (Photo #8). The lift station was surrounded by a fence with warning signs posted and a locked gate. Mr. Smith observed the control panel for the lift station (Photo #9). Both pumps were tested and appeared to be operating correctly. No alarm test button was available on the control panel. Inside of the wet well was observed (Photo #10). No buildup of grease or solids was observed.

Description: View of the lift station just prior to the extended aeration plant and lagoon system. Perimeter fence with locked gate and warning signs observed.

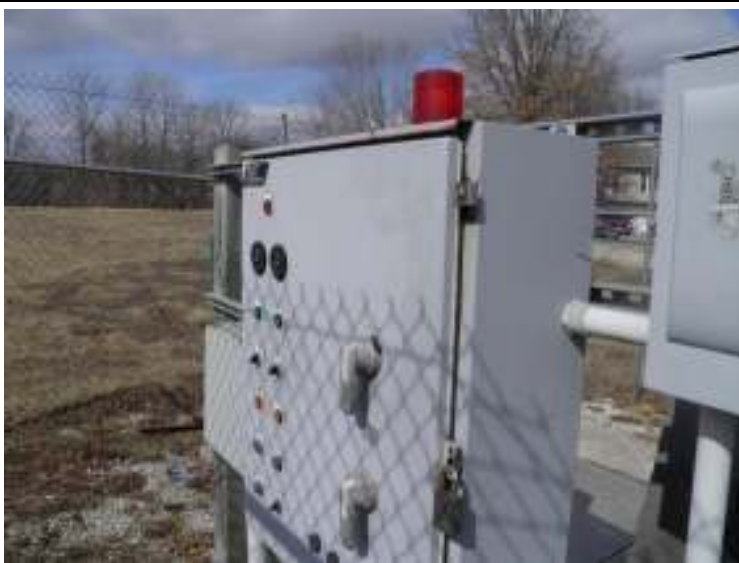
Photo #: 9
By: Mike Smith
Facility: BCSD - South Route K WWTF
Permit: #MO-0087173
Location: Boone County

Description: View of the control panel at lift station prior to the treatment plant. Both pumps tested and appeared to be functioning properly. No test for the alarm available.

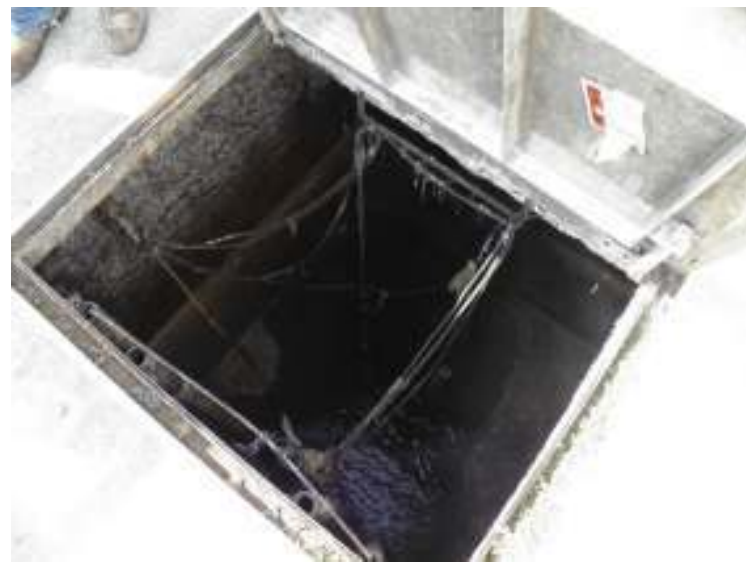
Photo #: 10
By: Mike Smith
Facility: BCSD - South Route K WWTF
Permit: #MO-0087173
Location: Boone County

Description: View inside the wet well at the lift station prior to the treatment plant. No concerns inside the wet well observed.

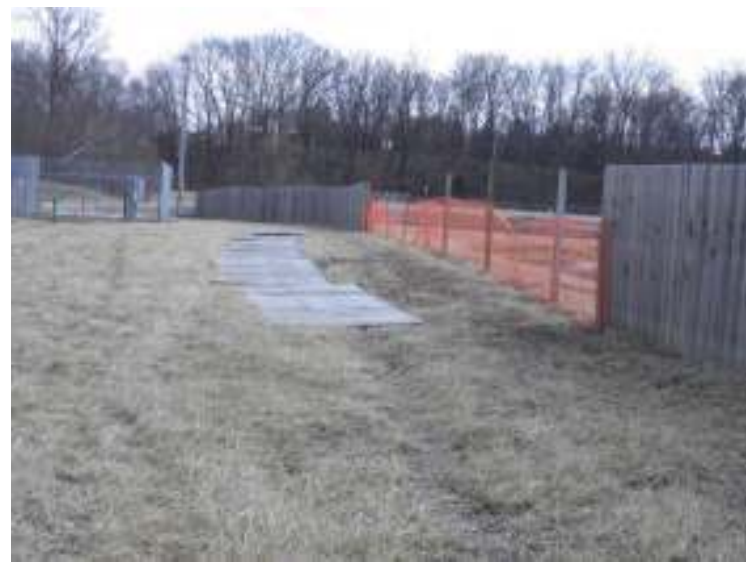
Photo #: 11
By: Mike Smith
Facility: BCSD - South Route K WWTF
Permit: #MO-0087173
Location: Boone County

Mr. Smith then made observations of the four-cell lagoon system. The gate to the lagoon system was locked upon arrival and a warning sign was observed posted on the gate. Part of the wooden perimeter fence around the facility was observed to be down on the ground (Photo #11). Mr. Sublet stated that a recent wind storm had blown down the fence and the frozen ground has prevented the fence from being repaired. He stated they were hoping to repair the fence later in the week if the weather warms up enough. Mr. Smith observed plastic orange fencing in place of the wooden fence at the time of the inspection. The remainder of the perimeter fence around the facility appeared to be in good condition (Photo #12). Warning signs were observed posted on all sides of the fence.

Description: View of area in the perimeter fence around the lagoons where the wooden fence was down. Mr. Sublet stated a recent wind storm blew down the fence. Plastic orange fence observed in place of the wooden fence.

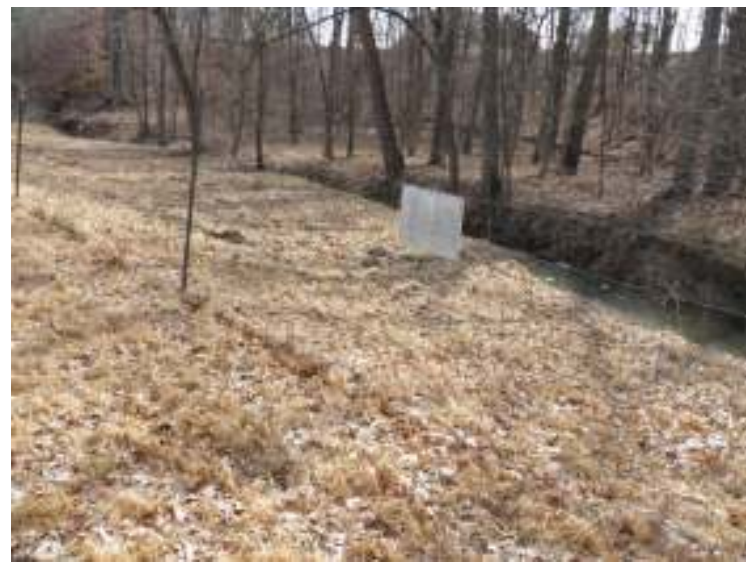
Photo #: 12
By: Mike Smith
Facility: BCSD - South Route K WWTF
Permit: #MO-0087173
Location: Boone County

Description: View of warning sign posted on the perimeter fence around the lagoon system.

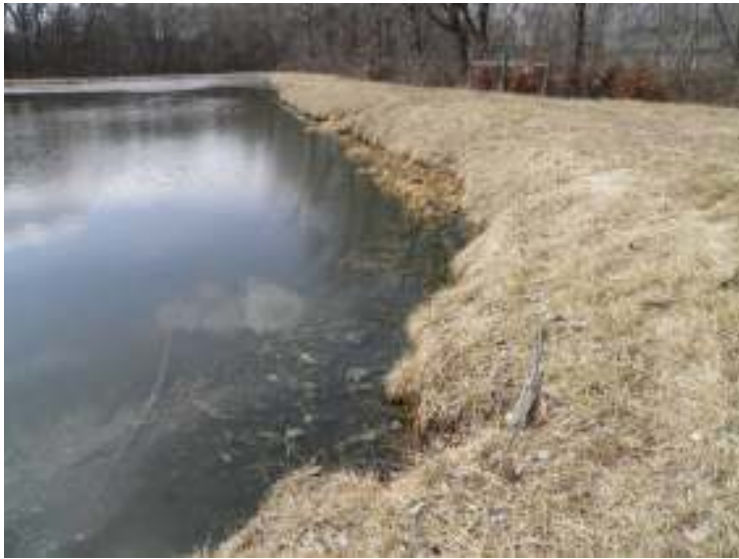
Photo #: 13
By: Mike Smith
Facility: BCSD - South Route K WWTF
Permit: #MO-0087173
Location: Boone County

The four lagoon cells were observed. Erosion damage and muskrat damage was observed on the inner lagoon berms of the first lagoon cell (Photo #13). Some duckweed was observed in the cell at the time of the inspection. Two feet of freeboard was available in the lagoon. No evidence of an unpermitted discharge through the lagoon berms was observed. No deep-rooted vegetation

Description: View of erosion and muskrat damage to the inner lagoon berms of the first lagoon cell.

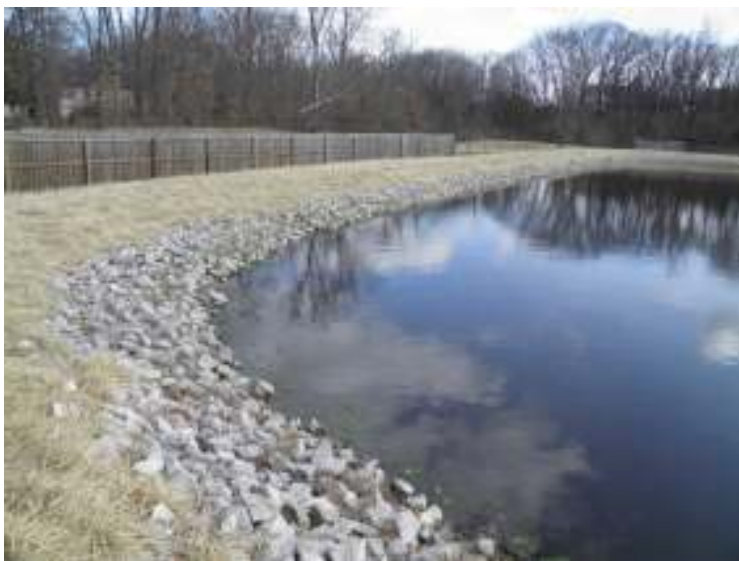
Photo #: 14
By: Mike Smith
Facility: BCSD - South Route K WWTF
Permit: #MO-0087173
Location: Boone County

was observed growing on the lagoon berms. According to the permit, the first cell of the lagoon is an aerated cell. No aerator was observed in the first cell of the lagoon. Mr. Smith observed the second lagoon cell. Rip-rap was observed on the inner berms of the second cell (Photo #14). The lagoon berms appeared to be in good condition. Over two feet of freeboard was available in the second cell. No evidence of an unpermitted discharge through the lagoon berms was observed. No deep-rooted vegetation was observed growing on the lagoon berms. The permit also lists the second lagoon cell as an aerated cell. An aerator was observed in the second cell, but was not functioning at the time of the inspection (Photo #15). Mr. Sublet stated they don't need to operate aerators since the lagoons receive very minimal flows and don't discharge.

Description: View of rip-rap observed on the inner lagoon berms of the second cell. Lagoon berms of the second cell appeared to be in good condition.

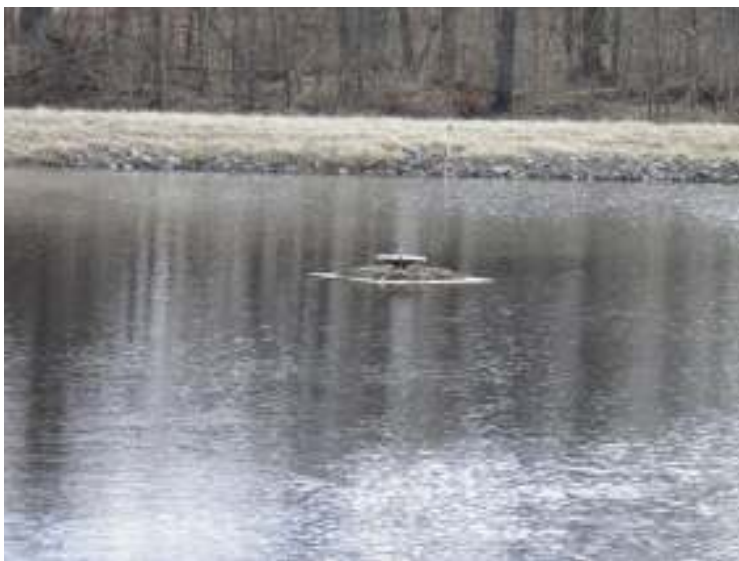
Photo #: 15
By: Mike Smith
Facility: BCSD - South Route K WWTF
Permit: #MO-0087173
Location: Boone County

Description: View of the aerator observed in the second lagoon cell. Aerator not functioning at the time of the inspection.

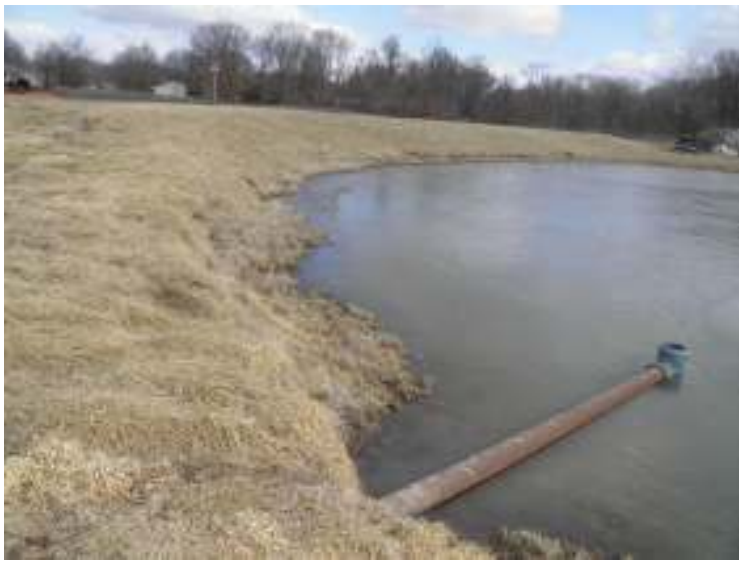
Photo #: 16
By: Mike Smith
Facility: BCSD - South Route K WWTF
Permit: #MO-0087173
Location: Boone County

Mr. Smith observed the third and fourth lagoon cells. Erosion damage was observed on the inner lagoon berms of both cells (Photos #16 & #17). No evidence of an unpermitted discharge was observed from either cell. Over two feet of freeboard was available in both the lagoons. No deep-rooted vegetation was discovered growing on the lagoon berms of either cell.

Description: View of erosion damage observed on the inner berms of the third lagoon cell.

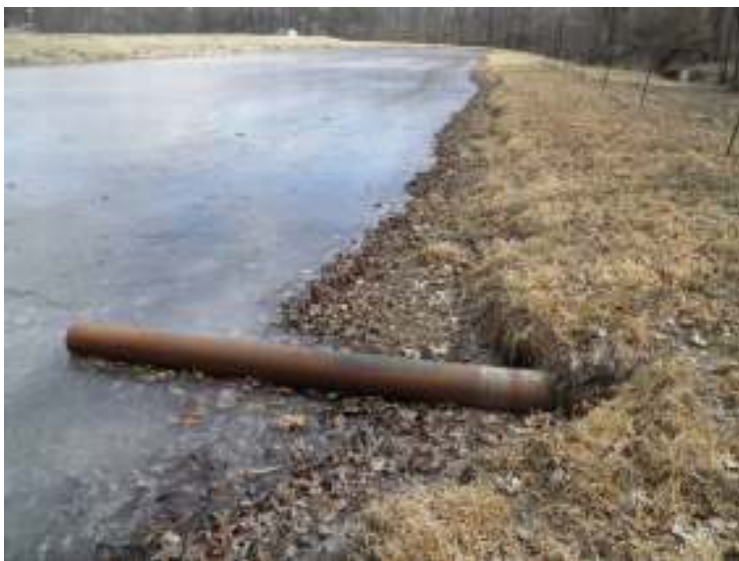
Photo #: 17
By: Mike Smith
Facility: BCSD - South Route K WWTF
Permit: #MO-0087173
Location: Boone County

Description: View of the eroded inner lagoon berms of the fourth lagoon cell. Inlet side of the discharge pipe observed.

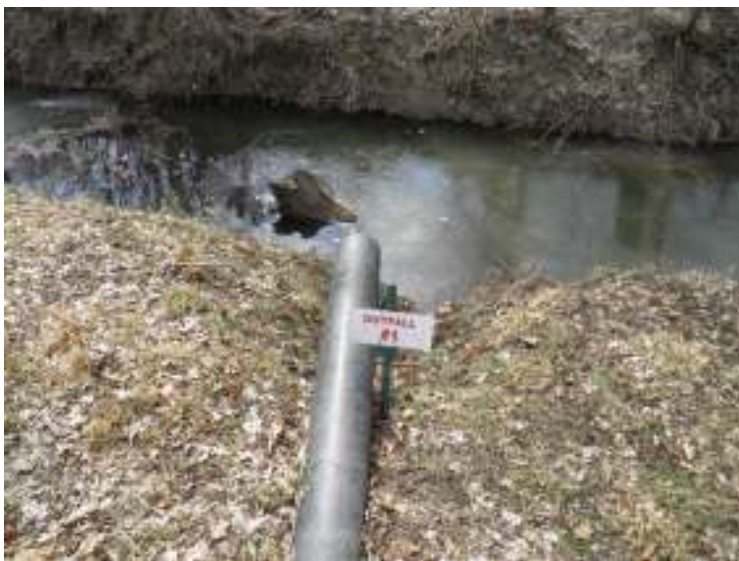
Photo #: 18
By: Mike Smith
Facility: BCSD - South Route K WWTF
Permit: #MO-0087173
Location: Boone County

Mr. Smith observed Outfall #001. The outfall location was marked with a sign in the field (Photo #18). The lagoon system was not discharging at the time of the inspection. The receiving stream was observed (Photo #19). No evidence of an impact from the lagoons was observed in the receiving stream.

Description: View of a sign marking Outfall #001. No discharge was occurring at the time of the inspection.

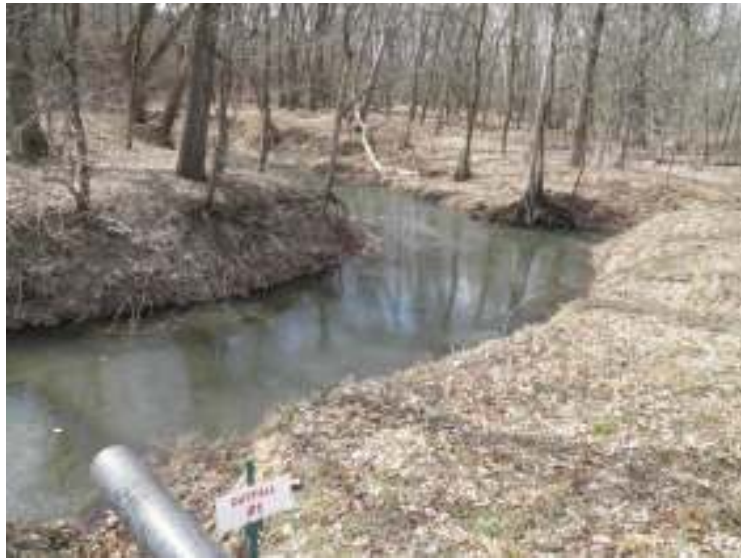
Photo #: 19
By: Mike Smith
Facility: BCSD - South Route K WWTF
Permit: #MO-0087173
Location: Boone County

Description: View of the receiving stream at Outfall #001. No impacts from the facility observed.

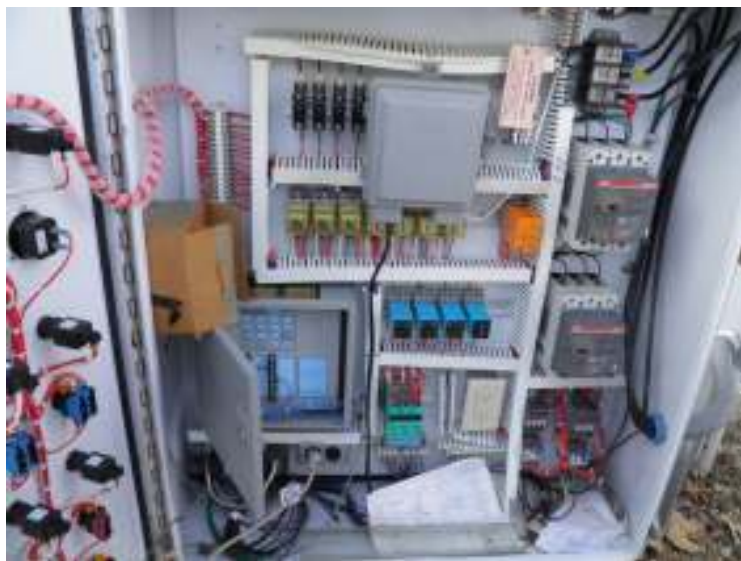
Photo #: 20
By: Mike Smith
Facility: BCSD - South Route K WWTF
Permit: #MO-0087173
Location: Boone County

Description: View inside the control panel at the lift station on the corner of New Meadow and Coneflower Streets. Both pumps tested and appeared to be functioning properly. No test for the alarm available.

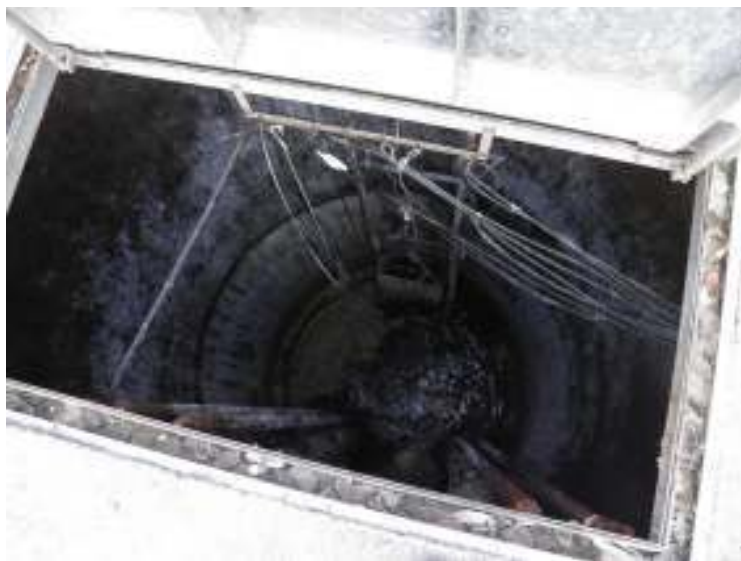
Photo #: 21
By: Mike Smith
Facility: BCSD - South Route K WWTF
Permit: #MO-0087173
Location: Boone County

Description: View inside the wet well at the lift station on the corner of New Meadow and Coneflower Streets. No concerns observed.

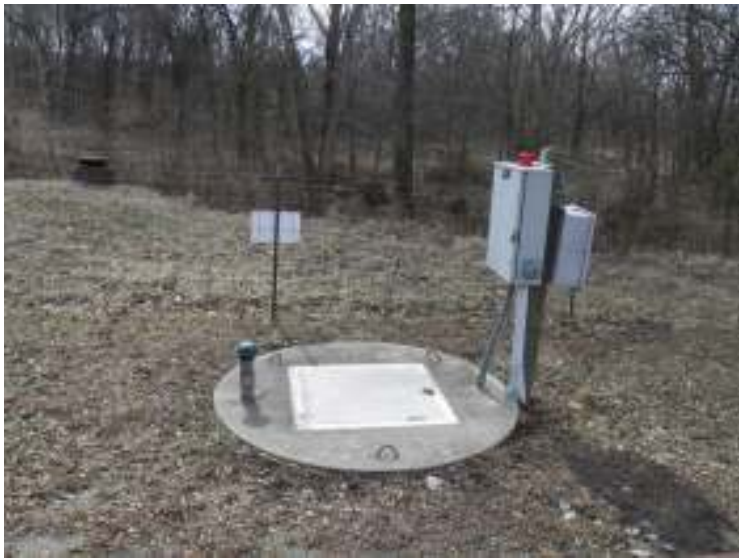
Photo #: 22
By: Mike Smith
Facility: BCSD - South Route K WWTF
Permit: #MO-0087173
Location: Boone County

Description: View of the lift station on Route K. No evidence of an overflow observed. Lift station surrounded by a fence with warning signs and a locked gate.

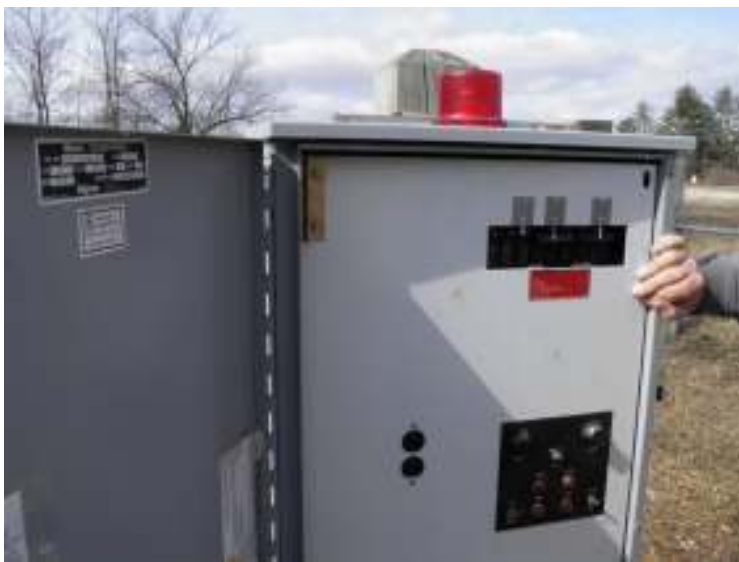
Photo #: 23
By: Mike Smith
Facility: BCSD - South Route K WWTF
Permit: #MO-0087173
Location: Boone County

Description: View of the control panel at the Route K lift station. Pumps tested and appeared to be working properly. Audiovisual alarm tested and did not activate and should be repaired.

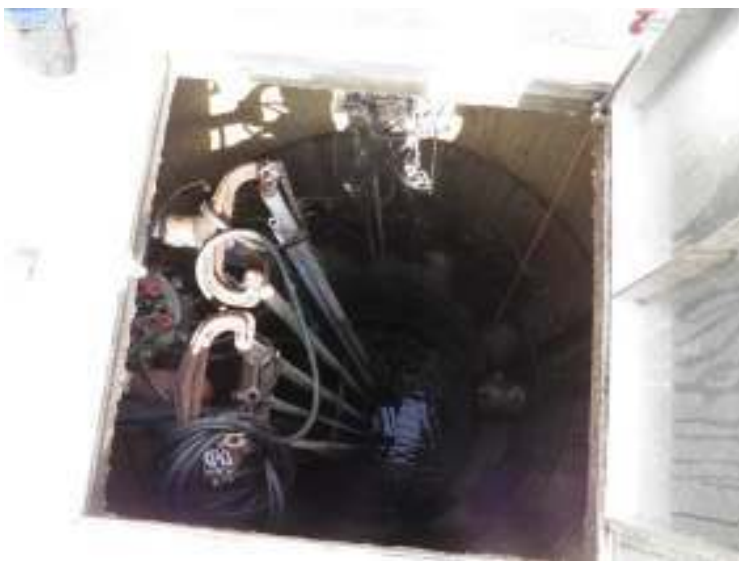
Photo #: 24
By: Mike Smith
Facility: BCSD - South Route K WWTF
Permit: #MO-0087173
Location: Boone County

Description: View inside the wet well at the Route K lift station. No concerns observed.

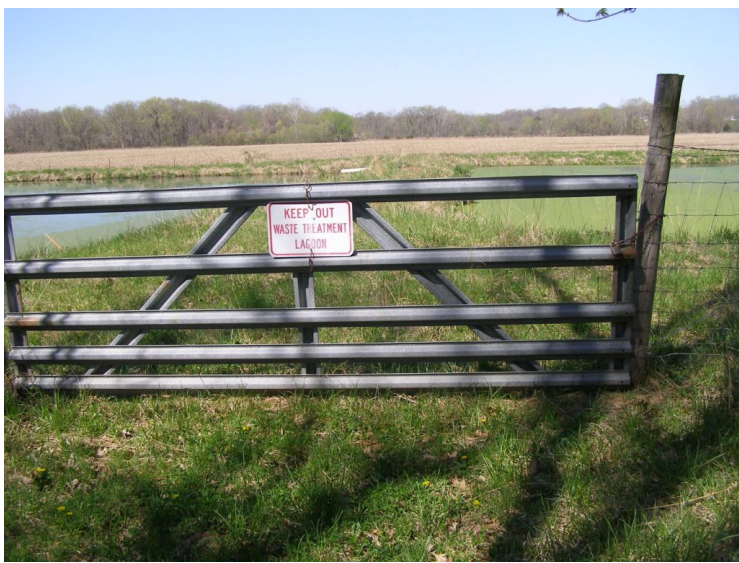
Photo #: 1 of 3
By: Mr. Sam Loyd
Facility: BCSD-Sugar Tree Hills Subdivision
Permit: MO-0083500
Location: Columbia, MO

Description: View of the entry gate with warning sign.

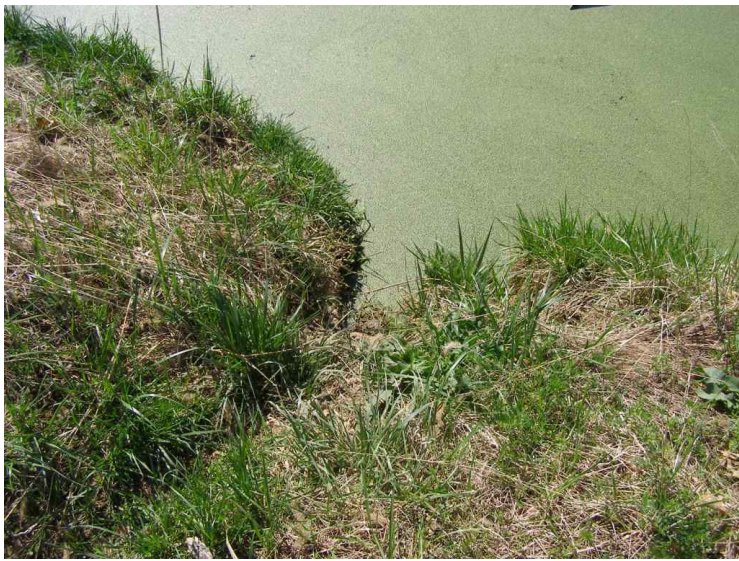
Photo #: 2 of 3
By: Mr. Sam Loyd
Facility: BCSD-Sugar Tree Hills Subdivision
Permit: MO-0083500
Location: Columbia, MO

1. Failed to maintain the inner berm slopes of the lagoon to be less than three to one (3:1) [10 CSR 20-8.020(13)(A)3.C.].

Description: View of the erosion around the transfer pipe between the two lagoon cells.

REQUIRED ACTION: The lagoon berms have developed erosion damage. The facility must monitor the erosion and take appropriate steps to prevent any unauthorized discharges from the berms due to the erosion damage, until the lagoon has been properly closed.

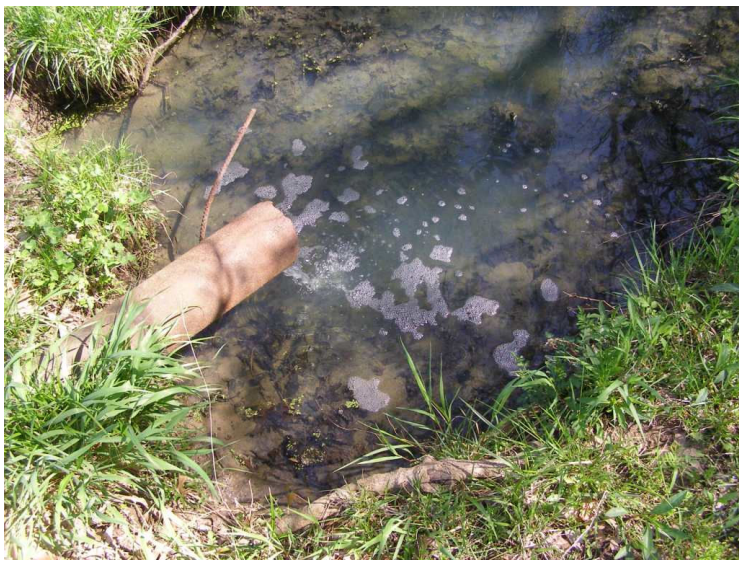
Photo #: 3 of 3
By: Mr. Sam Loyd
Facility: BCSD-Sugar Tree Hills Subdivision
Permit: MO-0083500
Location: Columbia, MO

Description: View of the outfall.

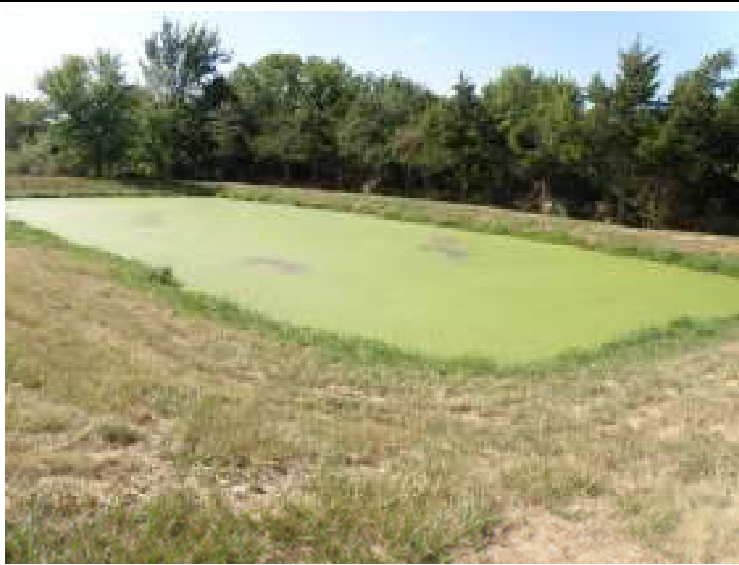
Photo #: 1
By: Leland Maize
Facility: BCSD, Sunnyslope WWTF
Permit: #MO-0095354
Location: Boone County

Description: Lagoon cell with sludge surfacing in two places. Duckweed covering the lagoon cell.

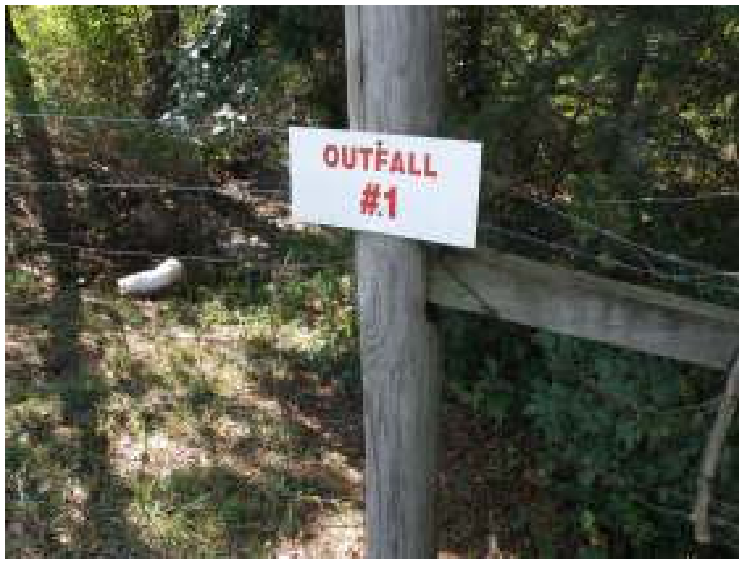
Photo #: 2
By: Leland Maize
Facility: BCSD, Sunnyslope WWTF
Permit: #MO-0095354
Location: Boone County

Description: Sign marking the facility's outfall.

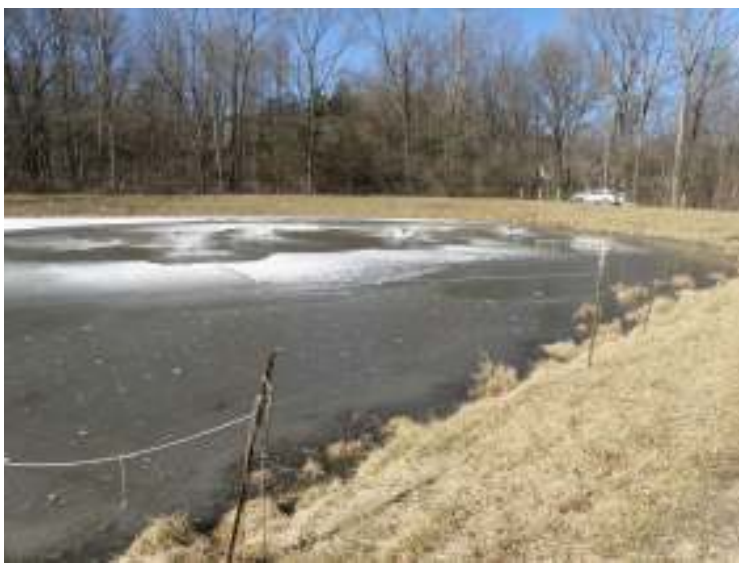
Photo #: 1
By: Leland Maize
Facility: BCSD, Trails West Subdivision
Permit: #MO-0092002
Location: Boone County

Description: Primary lagoon cell with aerators.
Inner berm has an uneven slope.
