5.200 BCRSD, Rollingwood Plat #1
Boone County
#MO-0038792

LETTER OF WARNING RESPONSE REQUIRED

Missouri Department of Natural Resources
Northeast Regional Office
Report of Inspection
BCRSD, Rollingwood Plat #1
Boone County
#MO-0038792
May 13, 2016

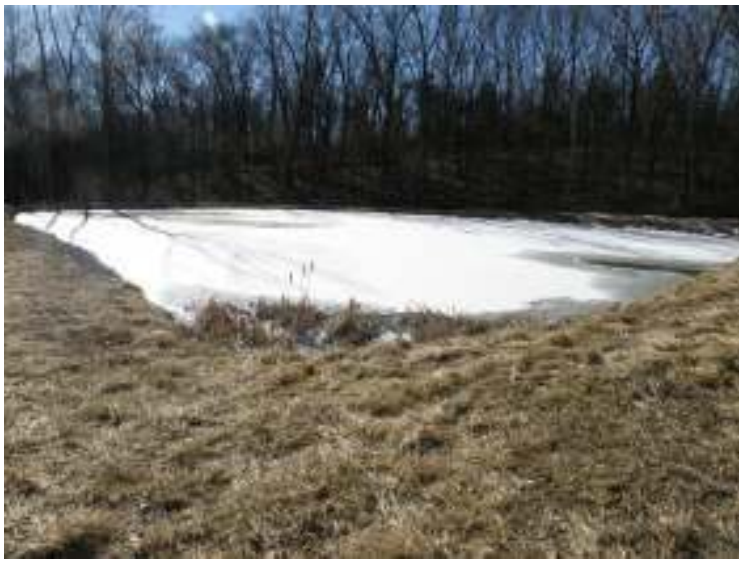
Photo #: 2
By: Leland Maize
Facility: BCSD, Trails West Subdivision
Permit: #MO-0092002
Location: Boone County

Description: Second lagoon cell. Covered with ice.
Cattails in the corner of the lagoon.

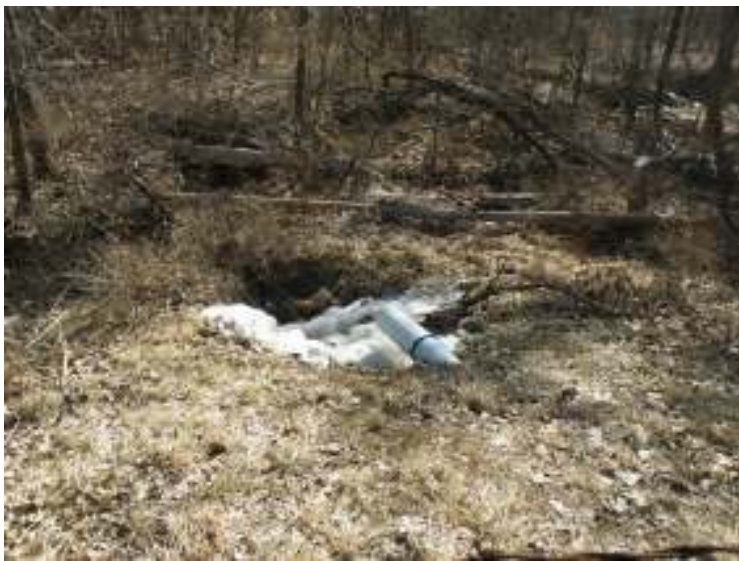
Photo #: 3
By: Leland Maize
Facility: BCSD, Trails West Subdivision
Permit: #MO-0092002
Location: Boone County

Description: Facility's Outfall. Ice observed below
the outfall.

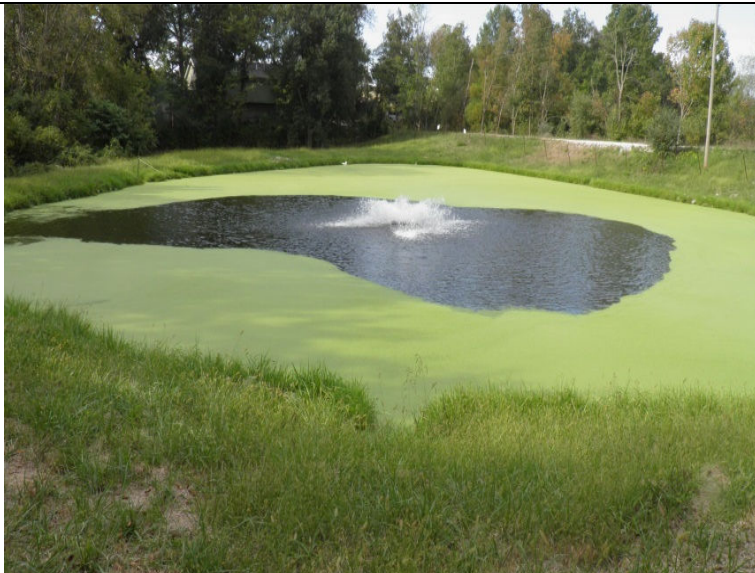
Photo #: 1
By: Mr. Michael Womack
Facility: BCSD Twin Lakes Subdivision
Permit: #MO-0101885
Location: Boone County

Description: Primary lagoon cell with aerator functioning. Inner lagoon berm damage on the north side of the primary lagoon cell is observed at the bottom of the photo.

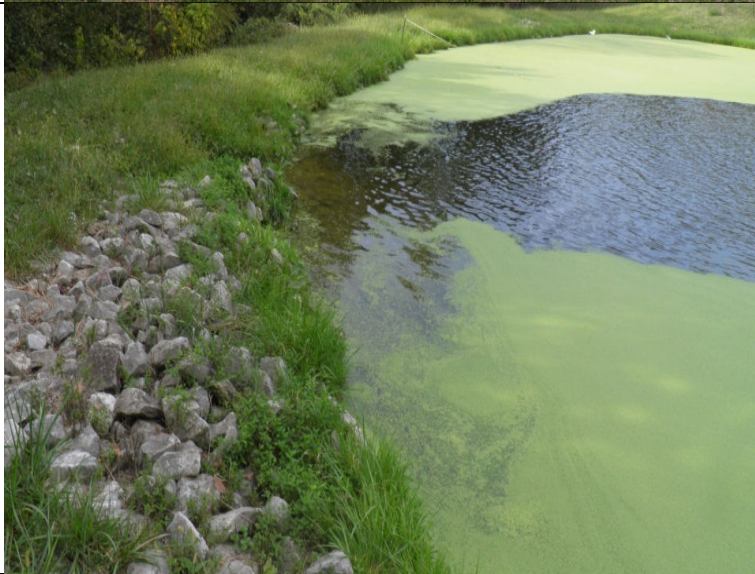
Photo #: 2
By: Mr. Michael Womack
Facility: BCSD Twin Lakes Subdivision
Permit: #MO-0101885
Location: Boone County

Description: Erosion damage is observed on the east side of the primary lagoon cell.

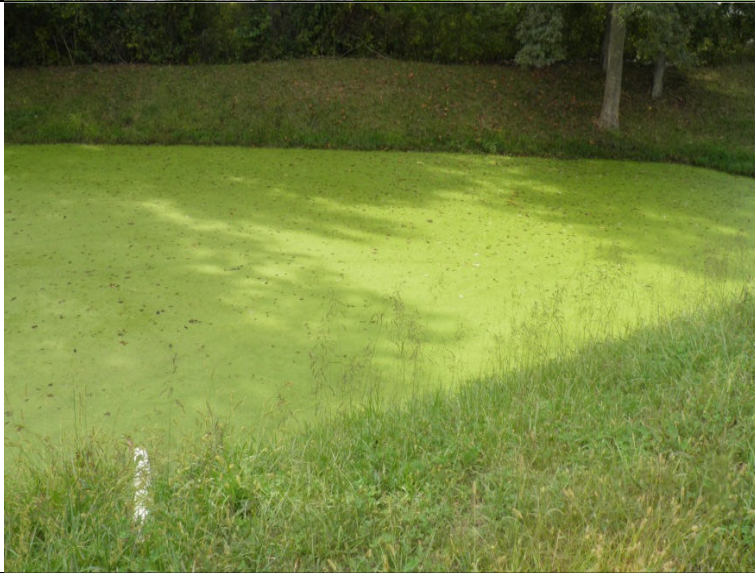
Photo #: 3
By: Mr. Michael Womack
Facility: BCSD Twin Lakes Subdivision
Permit: #MO-0101885
Location: Boone County

Description: Secondary lagoon cell that is covered with duckweed.

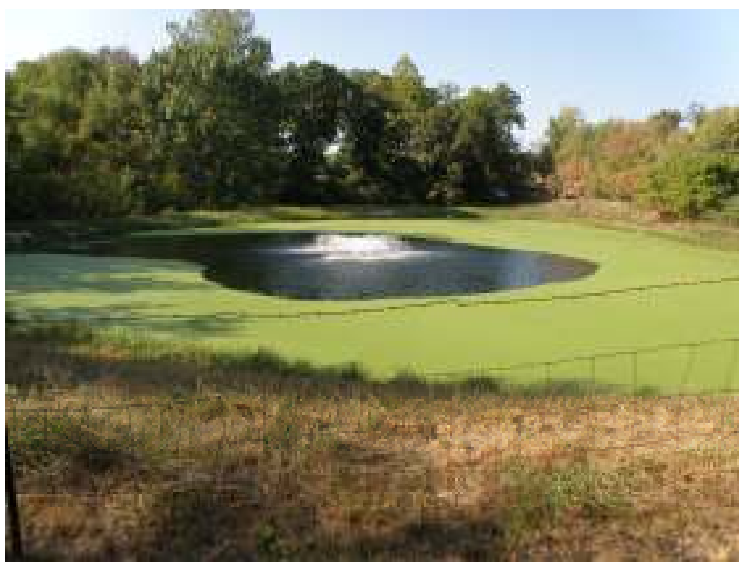
Photo #: 1
By: Leland Maize
Facility: BCSD, Twin Lakes Subdivision
Permit: #MO-0101885
Location: Boone County

Description: Primary lagoon cell with aerator functioning.

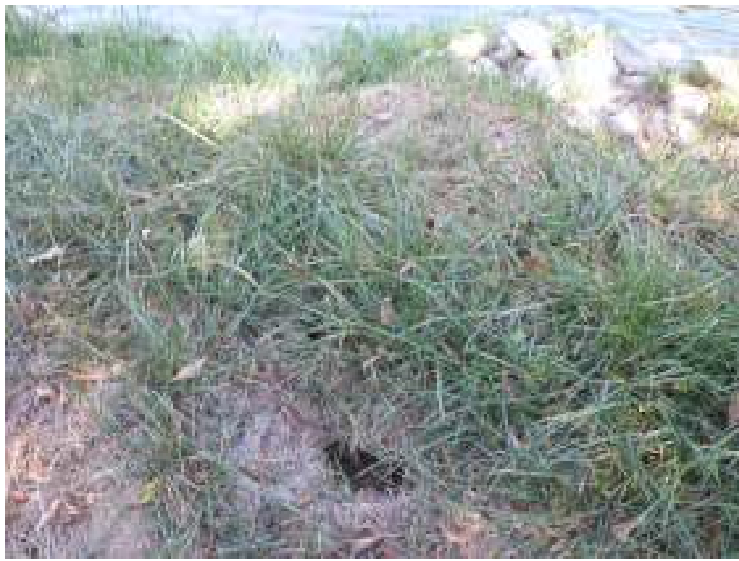
Photo #: 2
By: Leland Maize
Facility: BCSD, Twin Lakes Subdivision
Permit: #MO-0101885
Location: Boone County

Description: Hole observed on the outer lagoon berm.

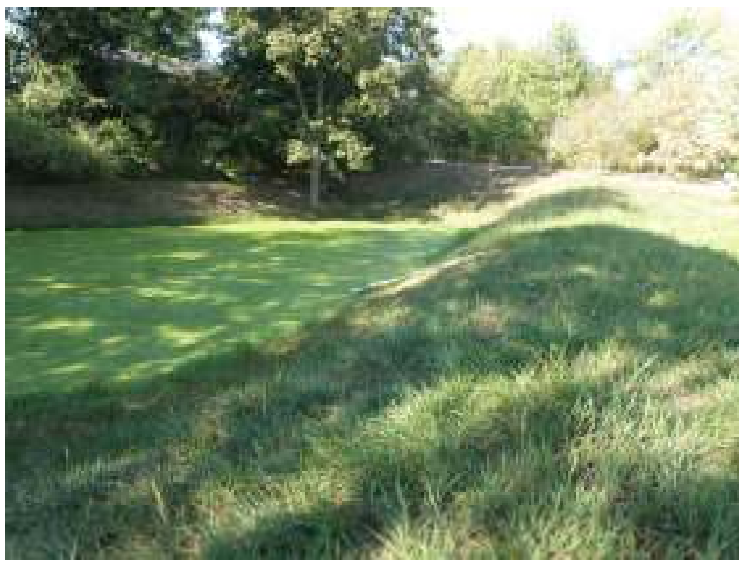
Photo #: 3
By: Leland Maize
Facility: BCSD, Twin Lakes Subdivision
Permit: #MO-0101885
Location: Boone County

Description: Second cell of lagoon. Covered with duckweed.
