**BEFORE THE PUBLIC SERVICE COMMISSION
OF THE STATE OF MISSOURI**

Case No. GS-2011-0248

STAFF'S FINAL REPORT

Gas Incident Report

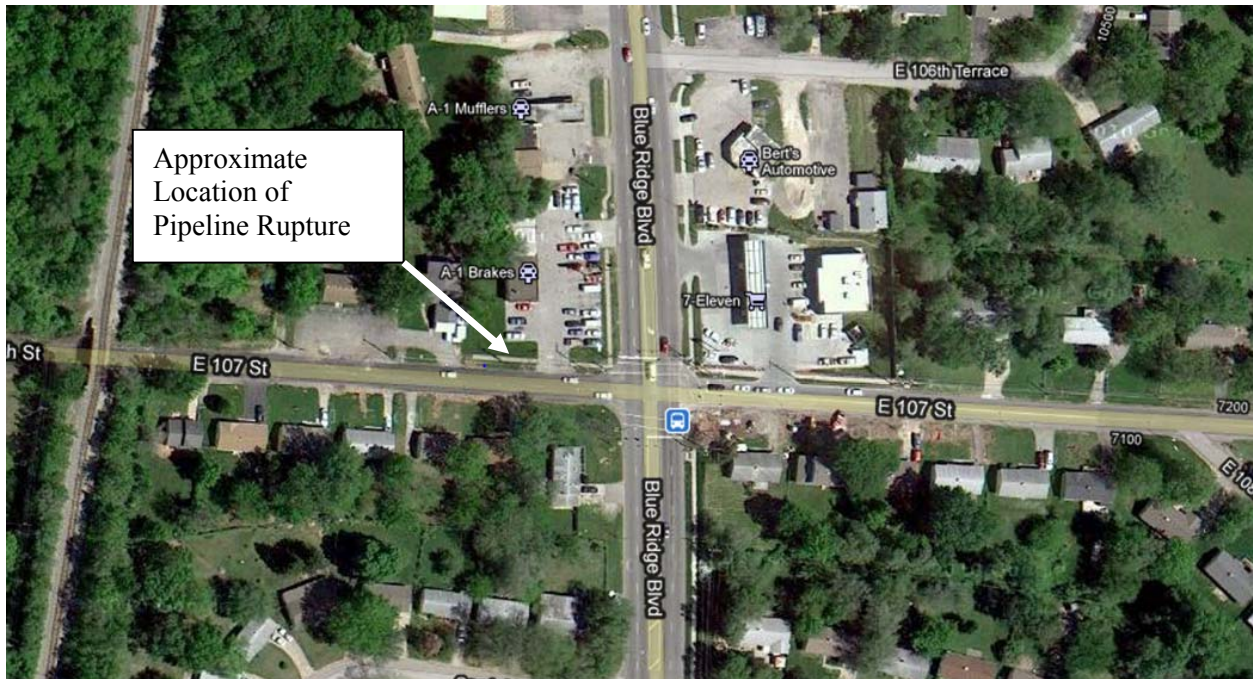
Figure 1: Approximate Location of Pipeline Rupture

The incident occurred in a Class 3¹⁷, HCA, near the intersection of 107th Street and Blue Ridge Boulevard in Kansas City, Missouri (see Figure 1). This area was determined to be an HCA using Method 2¹⁸ due to the proximity to several businesses and a daycare facility. The nearest building is the A-1 Auto Repair, located at the northwest corner of the intersection. The fracture occurred on cathodically protected, coated steel pipe located beneath the greenway on the north side of 107th Street, and adjacent to the parking lot of A-1 Auto Repair, approximately 35 feet south of the A-1 Auto Repair building (shown as A-1 Brakes and A-1 Mufflers on Figure 1).

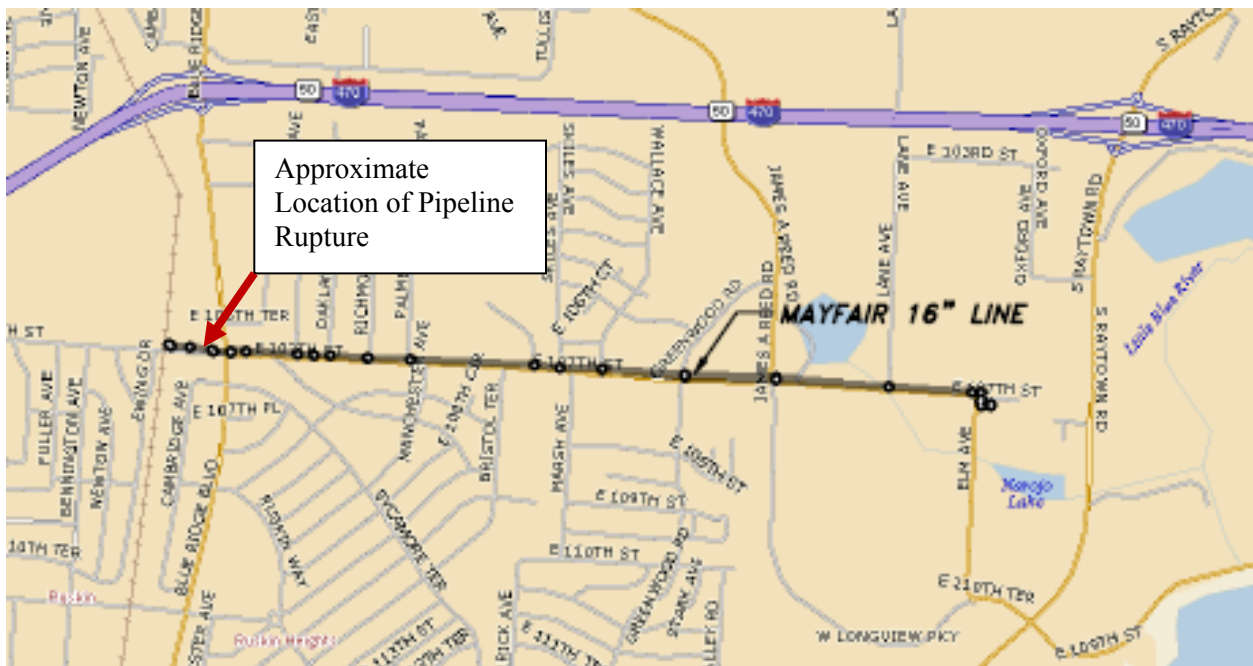
Figure 2: Mayfair 16-inch East Pipeline Involved in Incident

The Company odorizes the gas in the Mayfair 16-inch pipeline³⁵ and monitors odor intensity³⁶ at various locations monthly. The incident location is closest to the odor intensity monitoring location at 107th Street and Elm Avenue (see Figure 2, Elm Avenue is at the eastern terminus of the Mayfair 16-inch pipeline). On January 4, 2011, the Company determined that odorant
