Flinn Engineering, LLC
11216 Neumann Lane
Highland, Illinois 62249
618-550-8427
ksimpson@flinnengineering.com

March 14, 2022

Re: Engineering Report
Water and Wastewater Systems
Ironton, Missouri

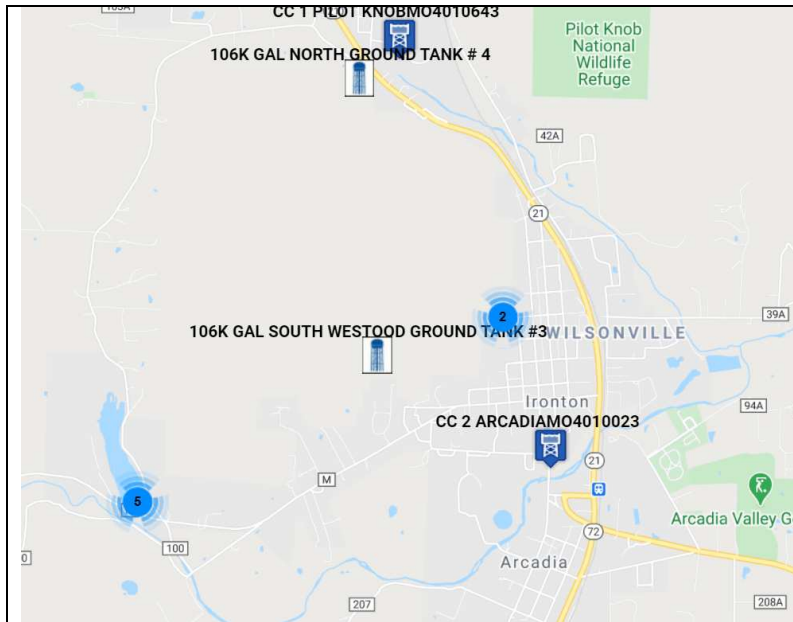
Photograph #: 001
Taken By: Zachary Miller
Entity: Ironton PWS
PWS ID: MO4010402
Location: Water Treatment Plant
Description: Approximate position of Ironton PWS major components.
Date Taken: 3/1/2021
Program: PDWB

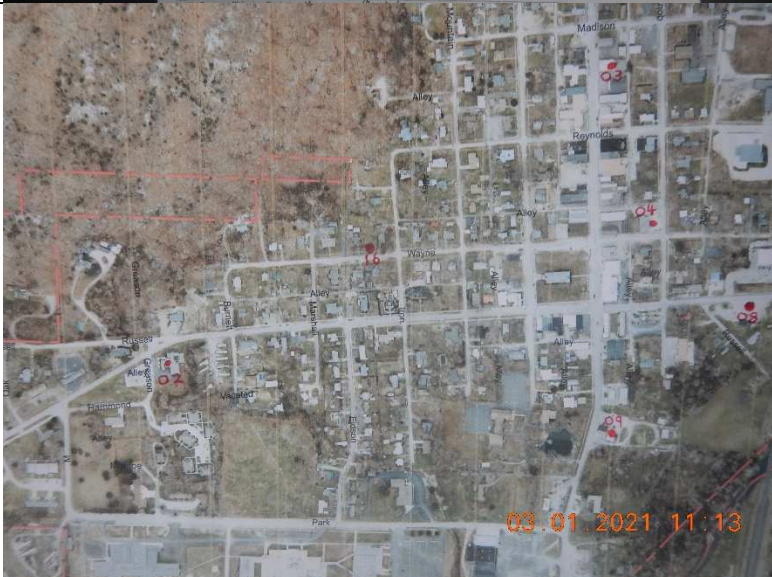
Photograph #: 003
Taken By: Zachary Miller
Entity: Ironton PWS
PWS ID: MO4010402
Location: Water Treatment Plant
Description: Distribution map
Date Taken: 3/1/2021
Program: PDWB

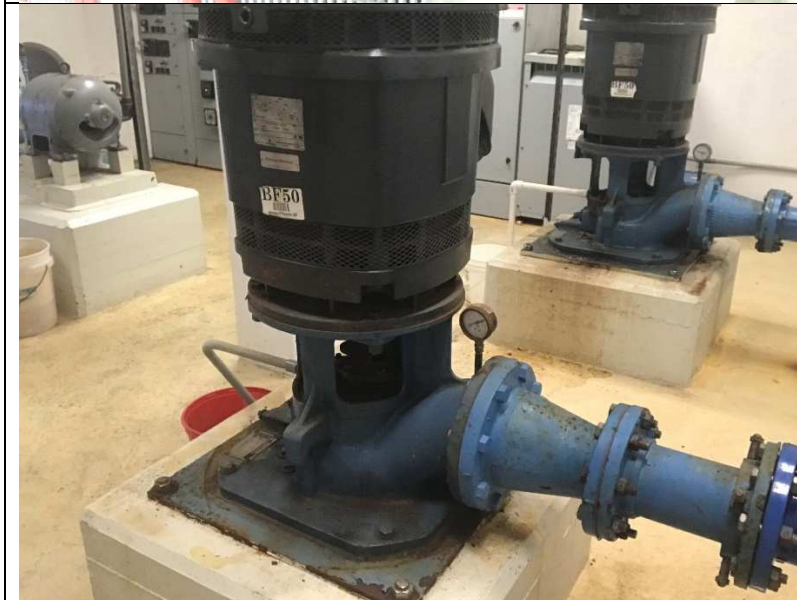
Photograph #: 006
Taken By: Zachary Miller
Entity: Ironton PWS
PWS ID: MO4010402
Location: Water Treatment Plant
Description: High Service Pumps
Date Taken: 3/1/2021
Program: PDWB

The Department recommends that the system obtain pump curves for the intake, high service, and backwash pumps and routinely compare each pumps operating conditions to the curves.

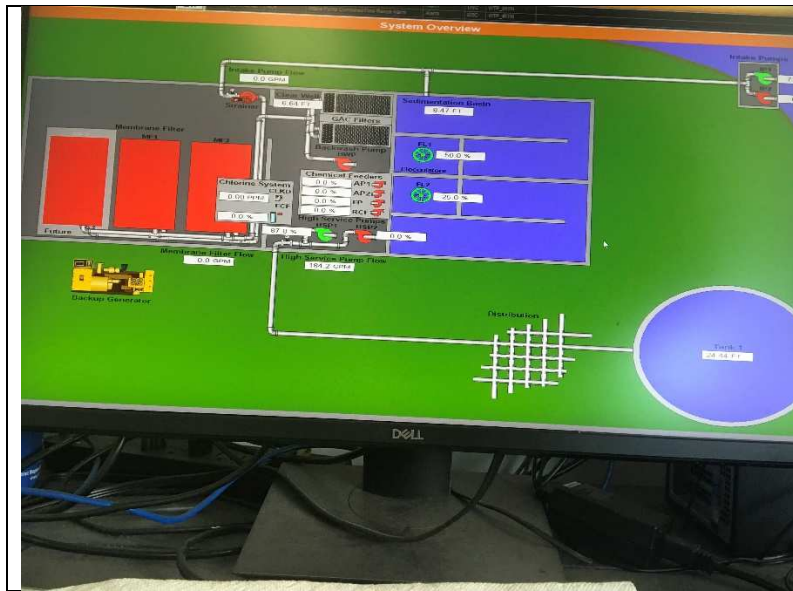
Photograph #: 007
Taken By: Zachary Miller
Entity: Ironton PWS
PWS ID: MO4010402
Location: Water Treatment Plant
Description: SCADA
Date Taken: 3/1/2021
Program: PDWB
