**LETTER OF WARNING  
RESPONSE REQUIRED**

**Missouri Department of Natural Resources**  
**Central Field Operations**  
**Report of Inspection**  
**Osage Water Co KK Wastewater Treatment Plant**  
**Highway KK / Camden County**  
**MOGD00340**  
**May 28, 2020**

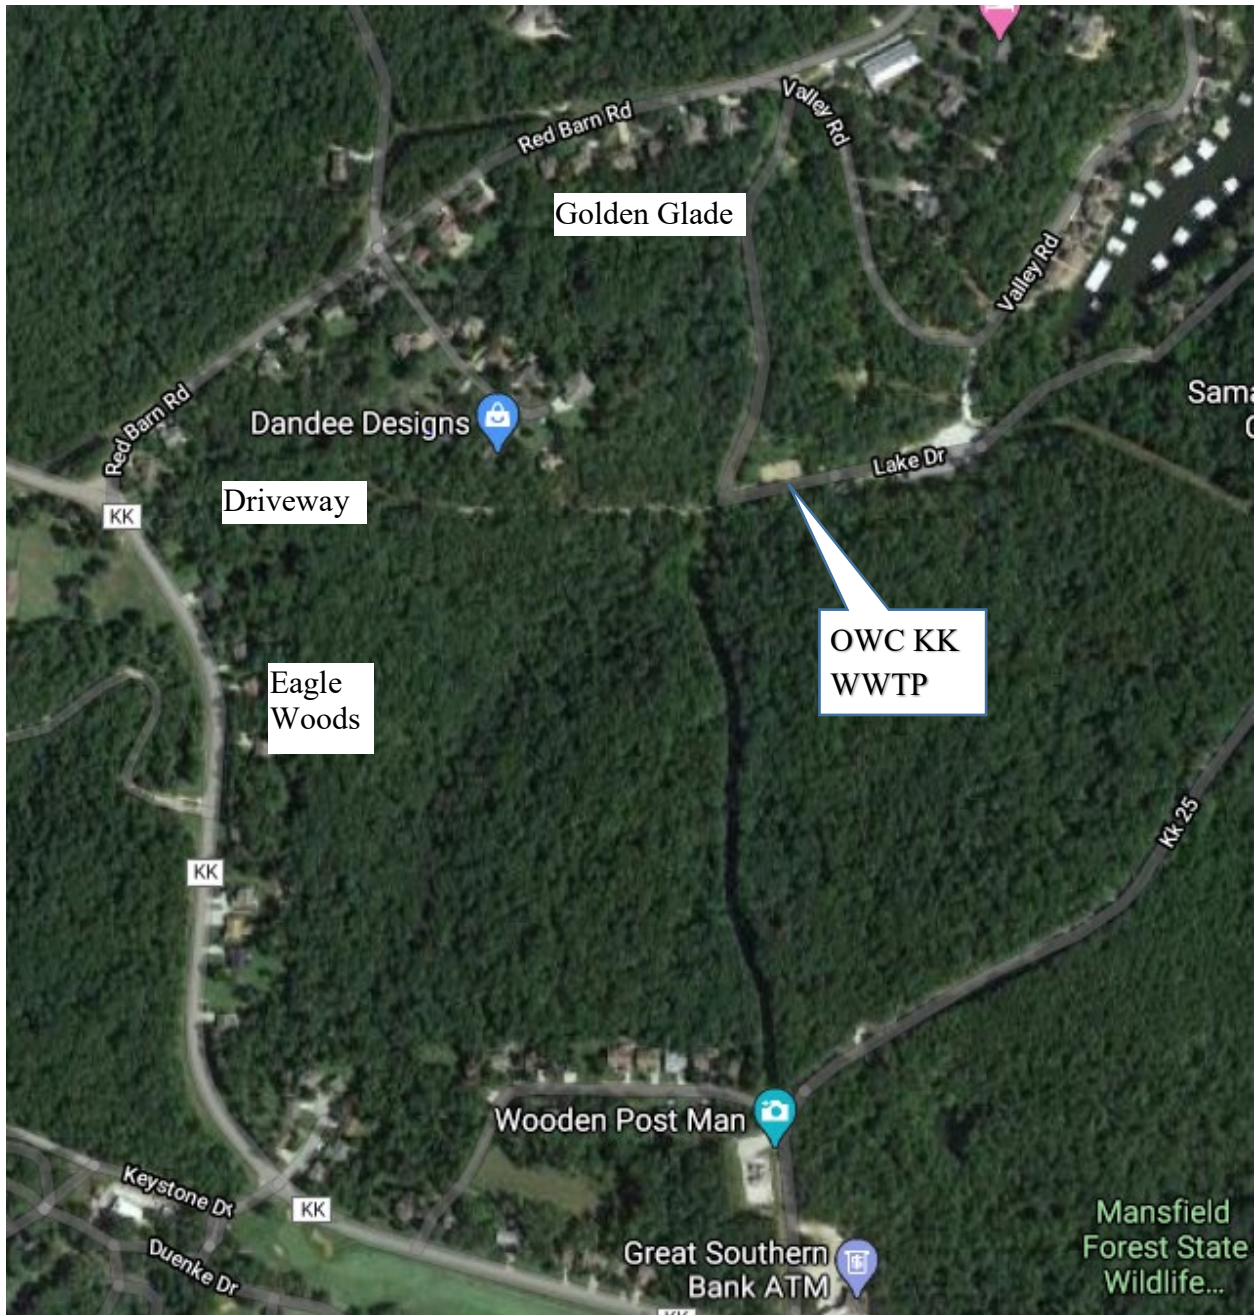
Figure 1: Aerial map view of the Eagle Woods and Golden Glade Subdivisions courtesy of Google Maps.

The inspection was conducted during normal business hours. Prior notification of the inspection was provided to ensure timely access to the site. Directly off of Highway KK, the facility is located down a long driveway between Eagle Woods and Golden Glade subdivisions (Figure #1). At the bottom of the big hill and about half way to the treatment plant, the driveway was partially washed out (**Recommendation #1**). If deterioration of the access road continues a future violation could be issued due to the facility not being readily accessible from the public right-of-way.

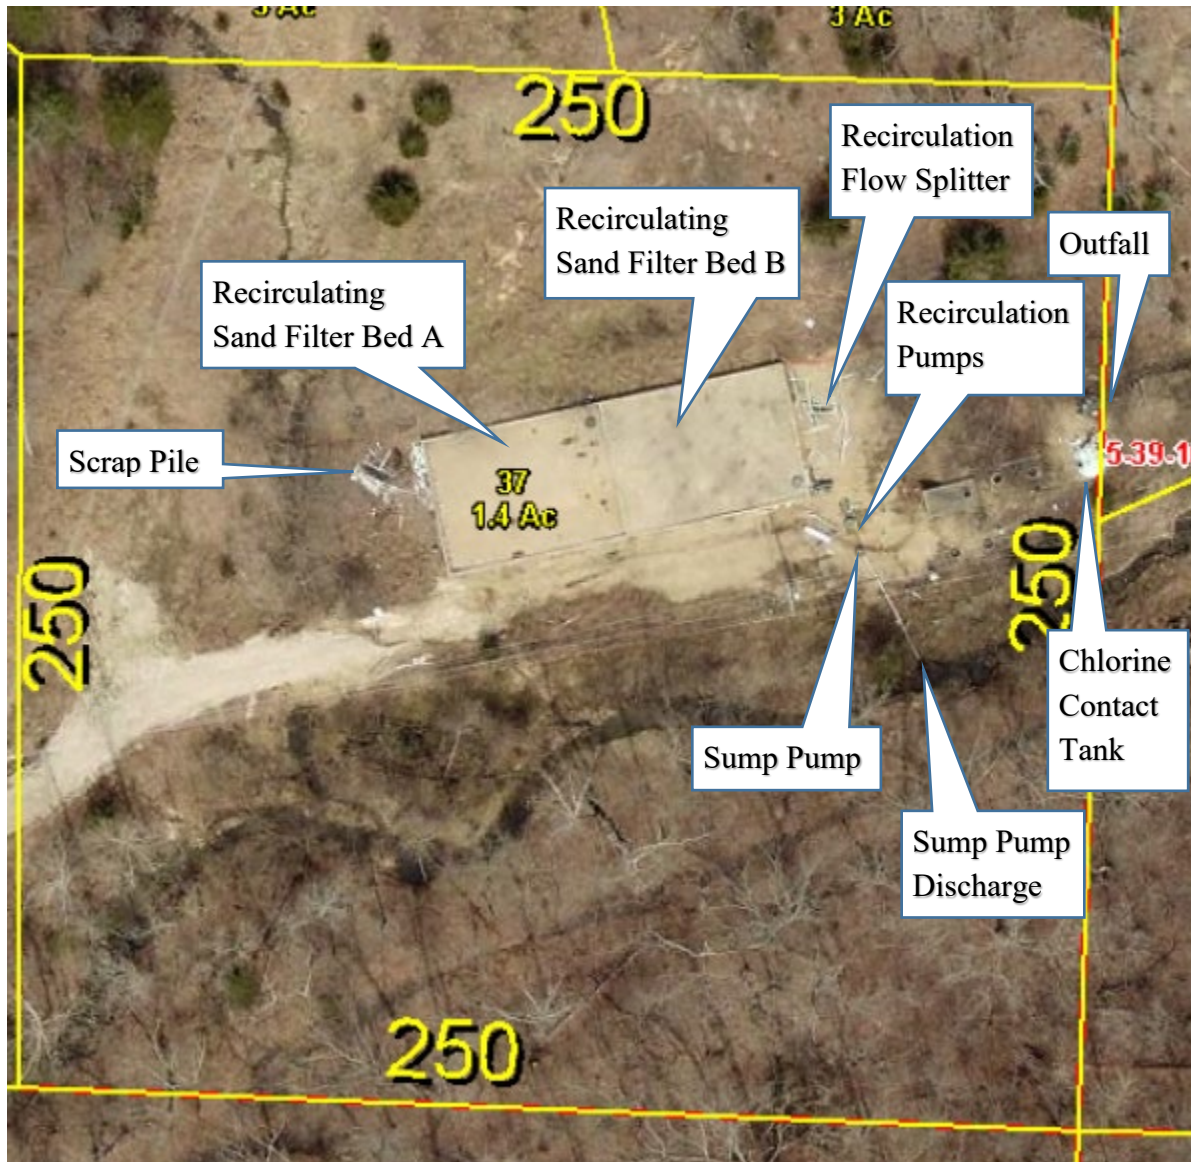
Figure 2: Aerial map of Osage Water Company KK WWTP courtesy of Camden County GIS System.

Upon arrival at the wastewater treatment facility (Figure #2), we met with Mr. Heppler and outlined the purpose and scope of the inspection. Mr. Heppler granted permission to access the site and accompanied us throughout the inspection. The gate appears unused and the fence does not surround the facility (Photo #1) (**Letter of Warning #1**).
