5.200 BCSD, Brown Station Wastewater Treatment Facility
Boone County
#MO-0135305

**REPORT OF COMPLIANCE INSPECTION
BROWN STATION WASTEWATER TREATMENT FACILITY
BOONE COUNTY
#MO-0135305
June 12, 2015**

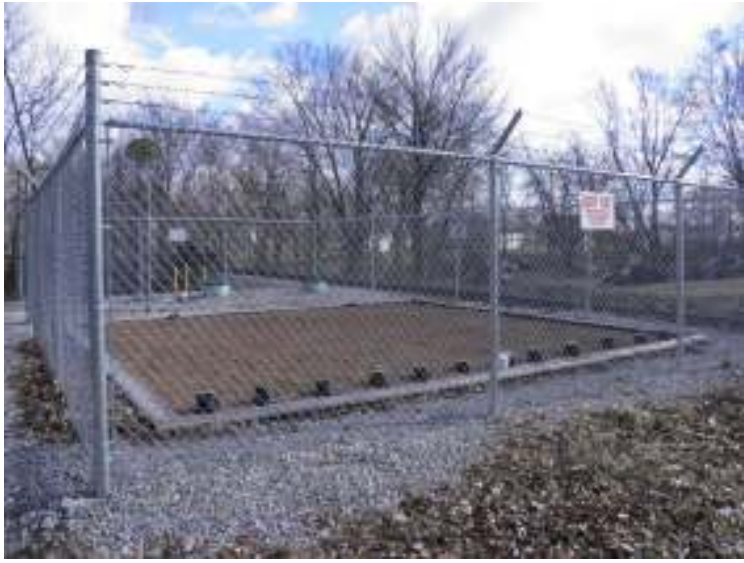
Photo #: 01
By: Michael Heaton
Facility: Brown Station WWTF
Permit: #MO-0135305
Location: Boone County

Description: Perimeter fence with signs posted on all sides of the facility.

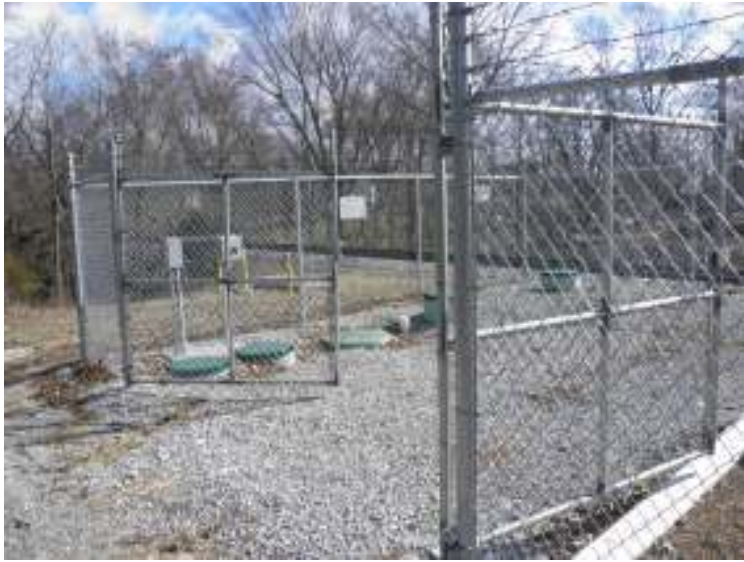
Photo #: 02
By: Michael Heaton
Facility: Brown Station WWTF
Permit: #MO-0135305
Location: Boone County

Description: Main entrance into the sand filter.

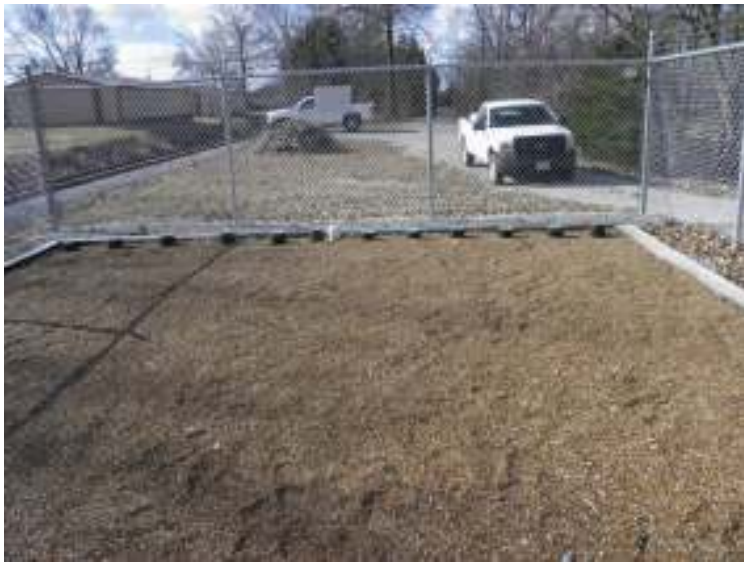
Photo #: 03
By: Michael Heaton
Facility: Brown Station WWTF
Permit: #MO-0135305
Location: Boone County

Description: Media in the sand filter.

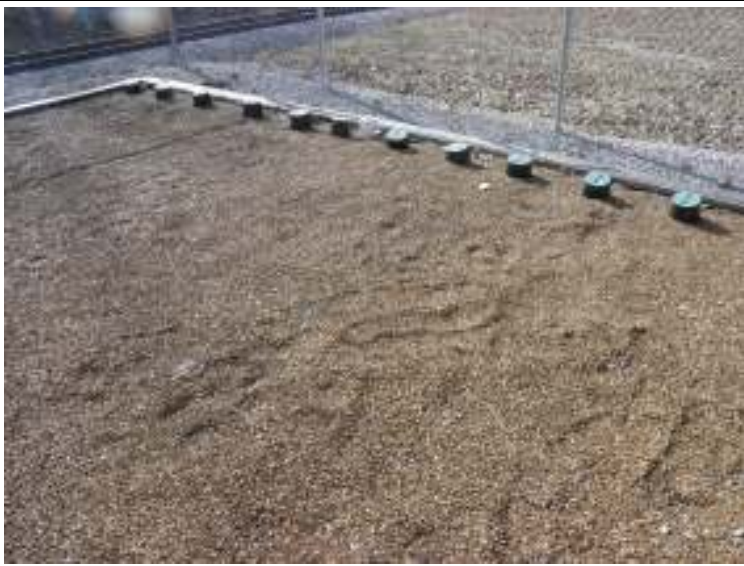
Photo #: 04
By: Michael Heaton
Facility: Brown Station WWTF
Permit: #MO-0135305
Location: Boone County

Description: Media in the sand filter. No pipes were exposed. Some slight pooling of wastewater was occurring on top of the media.

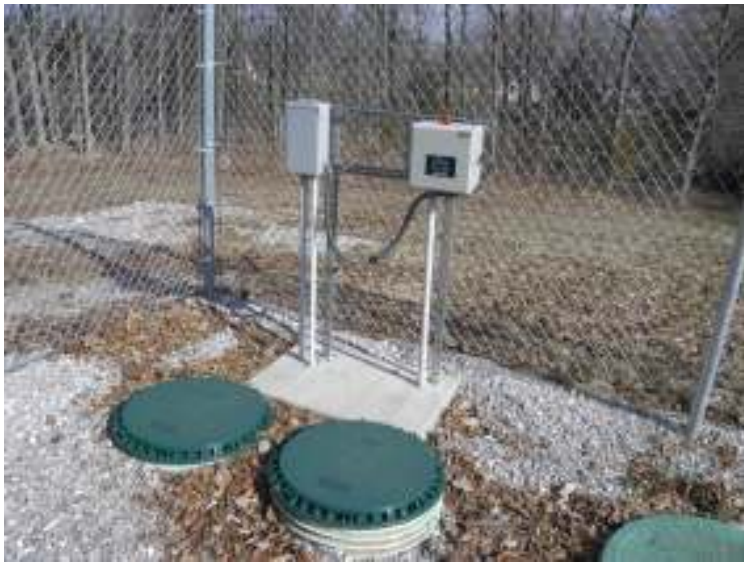
Photo #: 05
By: Michael Heaton
Facility: Brown Station WWTF
Permit: #MO-0135305
Location: Boone County

Description: Control panel and recirculating tanks.

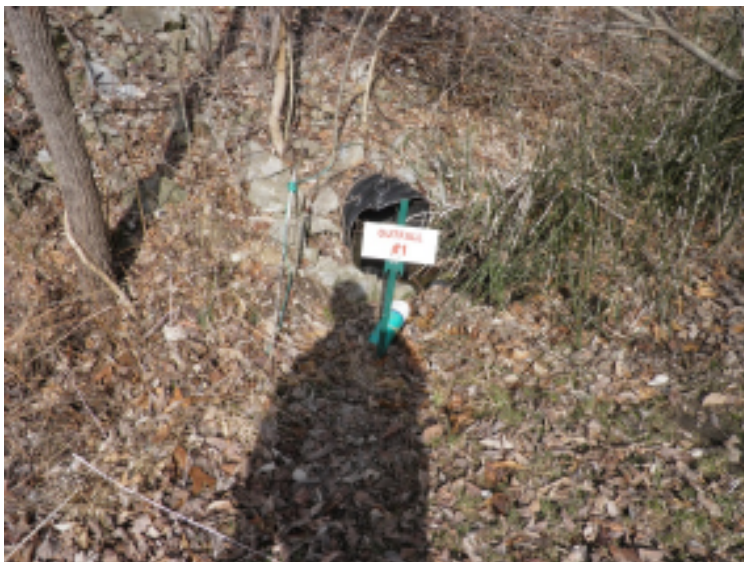
Photo #: 06
By: Michael Heaton
Facility: Brown Station WWTF
Permit: #MO-0135305
Location: Boone County

Description: Outfall location. Sign marking outfall location.

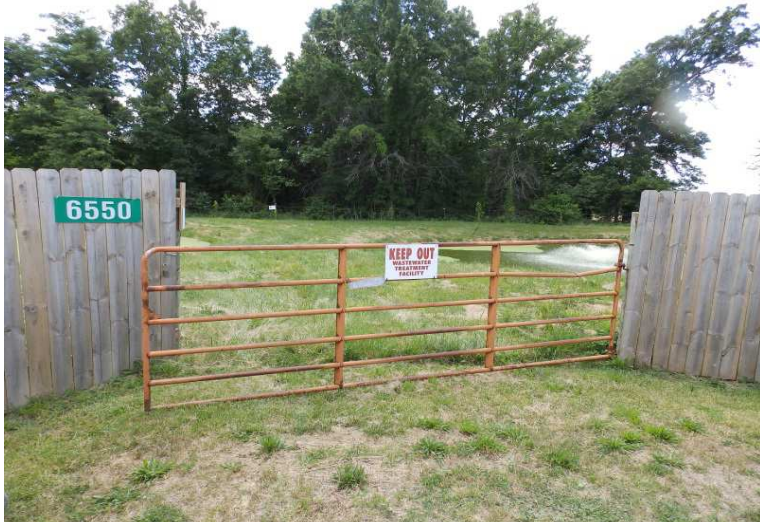
As I approached the facility, an all-weather access road was observed leading to the entrance of the facility. The facility was surrounded by a perimeter fence with a locked gate at the entrance (Photo #1). Warning signs were posted on each side of the perimeter fence.

Photograph #: 1
Taken by: Leland Maize
Entity: BCSD, Cedar Gate Subdivision
Permit: #MO-0096415
Location: Boone County
Description: Entrance gate to the facility with a warning sign posted on the fence. Gate was locked prior to the inspection.
Date Taken: June 7, 2016
Program: WPC Unit

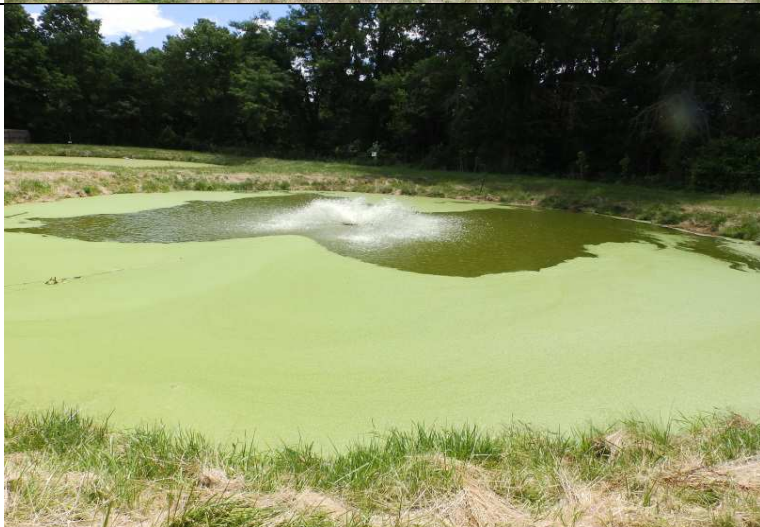
The facility consists of a two cell lagoon with sludge retained in the lagoon. The primary cell of the lagoon is aerated (Photo #2). During the inspection, I walked around the perimeter of the lagoon cells. I did not observe any signs of leaks in the lagoon berms or any damage to the lagoon berms. The vegetation surrounding the lagoon was approximately 12 to 14 inches in height. I did not observe any deep rooted vegetation on the lagoon berms. The aerator in the primary cell was functioning during the inspection. Approximately two-thirds of the primary lagoon cell was covered with duckweed. The second lagoon cell was completely covered with duckweed (Photo #3). The inlet side of the discharge pipe had a t fitting to prevent the discharge of duckweed (Photo #4). Both lagoon cells had greater than two feet of storage remaining at the time of the inspection.

Photograph #: 2
Taken by: Leland Maize
Entity: BCSD, Cedar Gate Subdivision
Permit: #MO-0096415
Location: Boone County
Description: Primary lagoon cell with aerator functioning during the inspection. Duckweed covered approximately two-thirds of the primary cell.
Date Taken: June 7, 2016
Program: WPC Unit

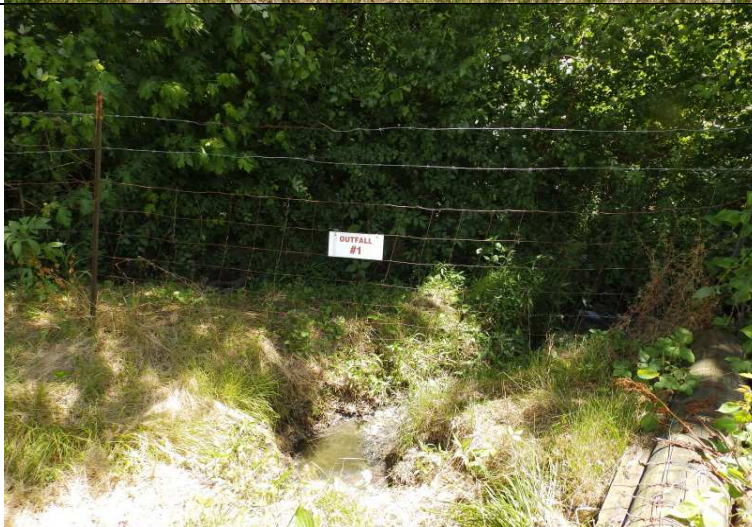
Photograph #: 5
Taken by: Leland Maize
Entity: BCSD, Cedar Gate Subdivision
Permit: #MO-0096415
Location: Boone County
Description: Sign marking the location of the facility's outfall.
Date Taken: June 7, 2016
Program: WPC Unit

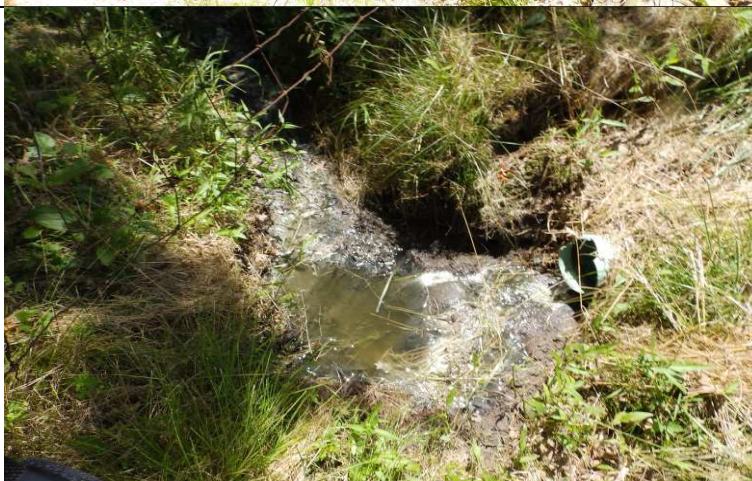
The inspection then proceeded with observations of the facility's outfall and the receiving stream. The outfall was marked in the field with a sign and was discharging during the inspection (Photo #5). Below the outfall, prior to the receiving stream, I observed a white film signifying the presence of sulfur bacteria (Photo #6). The effluent coming from the outfall had a strong sulfur odor at the time of the inspection. Samples were collected of the effluent for laboratory analyses. Water quality field monitoring was also conducted on the facility's effluent. Due to the low dissolved oxygen level in the facility's effluent, dissolved oxygen measurements were also taken in the receiving stream. Dissolved oxygen does not have water quality criteria in the receiving stream since the receiving stream does not have aquatic life as a designated use. The water quality field monitoring and laboratory results are provided in the Sampling and Monitoring section of this report. During the inspection I observed the receiving stream both upstream and downstream from the facility's outfall. I did not observe a visual impact from the facility on the receiving stream. I did not observe any duckweed in the receiving stream.

Photograph #: 6
Taken by: Leland Maize
Entity: BCSD, Cedar Gate Subdivision
Permit: #MO-0096415
Location: Boone County
Description: Outfall pipe with a white film in the area directly below the outfall pipe.
Date Taken: June 7, 2016
Program: WPC Unit

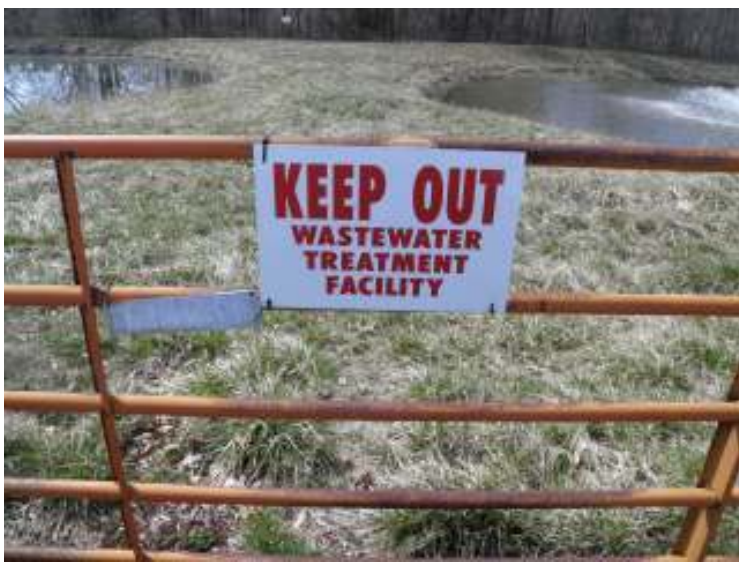
Photo #: 1
By: Mike Smith
Facility: BCSD - Cedar Gate Subdivision WWTF
Permit: #MO-0096415
Location: Boone County

Description: View of facility gate. Warning sign posted on gate. Gate was locked at the time of inspection.

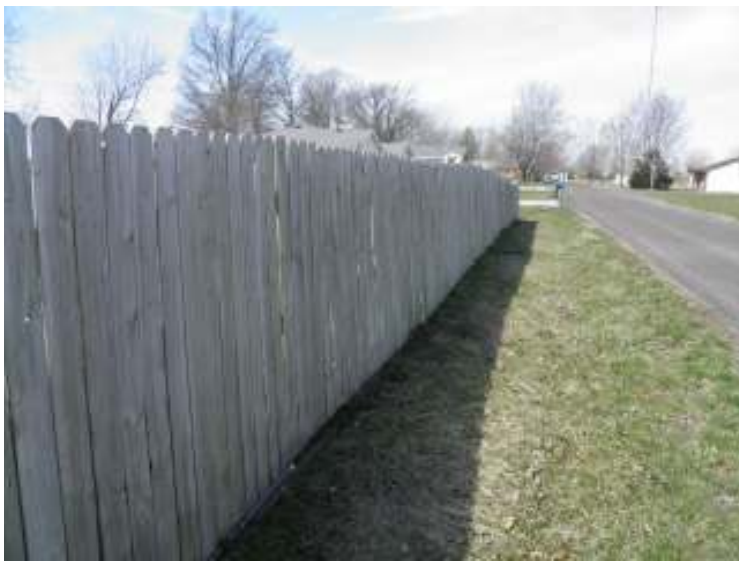
Photo #: 2
By: Mike Smith
Facility: BCSD - Cedar Gate Subdivision WWTF
Permit: #MO-0096415
Location: Boone County

Description: View of perimeter fencing.

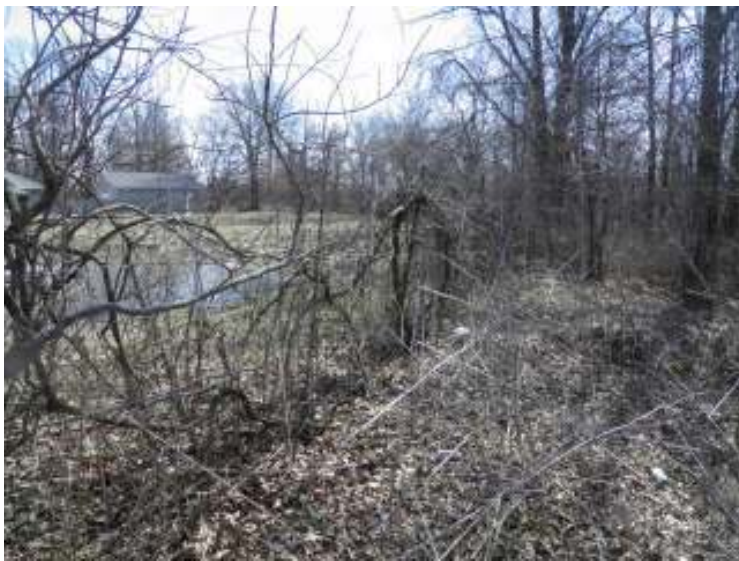
Photo #: 3
By: Mike Smith
Facility: BCSD - Cedar Gate Subdivision WWTF
Permit: #MO-0096415
Location: Boone County

Description: View of trees and vines growing within the perimeter fencing on the south side of the facility.

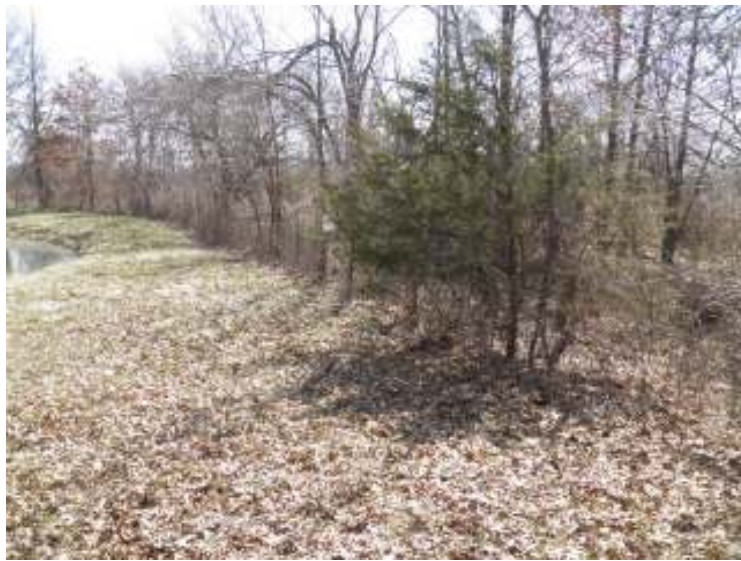
Photo #: 4
By: Mike Smith
Facility: BCSD - Cedar Gate Subdivision WWTF
Permit: #MO-0096415
Location: Boone County

Description: View of trees observed growing within the perimeter fencing on the south side of the facility.

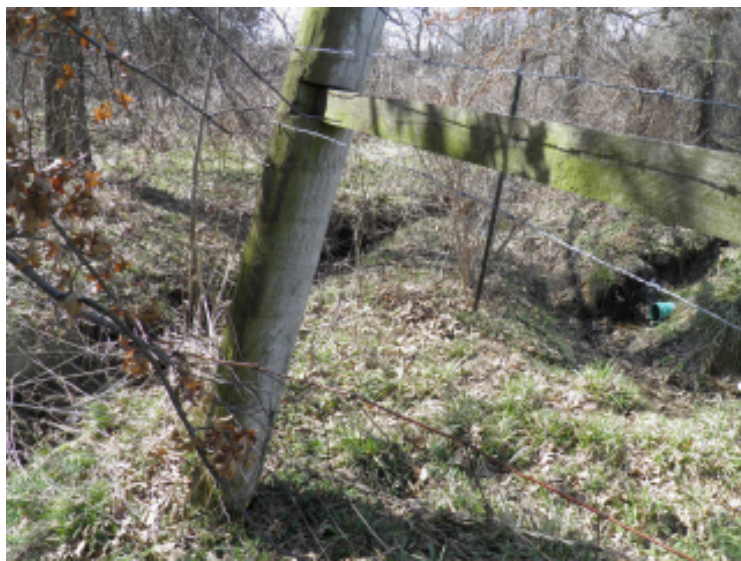
Photo #: 5
By: Mike Smith
Facility: BCSD - Cedar Gate Subdivision WWTF
Permit: #MO-0096415
Location: Boone County

Mr. Smith began the inspection by observing the facility's gate. The gate was locked at the time of inspection and a warning sign was observed posted on the gate (Photo #1). Mr. Smith observed the perimeter fencing surrounding the facility (Photo #2). Signs were observed posted on all four sides of the perimeter fence. Vines and trees were observed growing within the fencing on the south side of the facility (Photos #3 & 4). Mr. Smith observed a gap in the fencing in one area that could allow unauthorized access to the facility (Photo #5).

Description: Gap in the perimeter fencing observed that could allow unauthorized access to the facility.

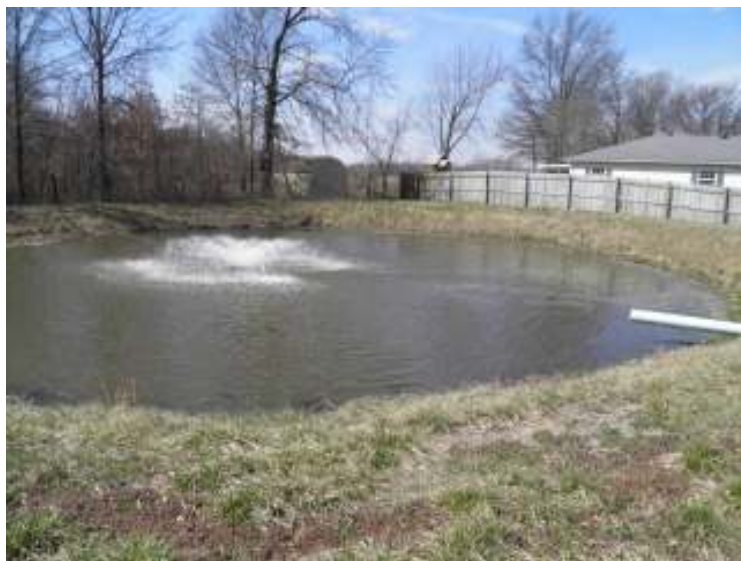
Photo #: 6
By: Mike Smith
Facility: BCSD - Cedar Gate Subdivision WWTF
Permit: #MO-0096415
Location: Boone County

Description: View of primary lagoon cell. Aerator was running at the time of inspection.

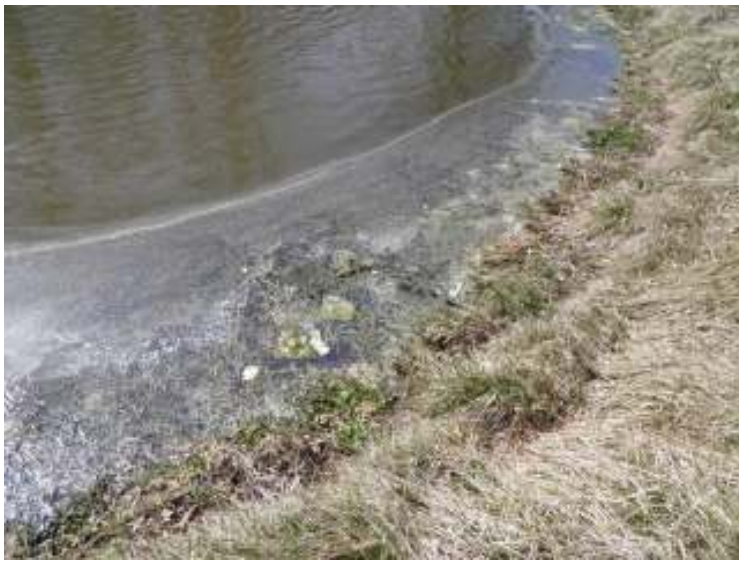
Photo #: 7
By: Mike Smith
Facility: BCSD - Cedar Gate Subdivision WWTF
Permit: #MO-0096415
Location: Boone County

Description: View of duckweed and trash observed in the primary lagoon cell.

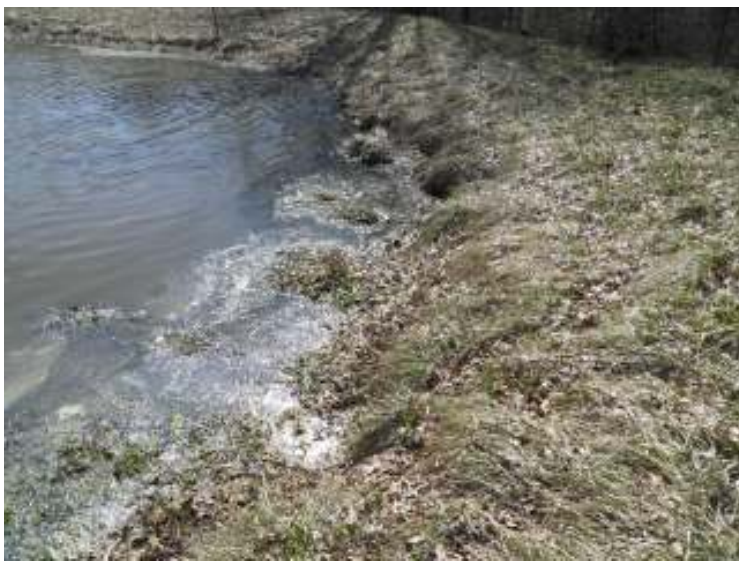
Photo #: 8
By: Mike Smith
Facility: BCSD - Cedar Gate Subdivision WWTF
Permit: #MO-0096415
Location: Boone County

Mr. Smith then observed the two cell lagoon system, beginning with the primary cell. The primary lagoon cell is aerated and the aerator was running at the time of inspection (Photo #6). Duckweed and trash were observed on top of the lagoon (Photo #7). Erosion of the inner lagoon berms was observed (Photo #8). Approximately three to four feet of freeboard appeared available in the lagoon.

Description: View of eroded inner berms of the primary lagoon cell.

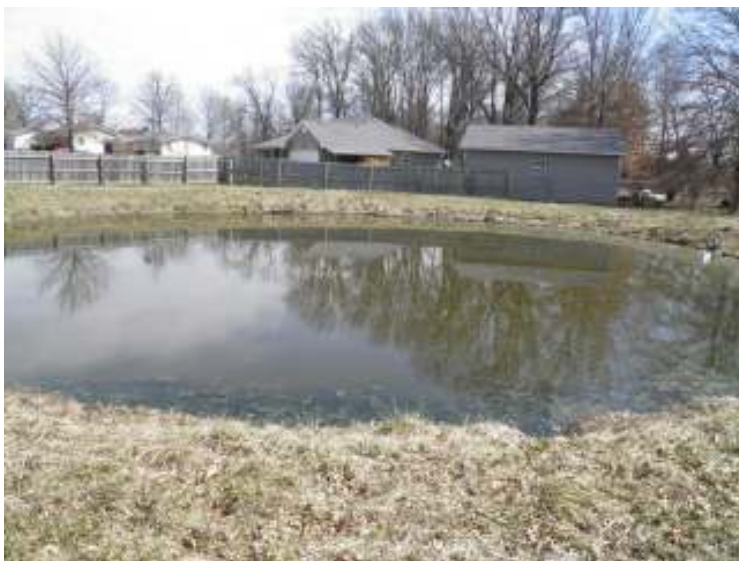
Photo #: 9
By: Mike Smith
Facility: BCSD - Cedar Gate Subdivision WWTF
Permit: #MO-0096415
Location: Boone County

Description: View of secondary lagoon cell.

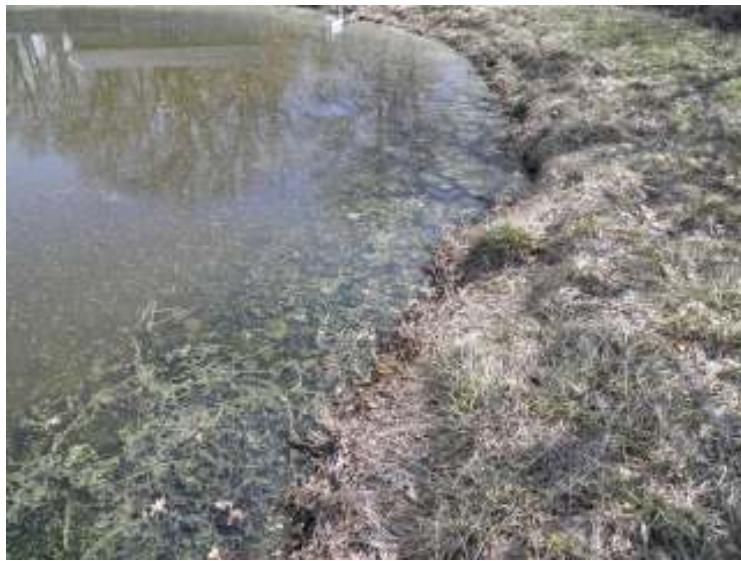
Photo #: 10
By: Mike Smith
Facility: BCSD - Cedar Gate Subdivision WWTF
Permit: #MO-0096415
Location: Boone County

The secondary lagoon cell was then observed (Photo #9). Duckweed was observed on the secondary cell (Photos #10-12). Erosion damage of the inner lagoon berms was observed, including muskrat burrows and bank dens (Photo #10-12). A T-fitting was observed on the inlet side of the discharge pipe to prevent the discharge of duckweed (Photo #13). Approximately two to three feet of freeboard appeared available in the lagoon. No evidence of an unpermitted discharge through the lagoon berms of either cell was observed. No deep-rooted vegetation was observed growing on the lagoon berms of either cell.

Description: View of duckweed in secondary cell.
Eroded inner berms observed.

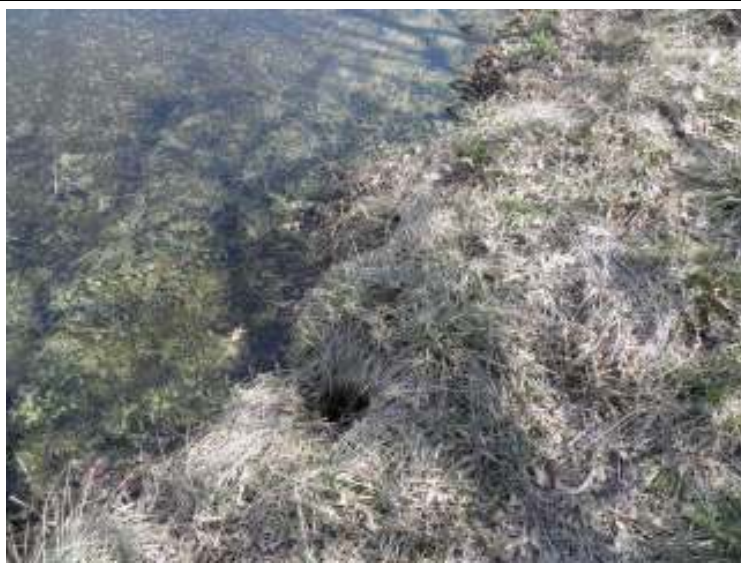
Photo #: 11
By: Mike Smith
Facility: BCSD - Cedar Gate Subdivision WWTF
Permit: #MO-0096415
Location: Boone County

Description: View of muskrat burrow in the lagoon
berm of the secondary cell. Duckweed also
observed.

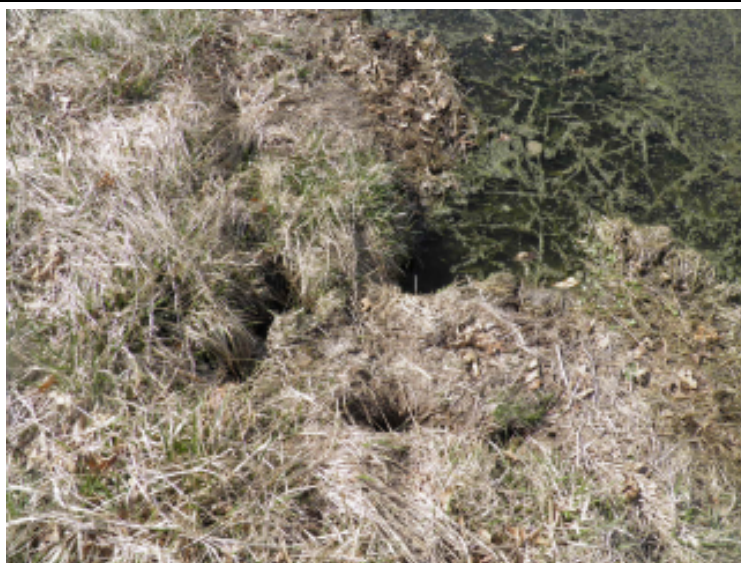
Photo #: 12
By: Mike Smith
Facility: BCSD - Cedar Gate Subdivision WWTF
Permit: #MO-0096415
Location: Boone County

Description: View of additional muskrat damage
observed on the inner berm of the secondary cell.

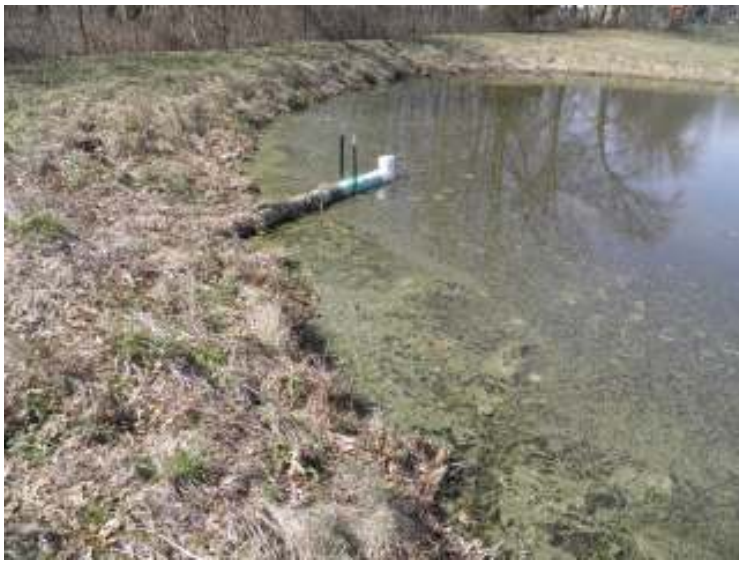
Photo #: 13
By: Mike Smith
Facility: BCSD - Cedar Gate Subdivision WWTF
Permit: #MO-0096415
Location: Boone County

Description: View of duckweed in secondary cell. T-fitting observed on the inlet side of the effluent pipe.

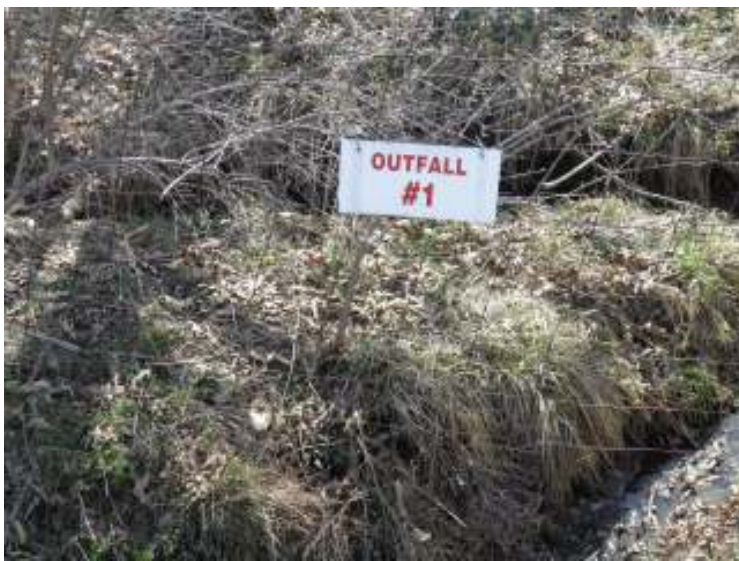
Photo #: 14
By: Mike Smith
Facility: BCSD - Cedar Gate Subdivision WWTF
Permit: #MO-0096415
Location: Boone County

Description: View of sign marking outfall location.

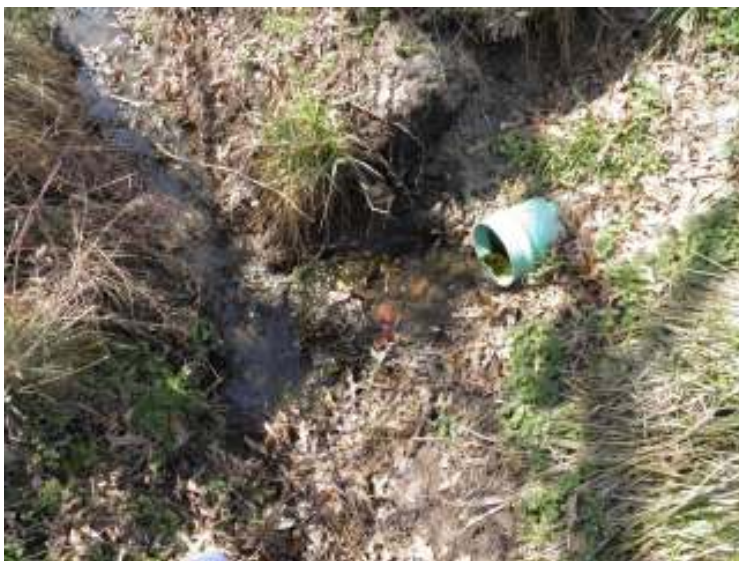
Photo #: 15
By: Mike Smith
Facility: BCSD - Cedar Gate Subdivision WWTF
Permit: #MO-0096415
Location: Boone County

Description: View of discharge pipe. Facility was discharging at the time of inspection. Effluent appeared clear. Limited space available below pipe for sampling.

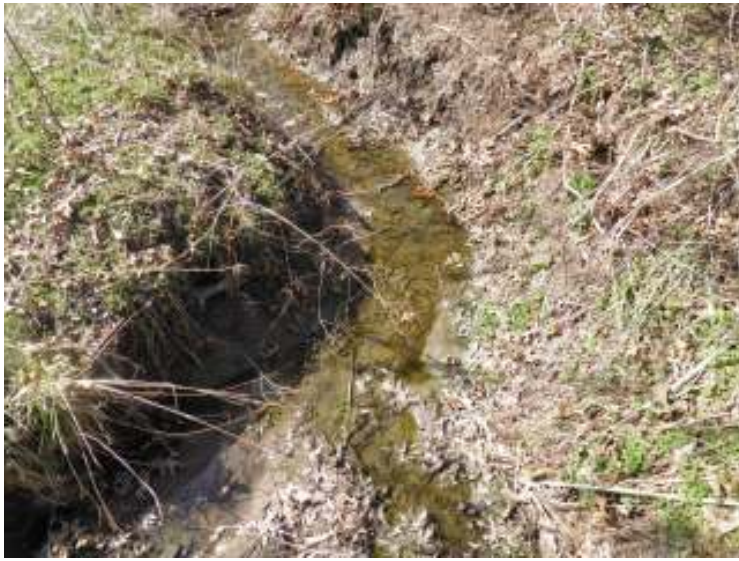
Photo #: 16

Description: View of receiving stream. No impacts from the facility observed.

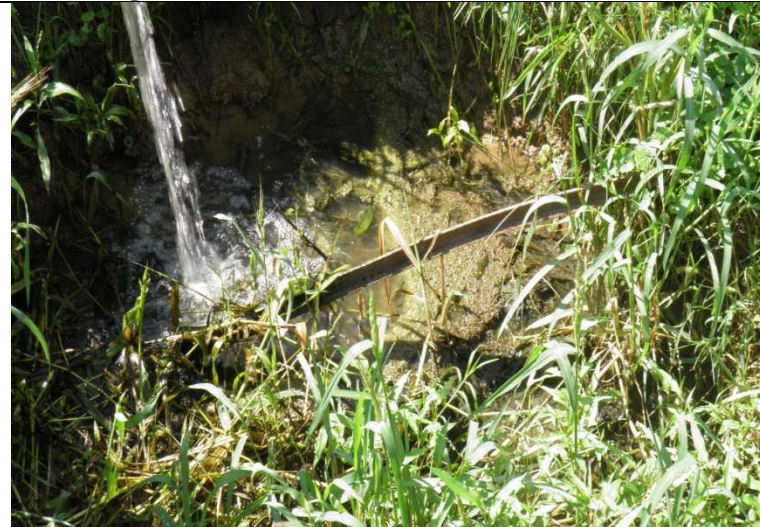
Photograph #: 4
Taken by: Michael Womack
Entity: BCRSD - Highfield Acres Wastewater Treatment Facility
Permit: #MO-0053376
Location: Boone
Description: Observation of duckweed below Outfall #001.
Date Taken: September 1, 2016
Program: WPC Unit

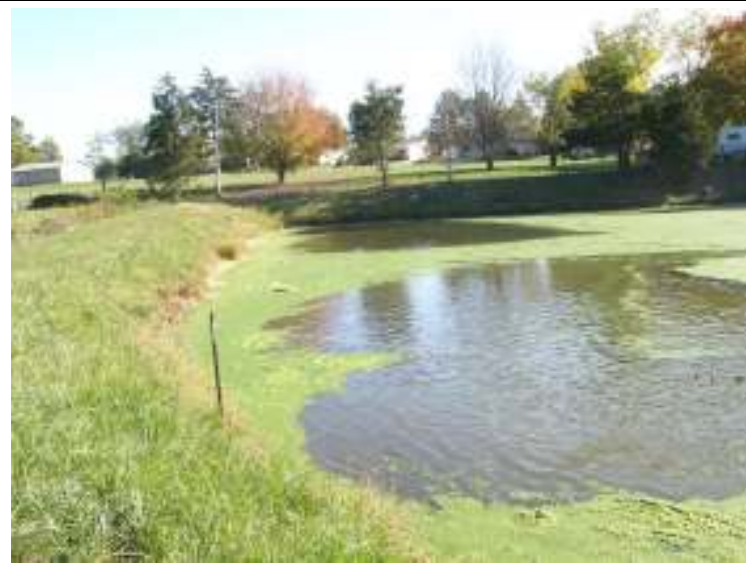
Photo #: 1
 By: Stephen Moss
 Facility: BCRSD Highfield Acres WWTF
 Permit: #MO-0053376
 Location: Boone County

Description: View of the outfall #002 lagoon.

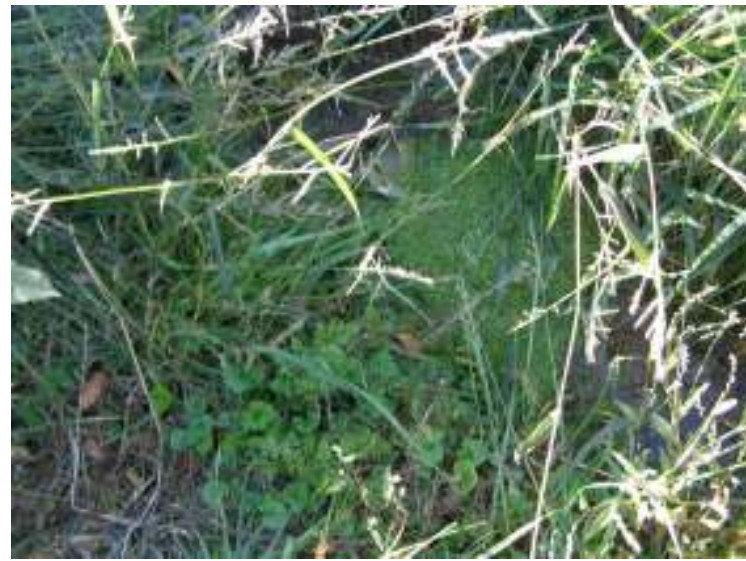
Photo #: 2
 By: Stephen Moss
 Facility: BCRSD Highfield Acres WWTF
 Permit: #MO-0053376
 Location: Boone County

Description: View of the duckweed in the receiving stream below Outfall #002.

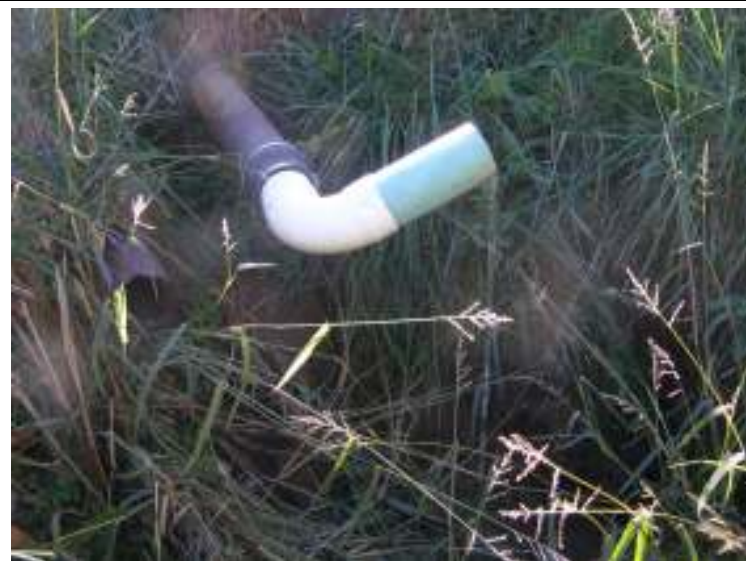
Photo #: 3
 By: Stephen Moss
 Facility: BCRSD Highfield Acres WWTF
 Permit: #MO-0053376
 Location: Boone County

Description: View of Outfall #002.

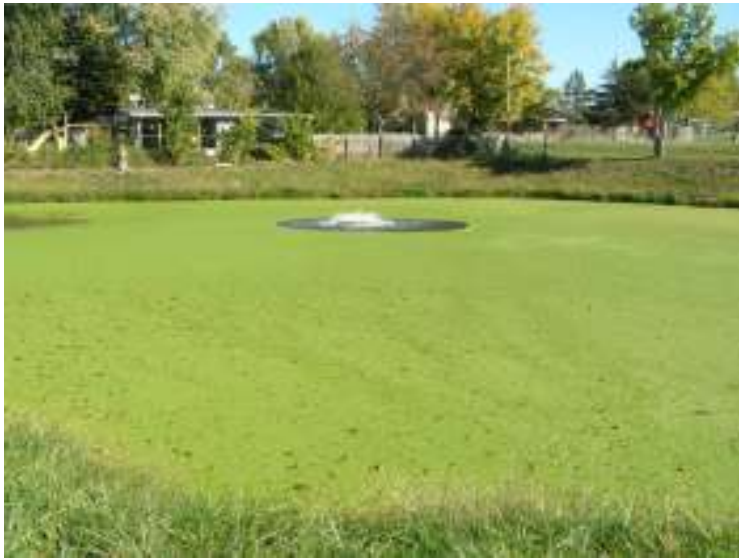
Photo #: 4
By: Stephen Moss
Facility: BCRSD Highfield Acres WWTF
Permit: #MO-0053376
Location: Boone County

Description: View of the Outfall #001 lagoon.

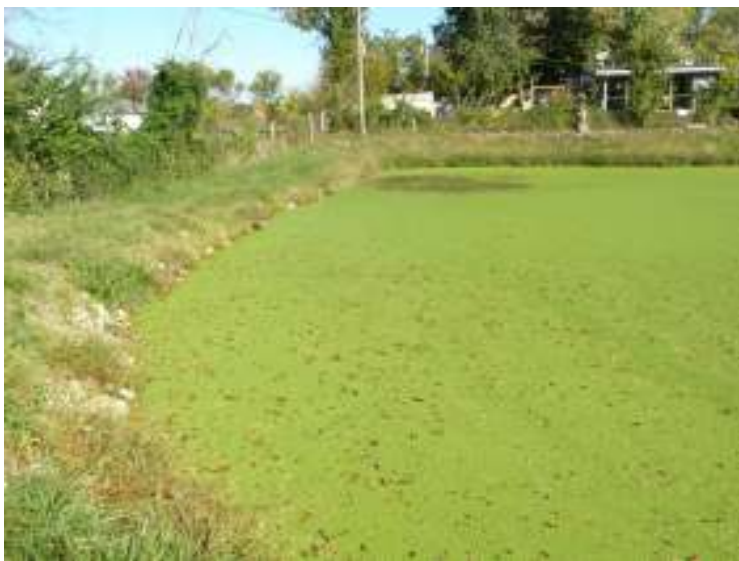
Photo #: 5
By: Stephen Moss
Facility: BCRSD Highfield Acres WWTF
Permit: #MO-0053376
Location: Boone County

Description: View of the riprapped section of Outfall #001.

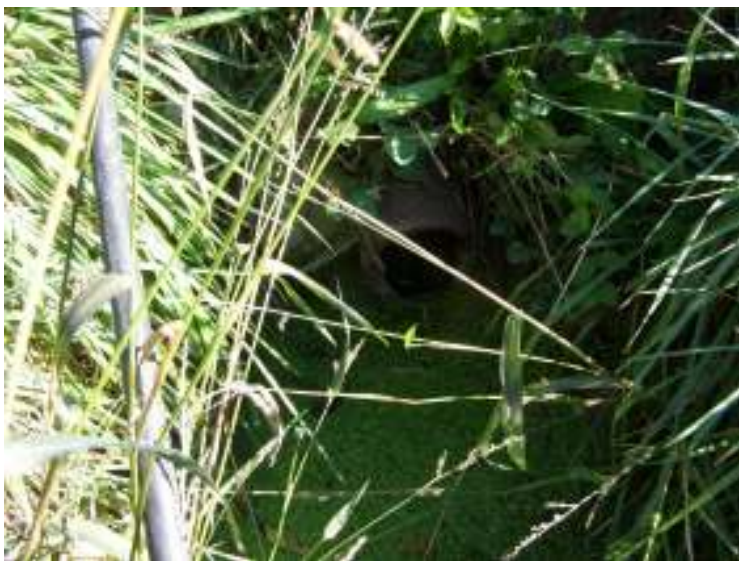
Photo #: 6
By: Stephen Moss
Facility: BCRSD Highfield Acres WWTF
Permit: #MO-0053376
Location: Boone County

Description: View of Outfall #001. Duckweed can be observed below the outfall.

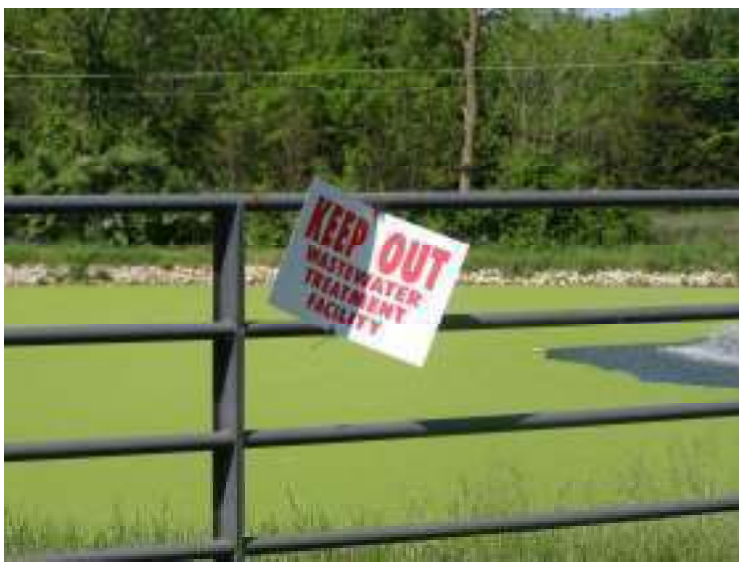
Photo #: 1
By: Stephen Moss
Facility: BCSD, Highfield Acres
Permit: #MO-0053376
Location: Boone County

Description: View of the gate with a warning sign posted on it.

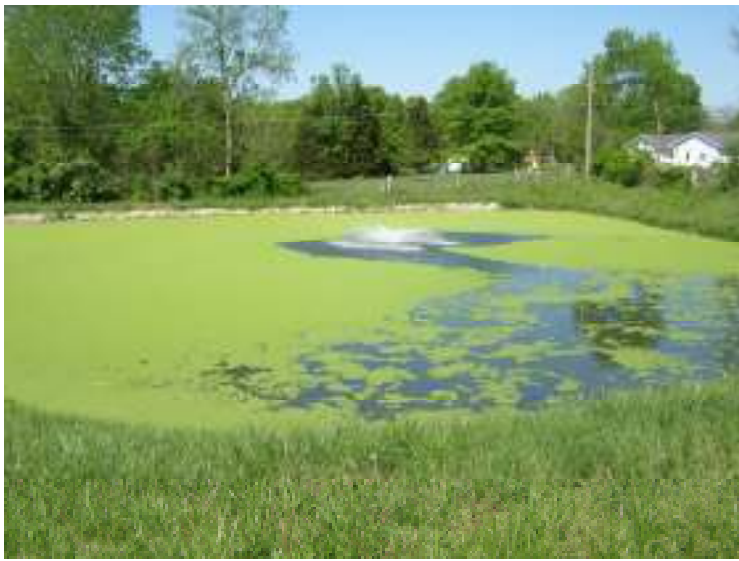
Photo #: 2
By: Stephen Moss
Facility: BCSD, Highfield Acres
Permit: #MO-0053376
Location: Boone County

Description: View of the Outfall #002 aerator and lagoon.

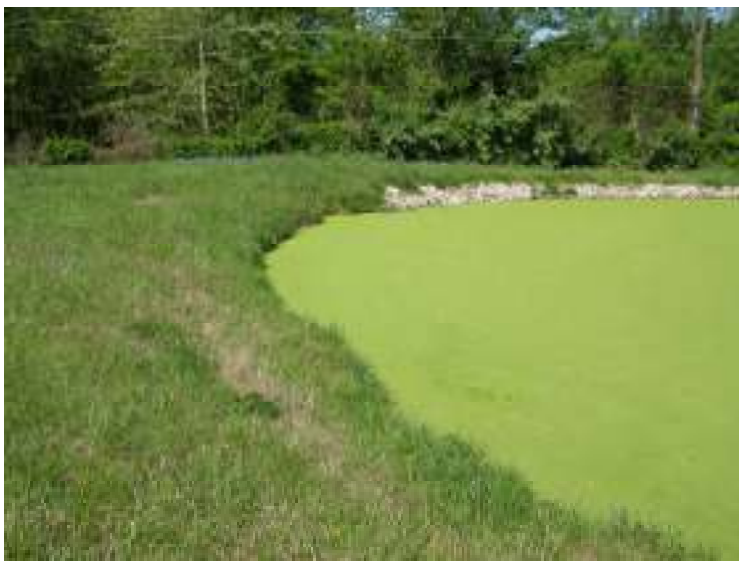
Photo #: 3
By: Stephen Moss
Facility: BCSD, Highfield Acres
Permit: #MO-0053376
Location: Boone County

Description: View of the rip rap on the west side of the Outfall #002 lagoon.

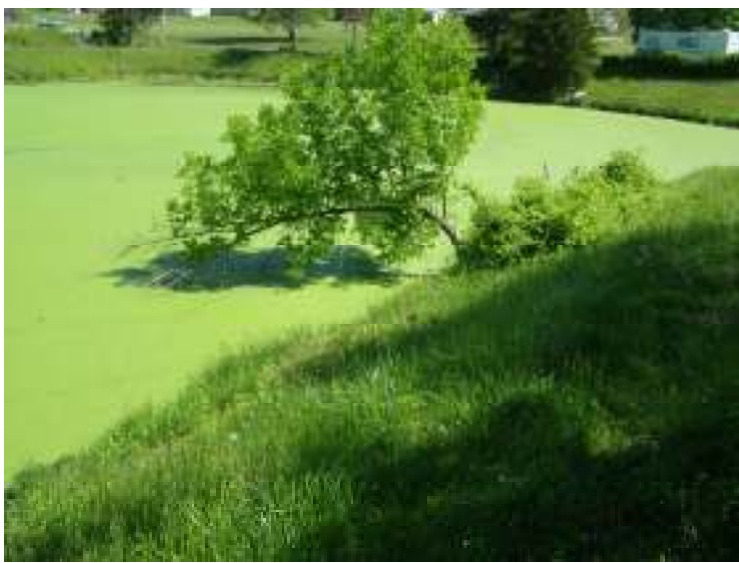
Photo #: 4
 By: Stephen Moss
 Facility: BCSD, Highfield Acres
 Permit: #MO-0053376
 Location: Boone County

Description: View of a tree growing on the inner berm slope of the Outfall #001 lagoon.

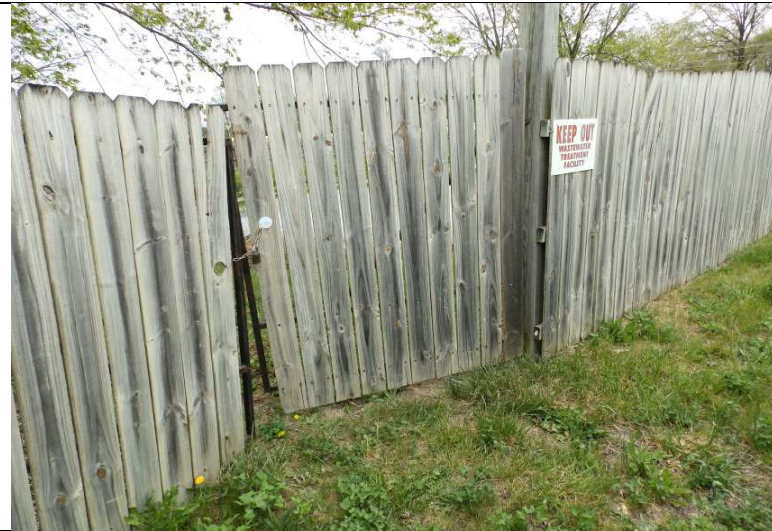
As I arrived at the facility, I observed that an all-weather access road to the lagoon system was available. The facility gate was equipped with a lock to prevent unauthorized access. A perimeter fence around the facility was observed and appeared to be in good condition. Warning signs were observed posted on all four sides of the perimeter fence (Photograph #1).

Photograph #: 1
Taken by: Michael Heaton
Entity: BCRSD, Lee Heights Wastewater Treatment Facility
Permit: #MO-0102113
Location: Boone County
Description: Front entrance to the facility with a sign restricting access.
Date Taken: May 2, 2018
Program: WPC Unit

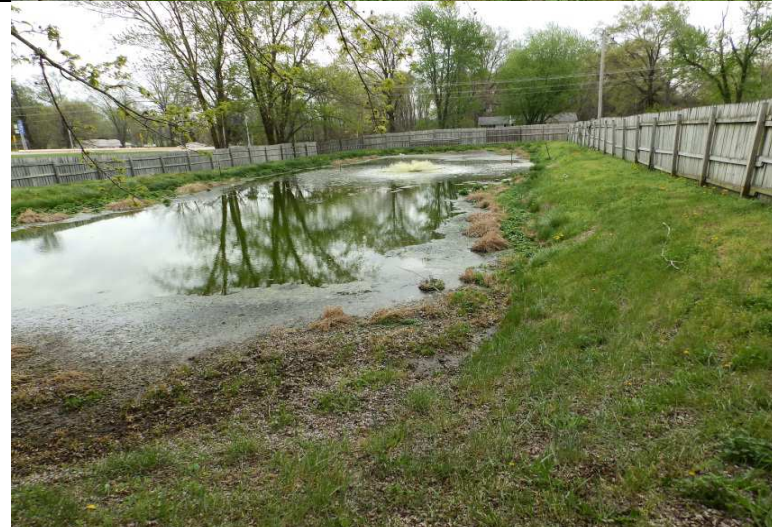
I then observed the one cell lagoon system. An operational aerator was observed near the center of the lagoon (Photograph #2). No woody vegetation was observed on the lagoon berms. Sludge deposits were observed on the outer edges of the lagoon (Photograph #3). Mr. Farnen stated that the lagoon is planned to be closed and a pump station installed to transfer the wastewater to the City of Columbia WWTF. I explained that a closure plan will need to be submitted and approved prior to closing the lagoon. Mr. Farnen stated that they are working through the calculations to determine the amount of sludge and what to do with the sludge.

Photograph #: 2
Taken by: Michael Heaton
Entity: BCRSD, Lee Heights Wastewater Treatment Facility
Permit: #MO-0102113
Location: Boone County
Description: Overview of the lagoon. Aerator was operational in the lagoon.
Date Taken: May 2, 2018
Program: WPC Unit

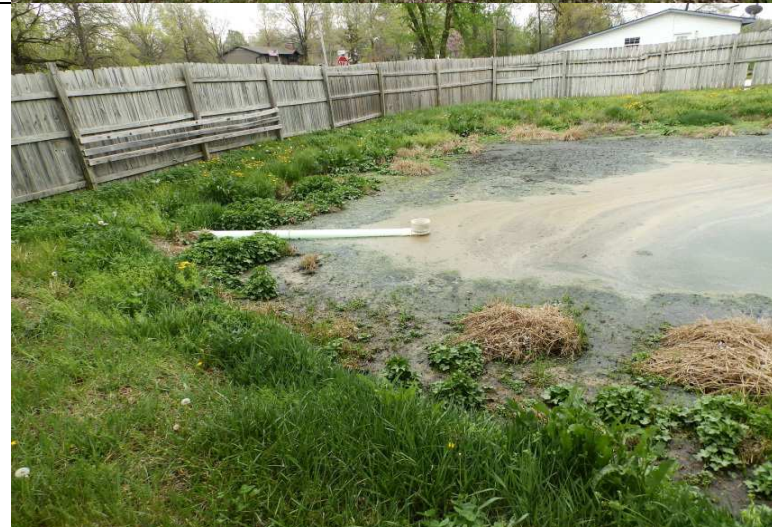
Photograph #: 3
Taken by: Michael Heaton
Entity: BCRSD, Lee Heights Wastewater Treatment Facility
Permit: #MO-0102113
Location: Boone County
Description: View of the discharge pipe in the lagoon. Sludge accumulation is visible around the bank.
Date Taken: May 2, 2018
Program: WPC Unit

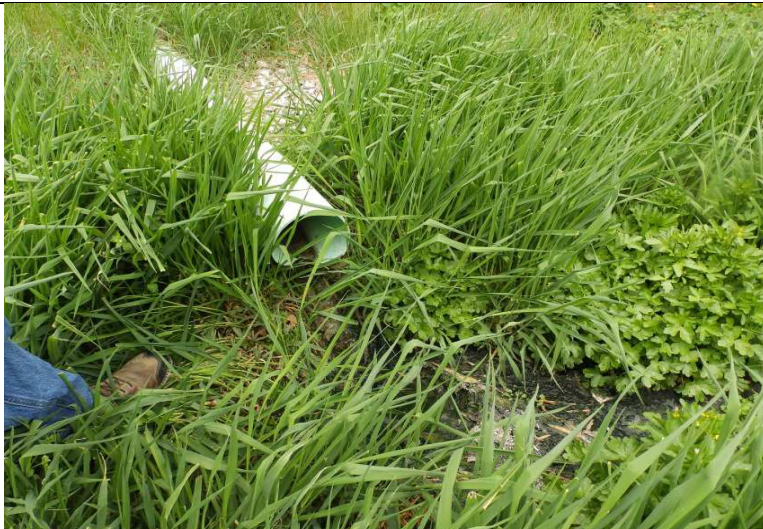
I then observed the outfall location. A sign marking the outfall was observed (Photograph #6). Effluent was not discharging at the time of the inspection (Photograph #4). The area below the outfall pipe was relatively dry with no pooling of water observed. The effluent that is discharged would flow to the road ditch and then through a culvert (Photograph #5).

Photograph #: 4
Taken by: Michael Heaton
Entity: BCRSD, Lee Heights Wastewater Treatment Facility
Permit: #MO-0102113
Location: Boone County
Description: Outfall #001. Outfall was not discharging at the time of the inspection.
Date Taken: May 2, 2018
Program: WPC Unit

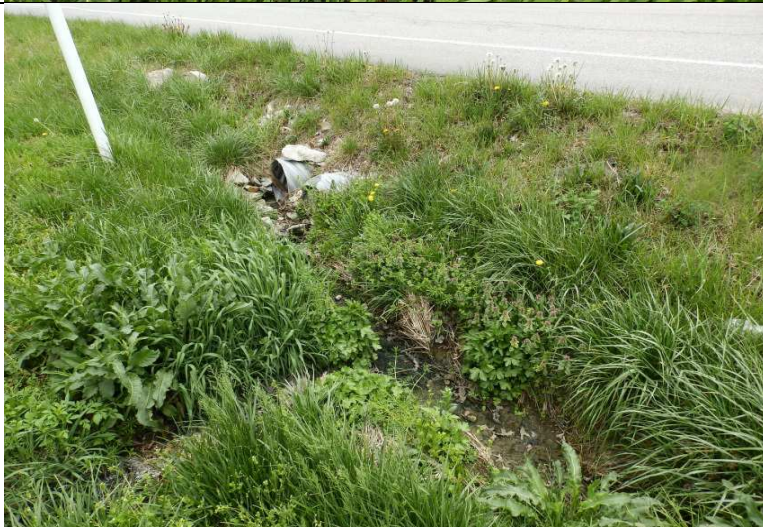
Photograph #: 5
Taken by: Michael Heaton
Entity: BCRSD, Lee Heights Wastewater Treatment Facility
Permit: #MO-0102113
Location: Boone County
Description: Flow from the outfall flows to the roadside ditch and through the culvert.
Date Taken: May 2, 2018
Program: WPC Unit

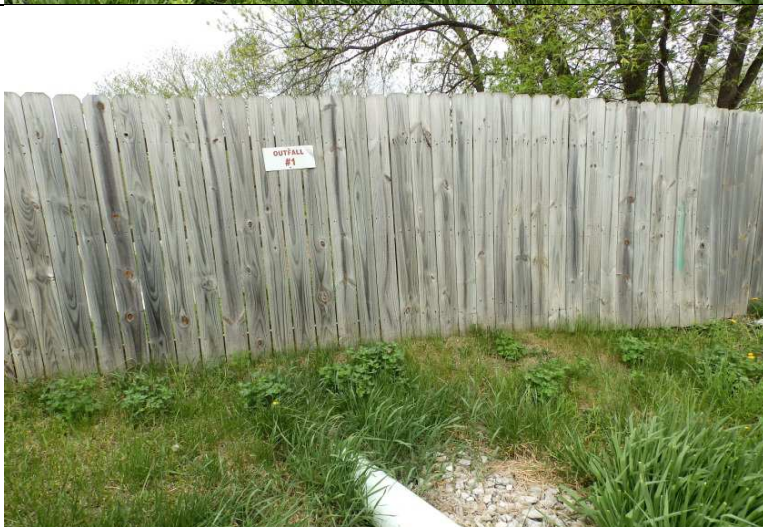
Photograph #: 6
Taken by: Michael Heaton
Entity: BCRSD, Lee Heights Wastewater Treatment Facility
Permit: #MO-0102113
Location: Boone County
Description: Sign marking the outfall location.
Date Taken: May 2, 2018
Program: WPC Unit

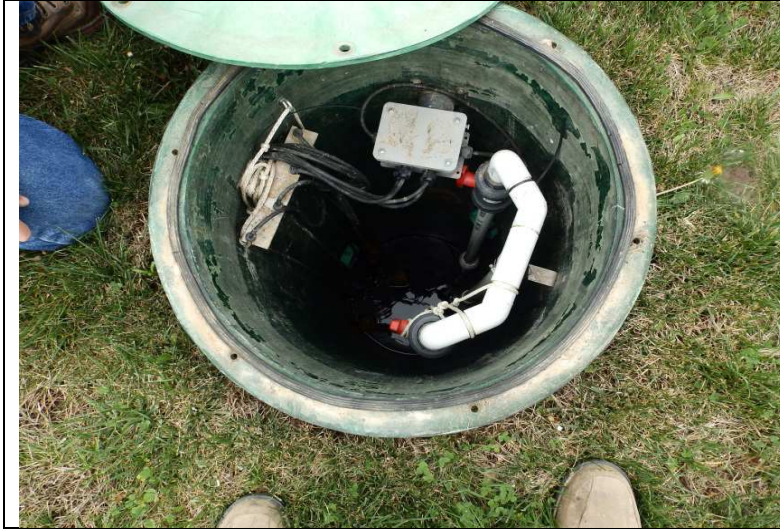
We then traveled across the road to a house that has a small individual pump station. Mr. Farnen stated that the pump station was installed for the residence because of the elevation of the house and backup problems. The pump station was observed and was operational (Photograph #7).

Photograph #: 7
Taken by: Michael Heaton
Entity: BCRSD, Lee Heights Wastewater
Treatment Facility
Permit: #MO-0102113
Location: Boone County
Description: Small pump station for single family
residence.
Date Taken: May 2, 2018
Program: WPC Unit

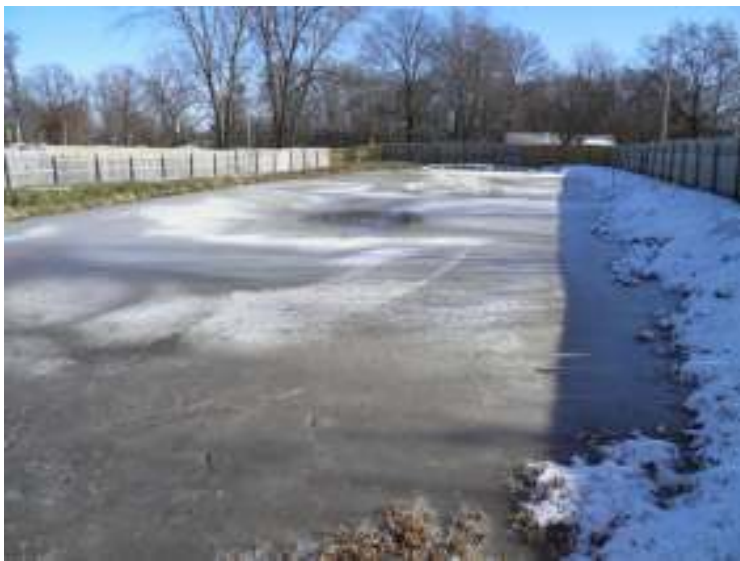
Photo #: 3
 By: Mike Smith
 Facility: BCSD - Lee Heights WWTF
 Permit: #MO-0102113
 Location: Boone County

Description: View of lagoon surface. Surface mostly frozen at the time of inspection.
