5.200 BCSD, Brown Station Wastewater Treatment Facility
Boone County
#MO-0135305

**REPORT OF COMPLIANCE INSPECTION
BROWN STATION WASTEWATER TREATMENT FACILITY
BOONE COUNTY
#MO-0135305
June 12, 2015**

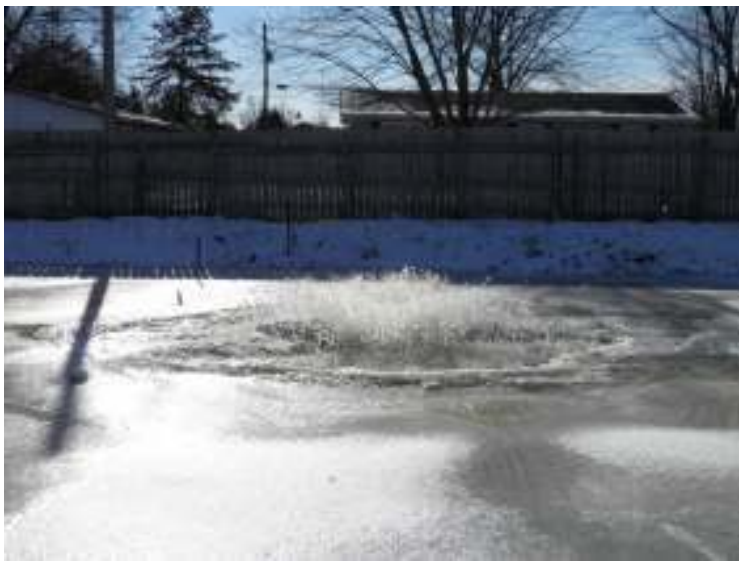
Photo #: 4
By: Mike Smith
Facility: BCSD - Lee Heights WWTF
Permit: #MO-0102113
Location: Boone County

Description: View of aerator. Aerator running at the time of inspection and appeared to be functioning properly.

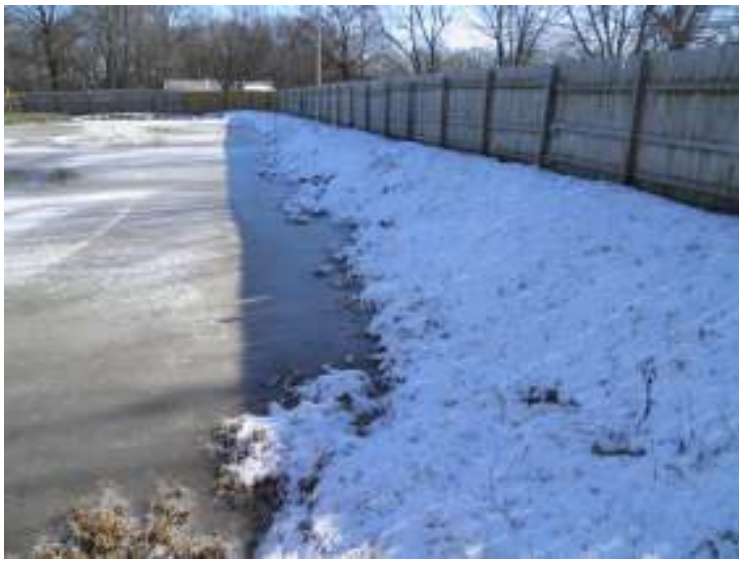
Photo #: 5
By: Mike Smith
Facility: BCSD - Lee Heights WWTF
Permit: #MO-0102113
Location: Boone County

Mr. Smith then observed the single-cell aerated lagoon. The surface of the lagoon was mostly frozen at the time of inspection (Photo #3). The aerator was running and appeared to be functioning properly (Photo #4). Erosion damage on the inner lagoon berms was observed, resulting in a slope steeper than three to one (Photos #5-7). The inlet side of the discharge pipe was observed and had a T-fitting on the end of the pipe (Photo #8).

Description: View of erosion damage observed on the inner lagoon berms.

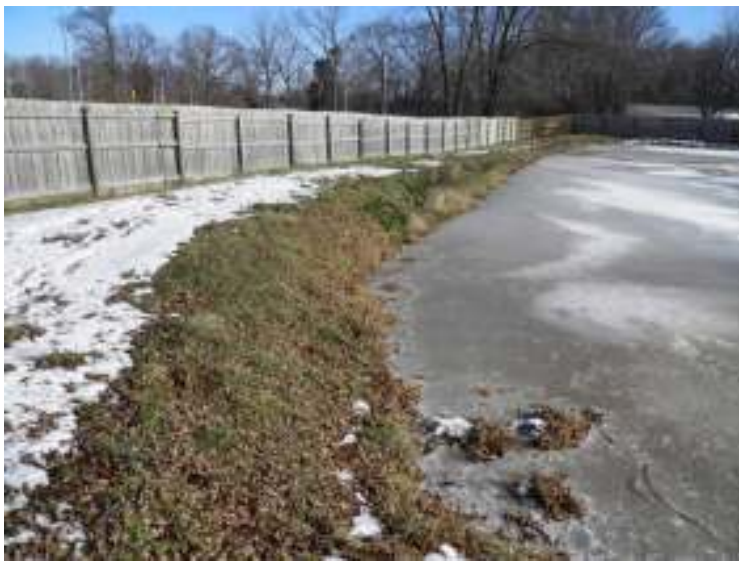
Photo #: 6
By: Mike Smith
Facility: BCSD - Lee Heights WWTF
Permit: #MO-0102113
Location: Boone County

Description: View of additional erosion damage observed on the inner lagoon berms.

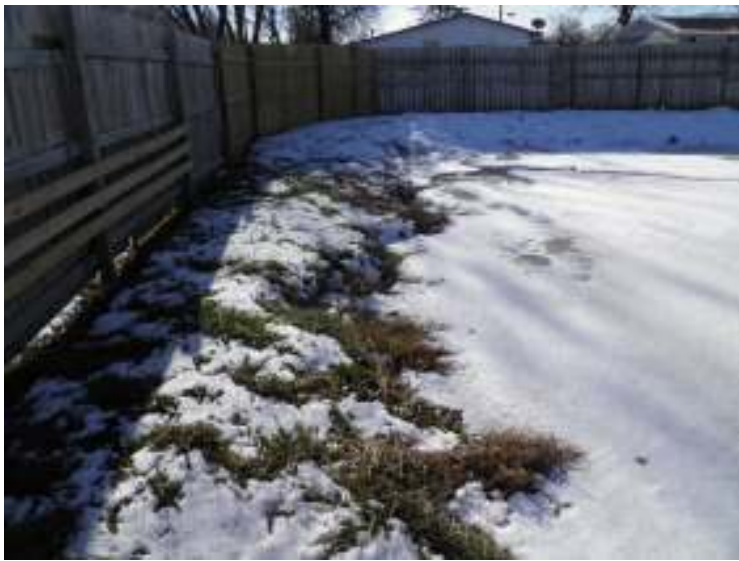
Photo #: 7
By: Mike Smith
Facility: BCSD - Lee Heights WWTF
Permit: #MO-0102113
Location: Boone County

Description: View of additional erosion damage observed on the inner lagoon berms.

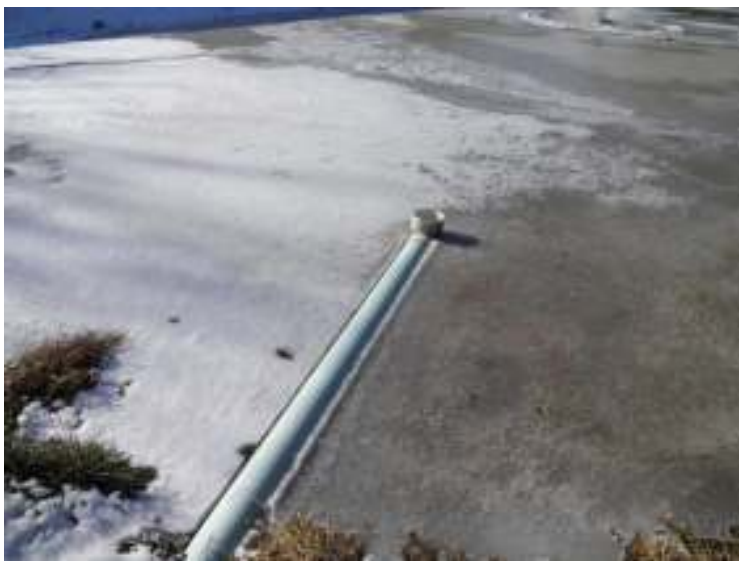
Photo #: 8
By: Mike Smith
Facility: BCSD - Lee Heights WWTF
Permit: #MO-0102113
Location: Boone County

Description: View of inlet side of the discharge pipe. T-fitting observed.

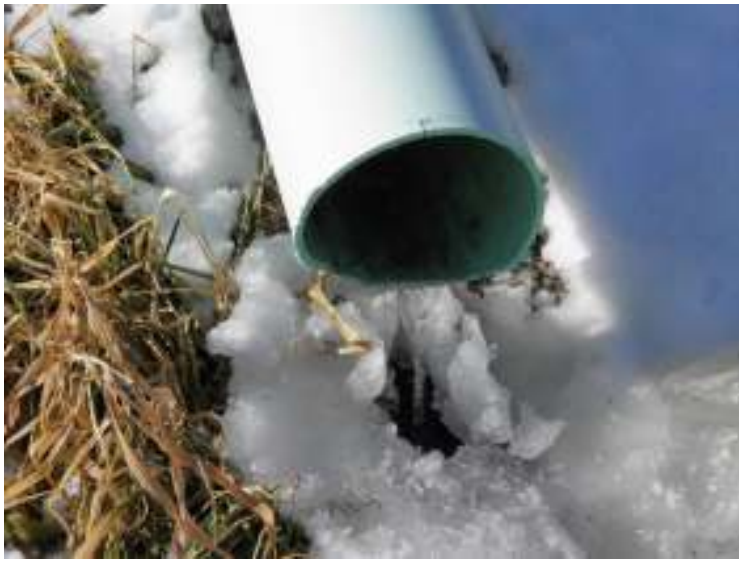
Photo #: 10
By: Mike Smith
Facility: BCSD - Lee Heights WWTF
Permit: #MO-0102113
Location: Boone County

Mr. Smith then observed the facility's outfall location. A sign marking the outfall was observed on the perimeter fence (Photo #9). The facility was discharging at the time of inspection (Photo #10). The effluent appeared clear and no odor was detected. The effluent from the facility enters a small drainage that flows into a road culvert under Highway Z (Photo #11). No evidence of a discharge of sludge was observed below the outfall.

Description: View of discharge pipe. Small discharge occurring at the time of inspection. Effluent appeared clear and no odor was observed.

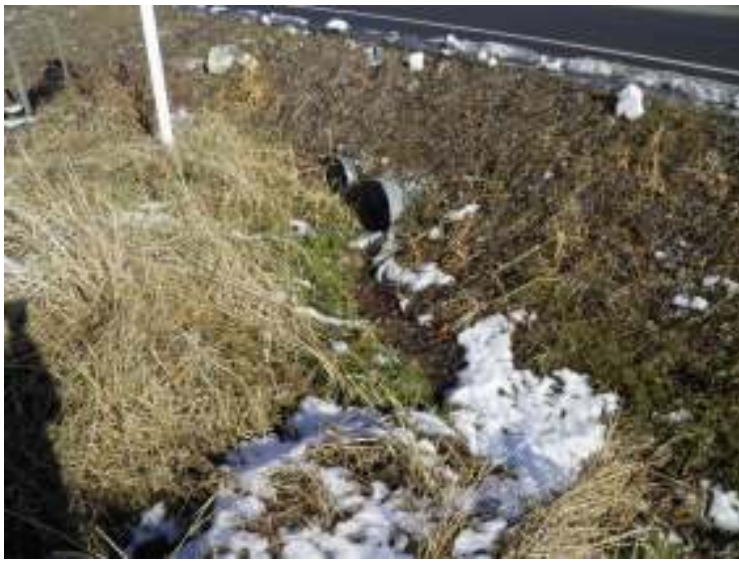
Photo #: 11
By: Mike Smith
Facility: BCSD - Lee Heights WWTF
Permit: #MO-0102113
Location: Boone County

Description: View of drainage below the outfall. Drainage flows into a road culvert under Highway Z. No concerns noted.

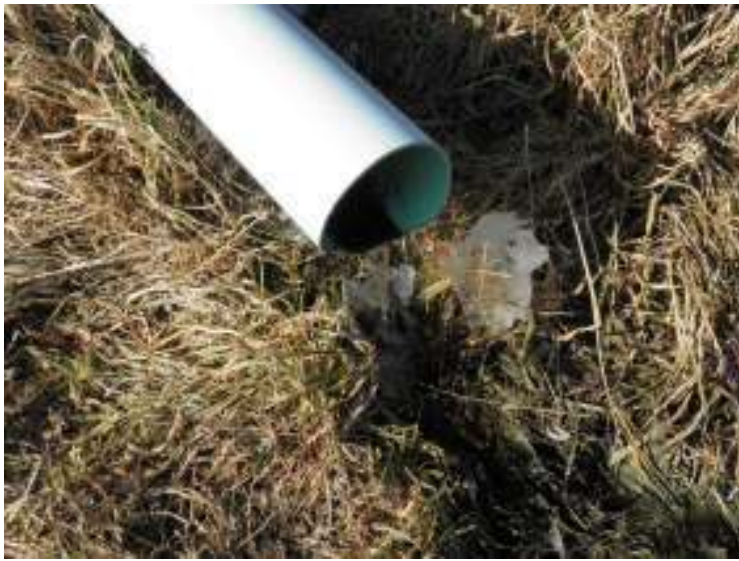
Photo #: 1
By: Mike Smith
Facility: BCSD - Lee Heights WWTF
Permit: #MO-0102113
Location: Boone County

Description: View of the facility's discharge pipe. Effluent discharging at the time of the inspection. Effluent appeared light green in color.

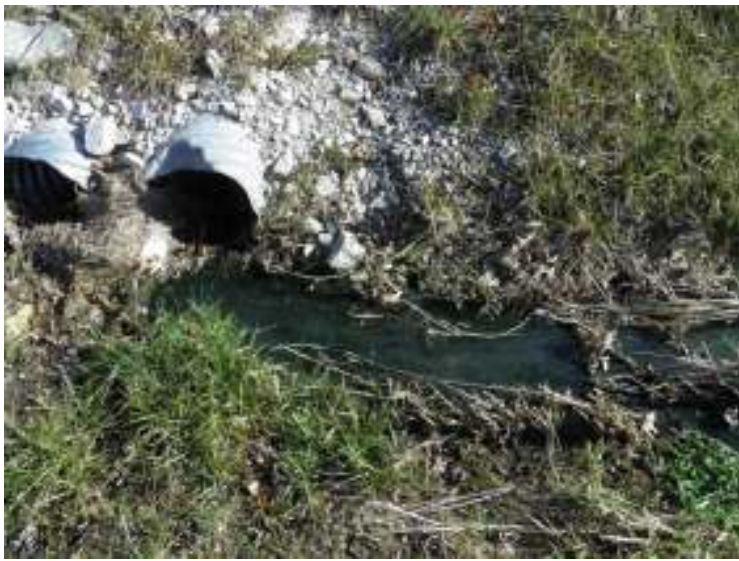
Photo #: 2
By: Mike Smith
Facility: BCSD - Lee Heights WWTF
Permit: #MO-0102113
Location: Boone County

Description: View of pooled water observed downstream of the outfall, just prior to the road culvert that travels under Highway Z. Ice observed on top of the water. Water appeared greenish in color.

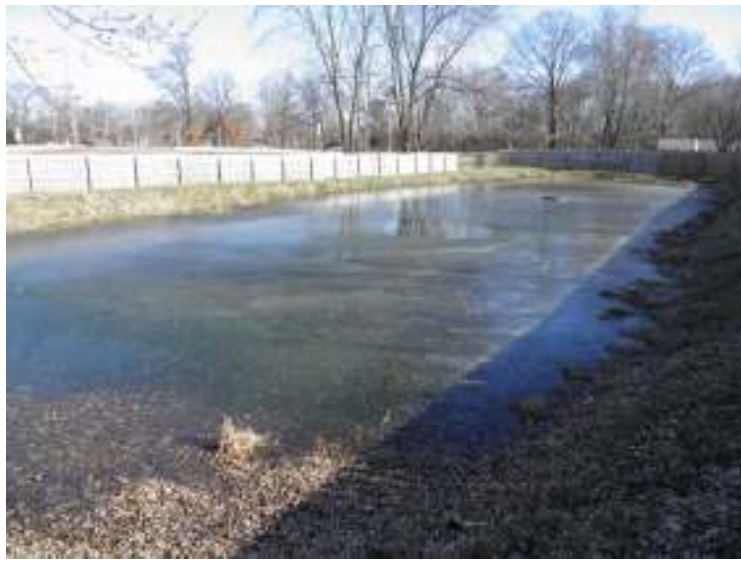
Photo #: 5
By: Mike Smith
Facility: BCSD - Lee Heights WWTF
Permit: #MO-0102113
Location: Boone County

The single cell lagoon was then observed (Photo #5). The surface of the lagoon was largely frozen. The wastewater in the lagoon appeared dark green in color. The facility's aerator was not functioning at the time of the inspection (Photo #6). Mr. Farnen stated he contacted someone to have it fixed. Erosion damage of the inner lagoon berms was observed (Photo #7). Over two feet of freeboard appeared available in the lagoon, however, a lower area in the berm was observed on the east side of the lagoon (Photo #8). Mr. Smith stated that the berm should be built up to ensure an overflow over the berm does not occur in the future. The influent side of the facility's discharge pipe was observed to have a T-fitting (Photo #9). No deep-rooted vegetation was observed growing on the lagoon berms. No holes through the berms or signs of an unpermitted discharge were observed at the time of the inspection

Description: View of the single cell lagoon. Lagoon surface largely frozen. Wastewater in the lagoon appeared dark green in color.

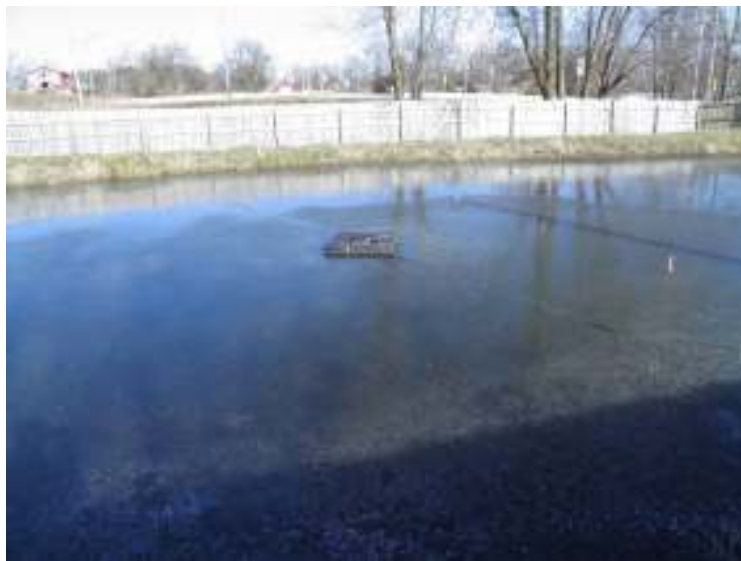
Photo #: 6
By: Mike Smith
Facility: BCSD - Lee Heights WWTF
Permit: #MO-0102113
Location: Boone County

Description: View of facility's aerator. Aerator was not functioning at the time of the inspection.

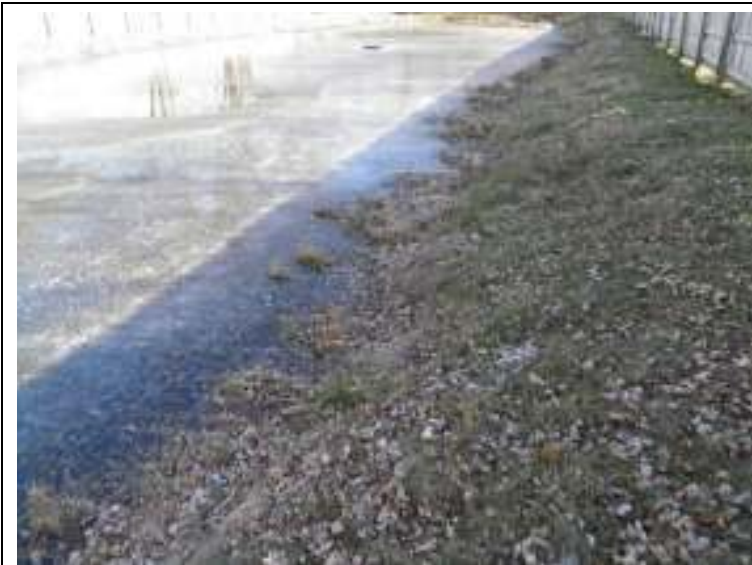
Photo #: 7
By: Mike Smith
Facility: BCSD - Lee Heights WWTF
Permit: #MO-0102113
Location: Boone County

Description: View of eroded inner lagoon berms.

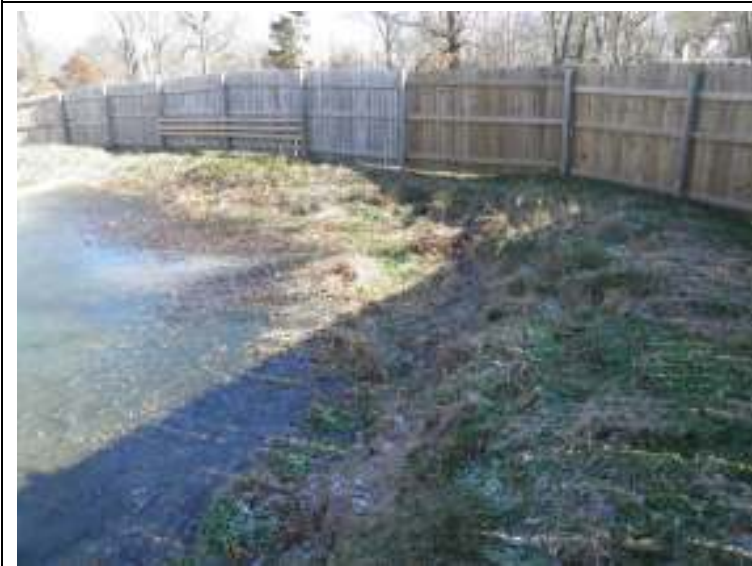
Photo #: 8
By: Mike Smith
Facility: BCSD - Lee Heights WWTF
Permit: #MO-0102113
Location: Boone County

Description: View of eroded inner lagoon berms. Low area in the berm observed. Mr. Smith recommended the berm be built up to prevent a possible overflow in the future.

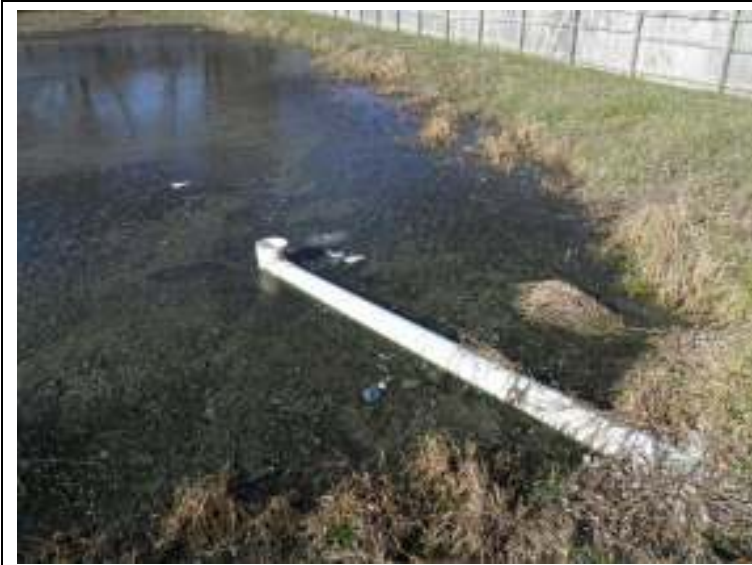
Photo #: 9
By: Mike Smith
Facility: BCSD - Lee Heights WWTF
Permit: #MO-0102113
Location: Boone County

Description: View of influent side of the discharge pipe. T-fitting on the end of the pipe observed.
