5.200 BCRSD, Oberlin Valley Wastewater Treatment Facility
Boone County
#MO-0117323

**LETTER OF WARNING
NO RESPONSE REQUIRED**

Missouri Department of Natural Resources
Northeast Regional Office
Report of Inspection
BCRSD, Oberlin Valley Wastewater Treatment Facility
North Oberlin Valley Road, Columbia,
Missouri, 65201, Boone County
#MO-0117323
May 23, 2018

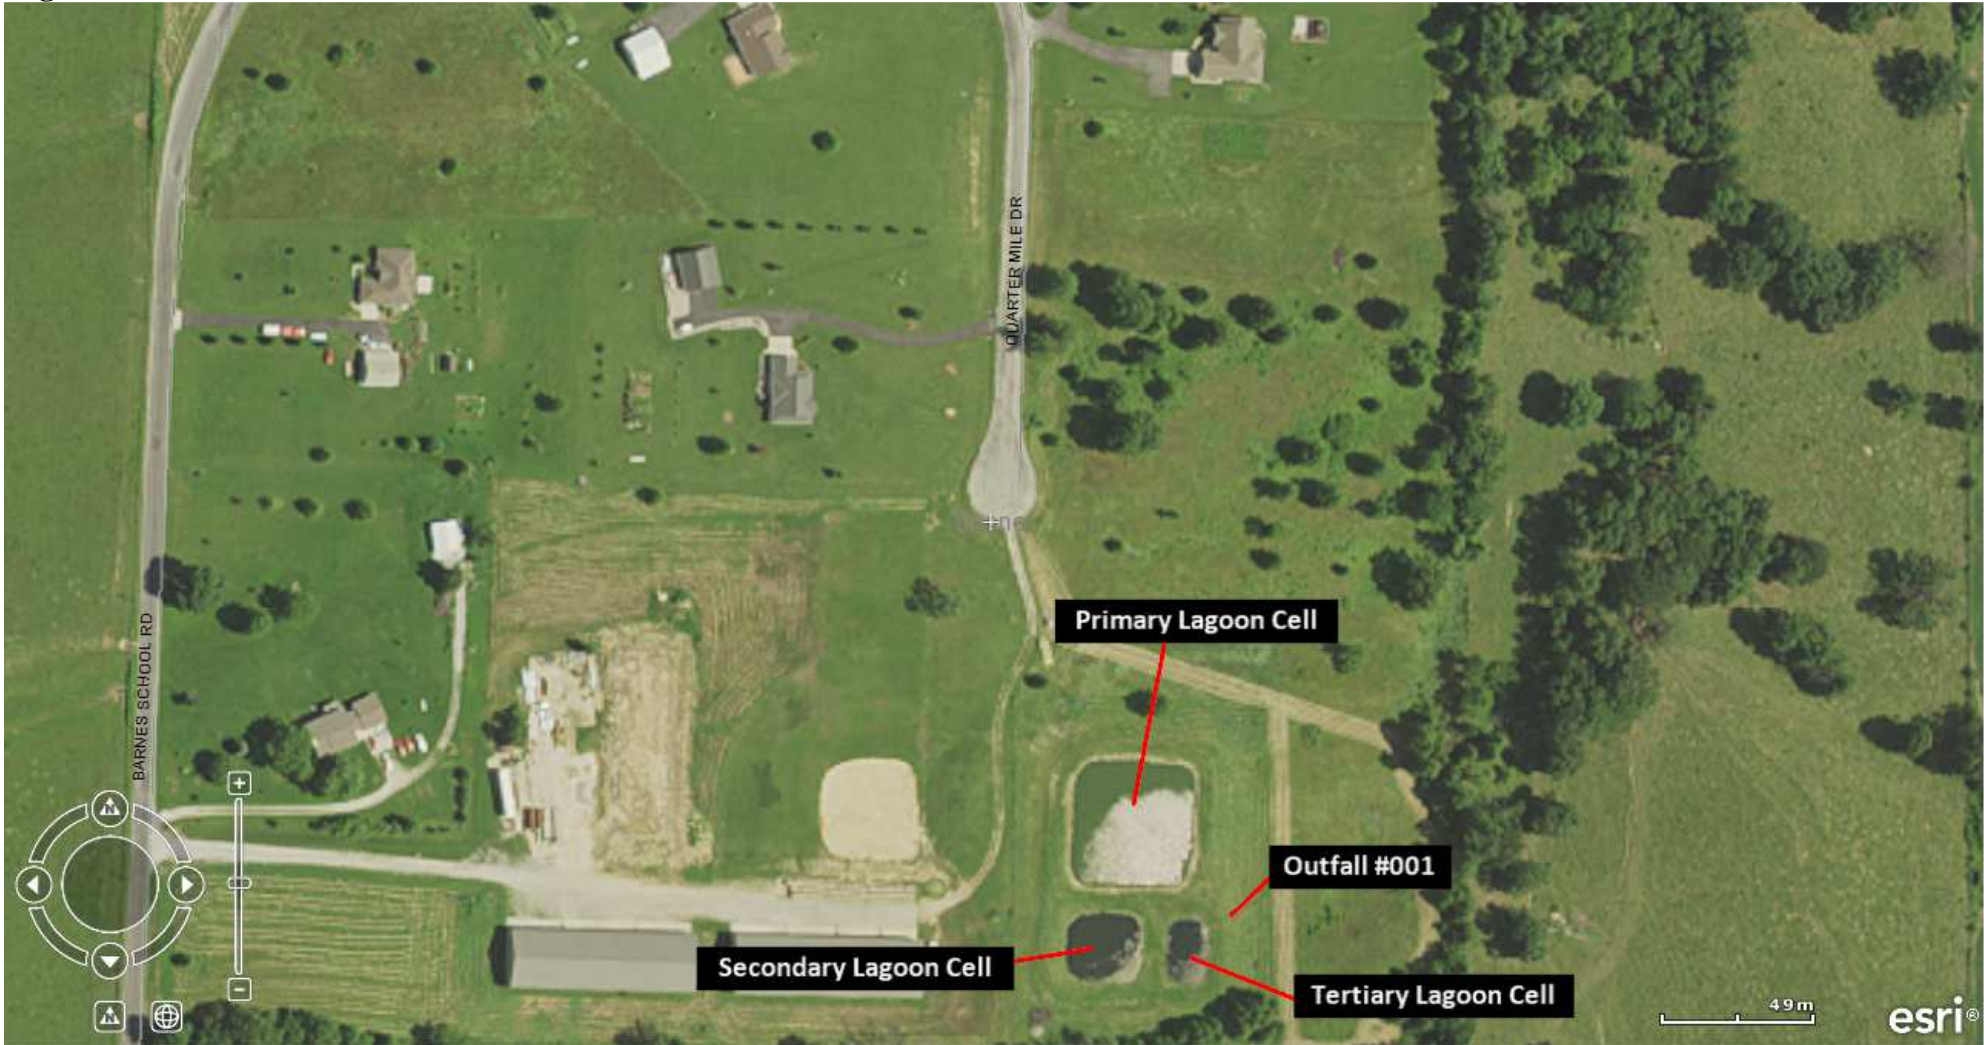
The inspection then proceeded with observations of the facility's outfall. The outfall was marked in the field with a sign (Photo #6). The outfall was not discharging during the inspection. Mr. Farnen explained that there are three different levels the facility can discharge from. The bottom two pipes are regulated with valves, which were closed during the inspection. The top pipe does not have a valve and discharges if the level is high enough. I observed the receiving stream upstream and downstream from the facility's outfall. I did not observe any impact on the receiving stream. Samples were not collected for water quality field monitoring and laboratory analyses since the facility was not discharging during the inspection.

Photograph #: 6
Taken by: Leland Maize
Entity: BCRSD, Quarter Mile Hills Subdivision
Permit: #MO-0126446
Location: Boone County
Description: Location of the outfall with a sign marking the location.
Date Taken: July 27, 2016
Program: WPC Unit

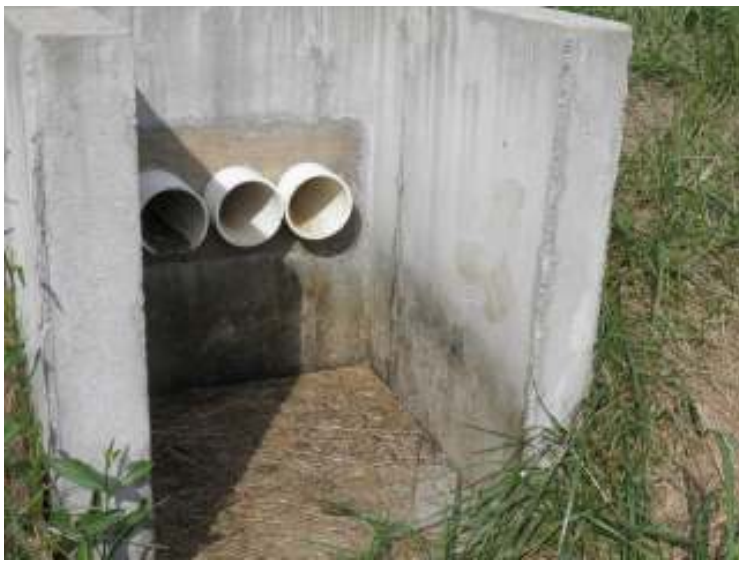
Photo #: 10

Mr. Smith observed the facility's outfall location, which was marked with a sign (Photo #9). None of the three discharge pipes were discharging at the time of inspection (Photo #10). No concerns below the outfall were observed.
