# Gas Incident Report

Laclede Gas Company Case No. GS-2011-0245

3810 Council Grove Avenue Pine Lawn, Missouri January 8, 2011

Energy Unit ... Regulatory Review Division December 2011 Jefferson City, Missouri

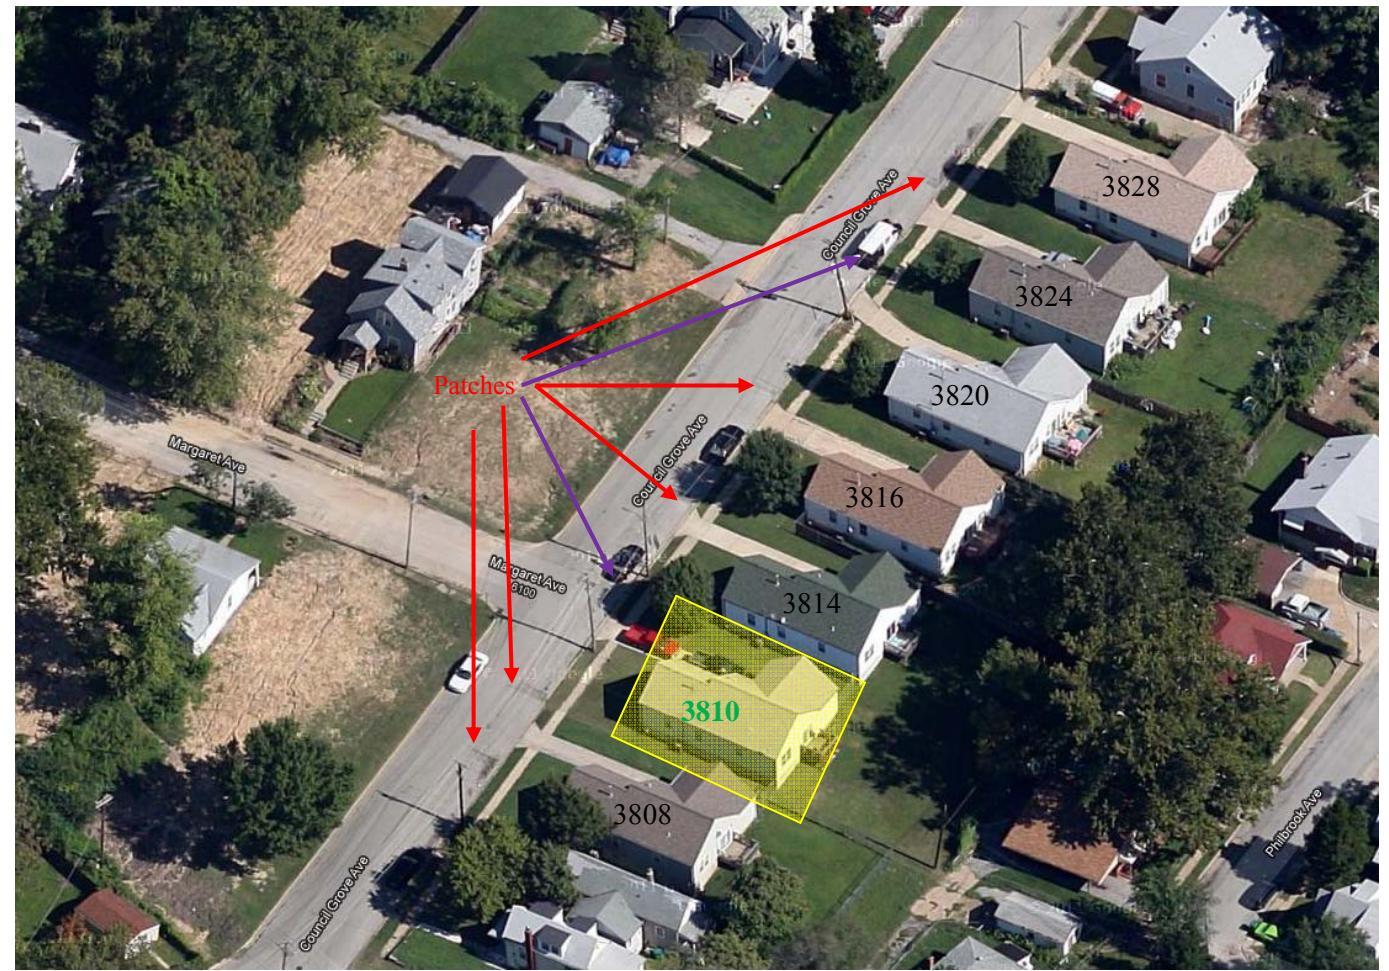
Figure 2 Surrounding Neighborhood View of 3810 Council Grove Avenue

As discussed further in Section 4.10.1, a previous excavation patch in the street at 3810 Council Grove Avenue corresponded to the location of the sanitary sewer lateral to 3810 Council Grove (See Appendix B-1, Photograph 2). Similar additional street patches from previous excavations between the east curb and the sanitary sewer main were also located in front of 3808, 3814, 3816, 3820, 3824, and 3828 Council Grove Avenue (See Appendix A-2, Figure 2). These street patches apparently correspond to the location of the sanitary sewer laterals installed to these addresses, which were built during the same time period as 3810 Council Grove.

**Figure 2** – Surrounding Neighborhood View of 3810 Council Grove Avenue. Note the similar construction of houses 3808 to 3828, which were built during the same time period. Red arrows show street patches from previous sanitary sewer lateral excavations in front of 3808, 3810, 3816, 3820 and 3828 Council Grove Avenue. The purple arrows show the approximate location of street patches from previous sanitary sewer lateral excavations in front of 3814 and 3824 Council Grove Avenue (the patches in the street are covered over by parked vehicles). The involved residence (3810 Council Grove Avenue) is shaded. (Map provided by Google Maps)

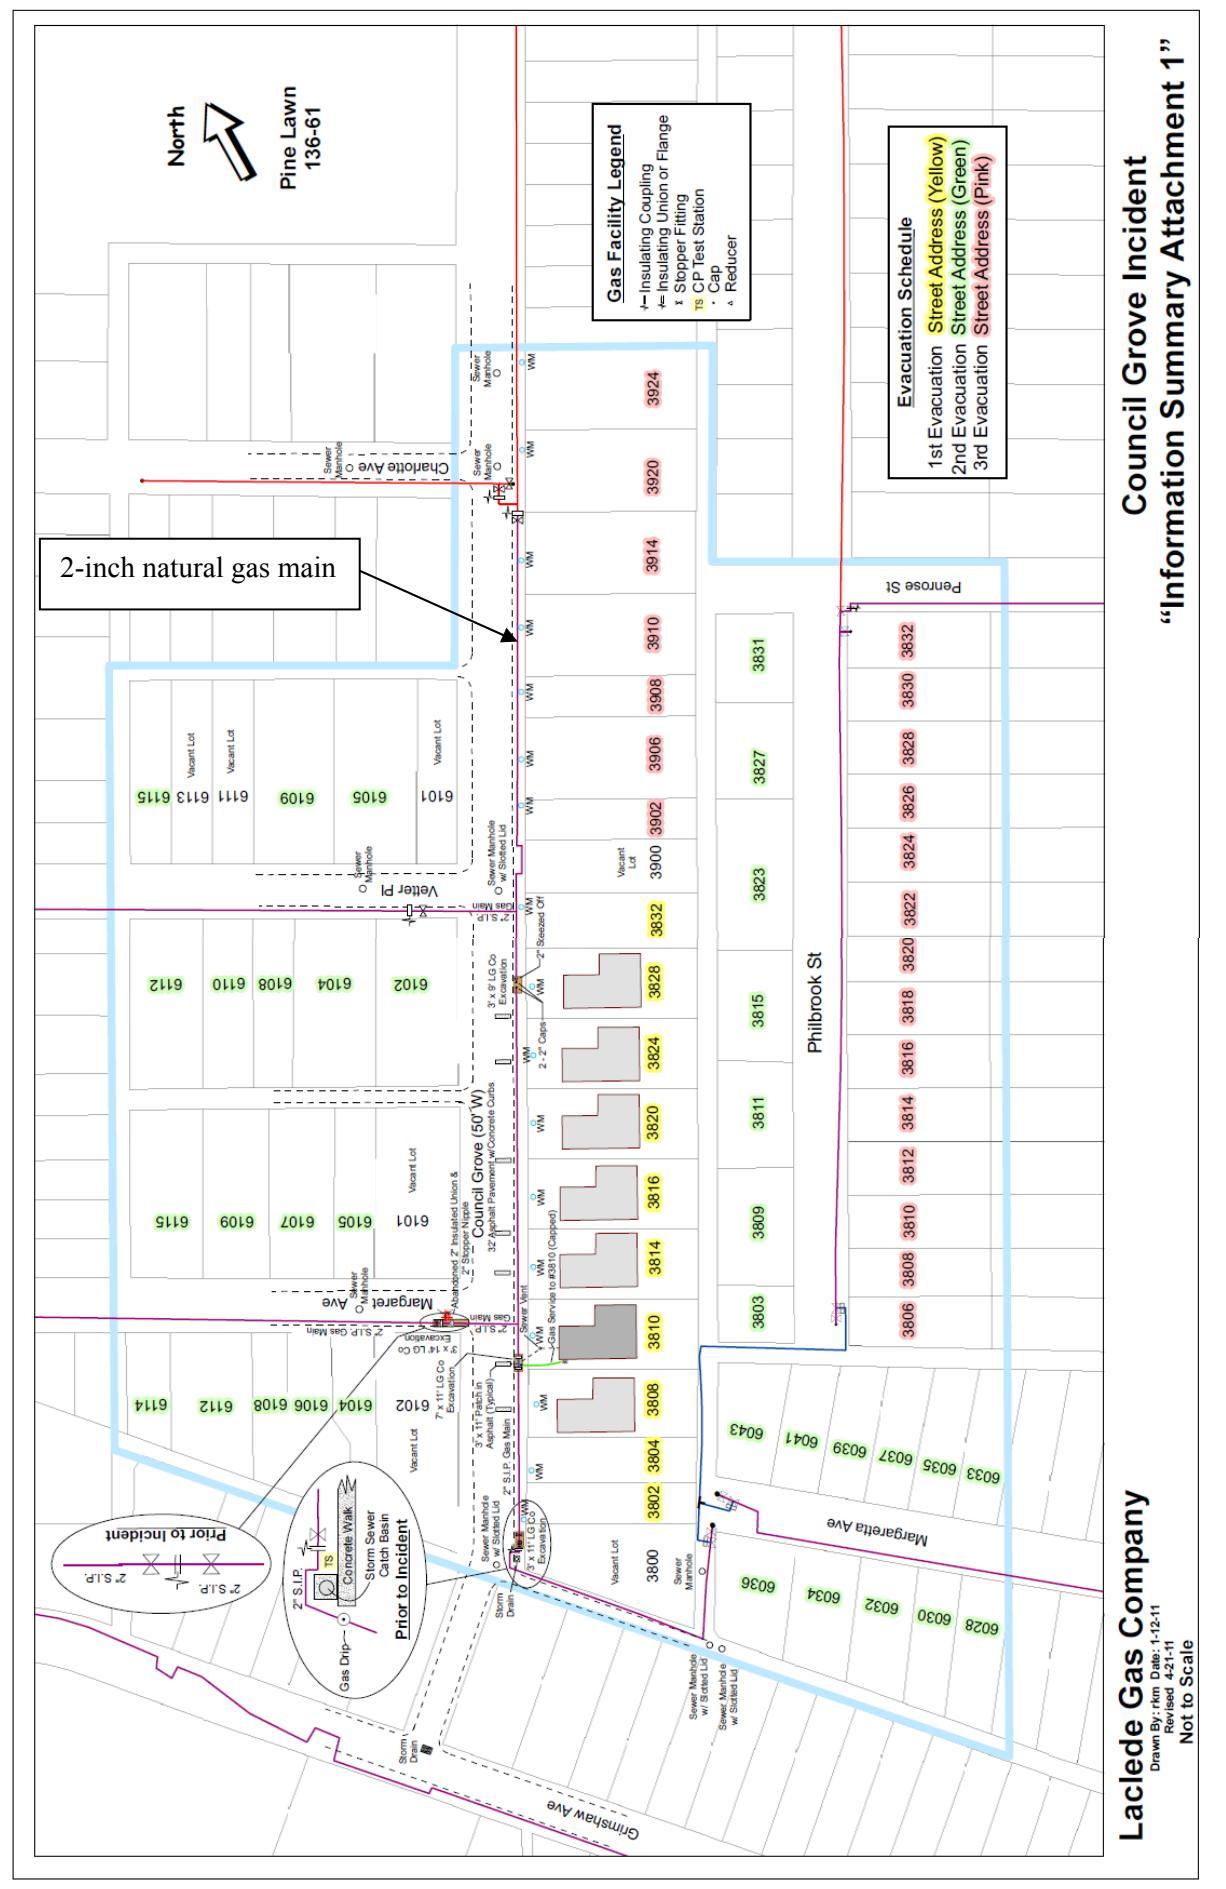
Figure 3 - Overall Plan View of Incident Area y) Appendix A-3

Natural gas service in the St. Louis, Missouri area is provided by Laclede Gas Company. The distribution main supplying the 3800 block of Council Grove Avenue is a 2-inch diameter coated steel gas main located parallel to and east of the east curb line of Council Grove Avenue (See Appendix A-3, Figure 3). The main was installed in 1953 and the depth of cover at the incident location was approximately 4½ feet. The main was operating at a pressure of approximately 18 psig at the time of the incident and the maximum allowable operating pressure<sup>2</sup> (MAOP) established by Laclede was 60 psig. The Company does not have records for the main regarding the pipe manufacturer or pipe specification. The Company also does not have records regarding the coating on the main, but the coating on the main at the incident location was observed to be factory-applied spiral-wrapped coating made with some type of coal-tar material.

All steel gas mains in the incident area were considered to have cathodic protection (CP) and Laclede was using operation and maintenance procedures for cathodically protected steel mains. The Company's map (See Appendix A-3, Figure 3) showed the steel main serving 3802 - 3914 Council Grove Avenue was electrically continuous (no insulating fitting shown) with a steel main extending east from Council Grove Avenue, which indicated both mains were connected to CP test station<sup>4</sup> 4410 located at 3800 Council Grove Avenue (vacant lot). This CP test station had been checked on an annual basis<sup>5</sup> and had been meeting the CP criterion that requires a negative polarized voltage of at least 0.85 volt (V), with reference to a saturated copper-copper sulfate half cell. After the incident, it was determined that an insulating union (not shown on the Company map) was located in the steel main just north of CP test station 4410 and there had been no CP test station connected to the electrically-isolated steel main serving 3802 - 3914 Council Grove Avenue. CP test station 4410 was only connected to an electrically-isolated steel main located along an alley between Council Grove Avenue and Margaretta Avenue to the east.
