**LETTER OF WARNING  
PUBLIC DRINKING WATER  
SIGNIFICANT DEFICIENCY  
RESPONSE REQUIRED**

**Missouri Department of Natural Resources  
Kansas City Regional Office, Public Drinking Water Branch  
Report of Sanitary Survey Inspection  
City of Garden City  
30109 South Little Road, Garden City, Cass County  
MO1010301**

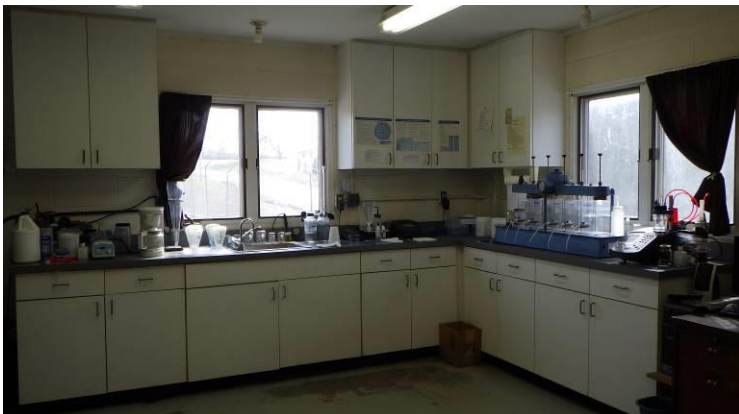
Photograph: 15  
Taken By: Denise Eagan  
Facility: Garden City PWS  
Permit: MO1010301  
Location: UTM 15N 397647/4269198

After the records review, we started the WTP tour in the laboratory (Photograph 15). All testing is done in house. A finished water continuous turbidity meter and a continuous chlorine monitor were located in the laboratory for easy viewing. The pH probe is stored in 7 SU buffer solution. The operators run a test in the morning to see if the meter is reading 7 SU. If the meter is not reading 7 SU, they recalibrate the meter using three (3) point calibration. The buffer solution is changed weekly. The pH 10 SU buffer solution was expired (**Unsatisfactory Finding 2**).

Description: Viewing the laboratory with jar testing equipment, various testing equipment, and sample taps.

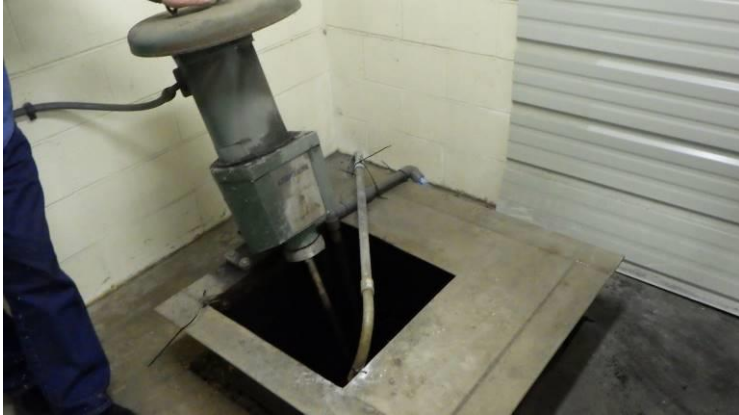
Photograph: 19  
Taken By: Denise Eagan  
Facility: Garden City PWS  
Permit: MO1010301  
Location: UTM 15N 397647/4269198

The secondary rapid mix basin has a mechanical mixer (Photograph 19). Caustic soda and chlorine dioxide are the only chemicals added at this location. Caustic soda is used to increase the pH while chlorine dioxide is used as an oxidizer and disinfectant. Mr. Brown stated that he was running at approximately a pH of 8-9 SUs. We went to the ground floor to observe the raw water piping with sodium permanganate feed point (Photograph 20). The sodium permanganate was not in a secondary containment and a drain was located nearby (Photograph 21, **Recommendation 26**). Mr. Brown stated the drain was connected to the WTP sanitary septic system with lateral field. Mr. Brown stated they cannot check the output of the permanganate pump as the water pressure is too high and would give inaccurate readings. The sodium chlorite for chlorine dioxide generation equipment is also stored in the area within secondary containment but was unlabeled (Photograph 22, **Recommendation 27**). After sodium permanganate is added, the water flows to the 5,000-gallon permanganate tank (Photograph 23). The water enters the bottom of the tank and leaves at the top of the tank for approximately eighteen (18) minutes of contact time with the permanganate. There was no lighting in the permanganate room (**Recommendation 28**).

Description: Viewing the secondary rapid mix with mechanical mixer and caustic chemical feed line.

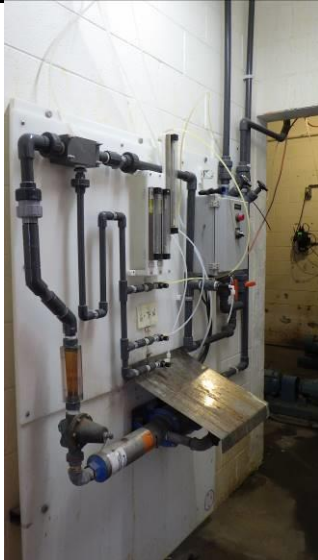
Photograph: 31  
Taken By: Denise Eagan  
Facility: Garden City PWS  
Permit: MO1010301  
Location: UTM 15N 397647/4269198

Description: Viewing the chlorine dioxide generation equipment with water sources on the top right of the photograph.

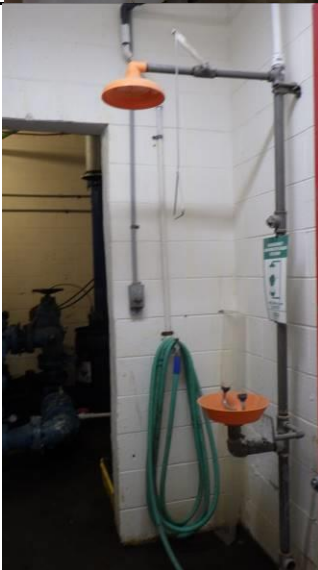
Photograph: 32  
Taken By: Denise Eagan  
Facility: Garden City PWS  
Permit: MO1010301  
Location: UTM 15N 397647/4269198

Description: Viewing the safety shower, eyewash station, and hose used to clean the chemical area. Raw water piping visible through the doorway.

33. Ensure the safety shower and eye wash station are flushed on a routine basis to ensure fresh water is available when needed.
34. Ensure proper Personal Protective Equipment (PPE) is obtained and worn by all operators working with the chemicals to prevent any potential injuries due to chemical burns.
35. Ensure to clean the backwash and CIP tank on a regular basis, such as annually, to help prevent fouling of filters.
36. Ensure to change the hoses entering the turbidity meters regularly to prevent potential build up in the hoses from fouling the meters or causing false positives.

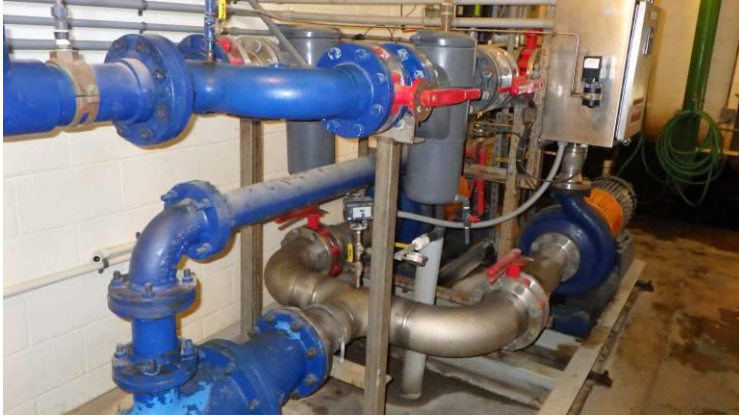
Photograph: 34  
Taken By: Denise Eagan  
Facility: Garden City PWS  
Permit: MO1010301  
Location: UTM 15N 397647/4269198

We returned to the WTP and observed the Ultra Filtration (UF) system including the pumps (Photograph 34) and the filter trains (Photograph 35). The UF system has two (2) trains consisting of seven (7) canisters per train. Mr. Brown stated they conduct direct integrity testing (DIT) once per week after getting written permission from Maher Jaafari, PDWB Engineering Section. The canisters can have 20-25 straws pinned before they need to be replaced. On February 24, 2020, train 2 had a significant failure of the (DIT) with a final pounds per square inch (psi) of 11.5. It was unclear if this led to a breakthrough on turbidity because Mr. Brown also indicated that he had recently had a technician out to fix his turbidity meters as he was having turbidity spikes. Either could have been responsible for elevated turbidity readings. We

Description: Viewing the two horizontal turbine pumps for the UF system

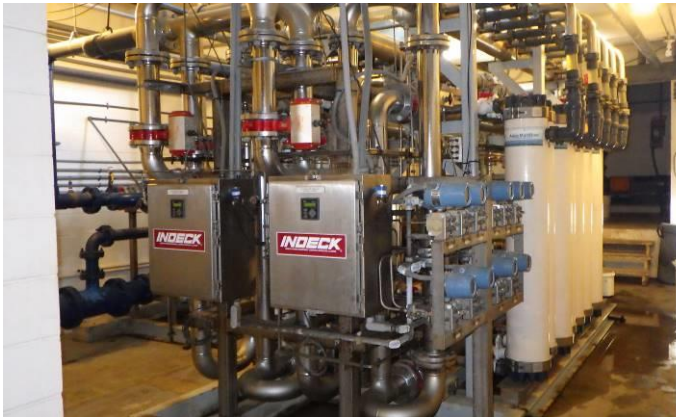
Photograph: 35  
Taken By: Denise Eagan  
Facility: Garden City PWS  
Permit: MO1010301  
Location: UTM 15N 397647/4269198

Description: Viewing the UF system with pressure gages, canisters, and view ports over the canisters for DIT.

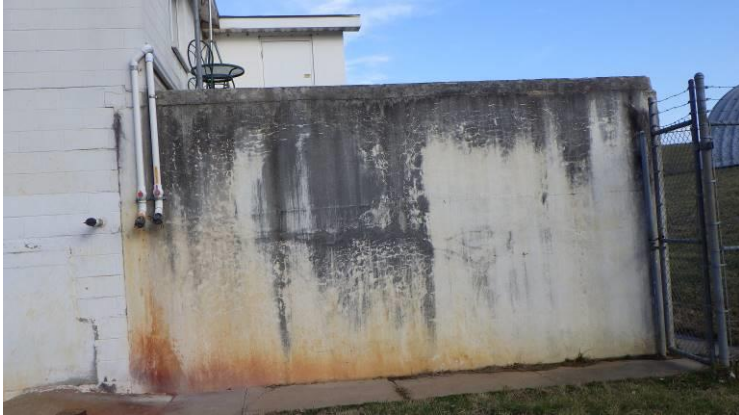
Photograph: 37  
Taken By: Denise Eagan  
Facility: Garden City PWS  
Permit: MO1010301  
Location: UTM 15N 397647/4269198

Description: Viewing the exterior of the transfer basin with bulk chemical filling connection points.

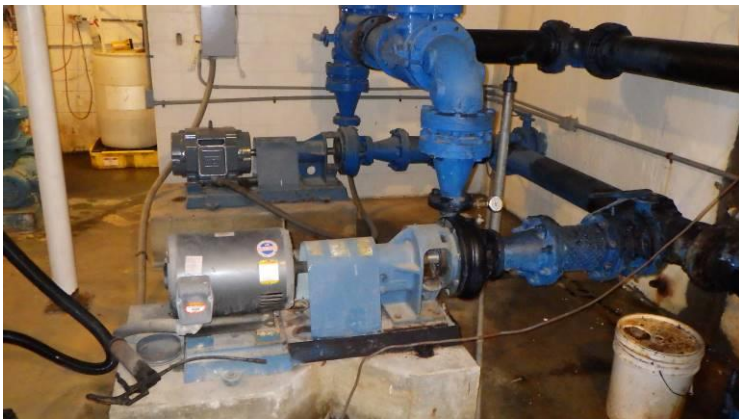
Photograph: 38  
Taken By: Denise Eagan  
Facility: Garden City PWS  
Permit: MO1010301  
Location: UTM 15N 397647/4269198

then observed the two (2) horizontal turbine transfer pumps, which transfer water from the transfer basin to the clearwell (Photograph 36). The transfer pumps turn on once the water has reached a depth of seven (7) feet in the transfer basin and turns off once the water has reached a depth of five (5) feet in the transfer basin (Photograph 37). I observed another cleaning hose tied into the finished water without a backflow prevention device but it did have a meter to help track water loss. Behind the piping was a chemical feed pump, which appeared to no longer be in use, but had a leaked at some point eroded the paint from the wall. The two (2) horizontal turbine high service pumps were located next to the transfer pumps (Photograph 38). The high service pumps rotate automatically after filling the towers.

Description: Viewing the two horizontal turbine high service pumps.

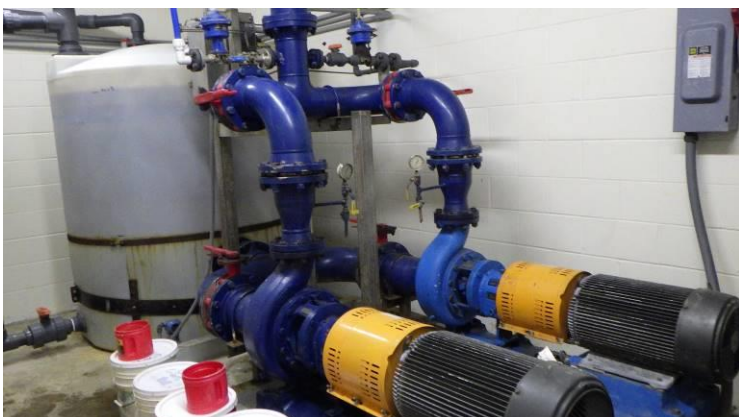
Photograph: 39  
Taken By: Denise Eagan  
Facility: Garden City PWS  
Permit: MO1010301  
Location: UTM 15N 397647/4269198

Next, we observed the UF system backwash pumps and backwash tank (Photograph 39). The backwash has two (2) horizontal turbine pumps. The backwash tank is filled using water directly after filtration. There is no schedule to routinely clean the tank (**Recommendation 35**). The flow is split between the backwash tank and the transfer basin. Backwash occurs automatically every twenty-four (24) minutes. The Clean-In-Place (CIP) tank is also located at this location (Photograph 40). This is used for offline cleaning of the filters which occurs approximately once per month or as the filter plugs. The trigger to perform a non-routine offline cleaning is a transmembrane pressure (TMP) value of nineteen (19) psi versus thirty (30) psi. The cleaning consists of either a high pH or a low pH cleaning, which rinses the filters for forty-five (45) minutes one direction, then forty-five (45) minutes the opposite direction. The CIP tank is filled using finished water while maintaining an air gap, and then the operators add either citric acid or calcium hypochlorite by hand to raise the pH to 12.0 SU or lower the pH to 2.5 SU. The water is also heated to 77°F in the CIP tank for the offline cleaning process.

Description: Viewing the two horizontal turbine backwash pumps, the backwash tank, along with the chemicals used to offline clean the filters.

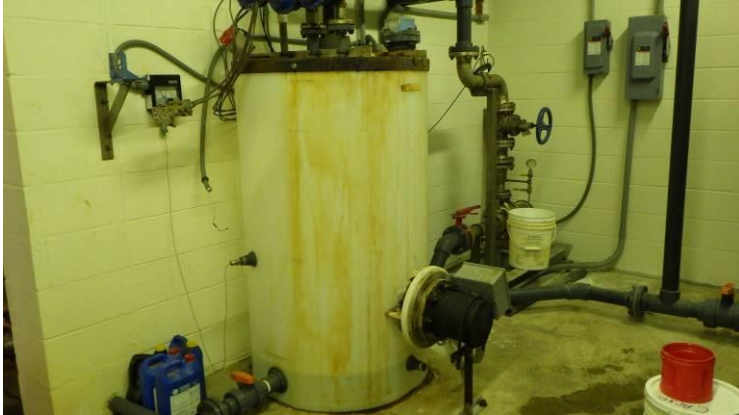
Photograph: 40  
Taken By: Denise Eagan  
Facility: Garden City PWS  
Permit: MO1010301  
Location: UTM 15N 397647/4269198

Description: Viewing the CIP tank with staining down the front.

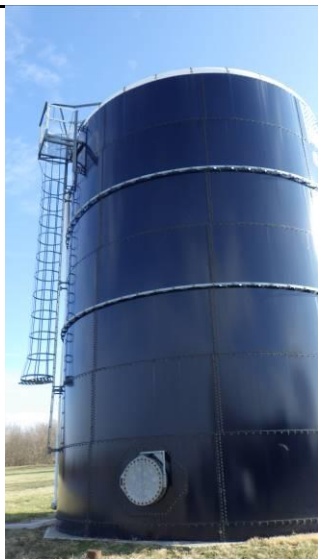
Photograph: 42  
Taken By: Denise Eagan  
Facility: Garden City PWS  
Permit: MO1010301  
Location: UTM 15N 397646/4269098

Lastly, we observed the clearwell (Photograph 42). The clearwell had a manway on ground level. The ladder was locked to prevent vandalism. The overflow was fitted with #18 mesh screen to which was adequate to prevent the entrance of contaminants. The overflow also had splash pad to prevent against erosion. During observation of the outside of the clearwell tank, three (3) active leaks were discovered (Photographs 43-45, **Significant Deficiency 1**).

Description: Viewing the clearwell with manway, locked ladder entry, and overflow on the left side of the standpipe.
