FINDING OF COMPLIANCE

Missouri Department of Natural Resources
Southeast Regional Office/Public Drinking Water Program
Report of Inspection
Hillcrest Utility Operating Company, Inc.
Highway K, Cape Girardeau, MO 63702
Cape Girardeau County Missouri
MO4036038
February 1, 2018

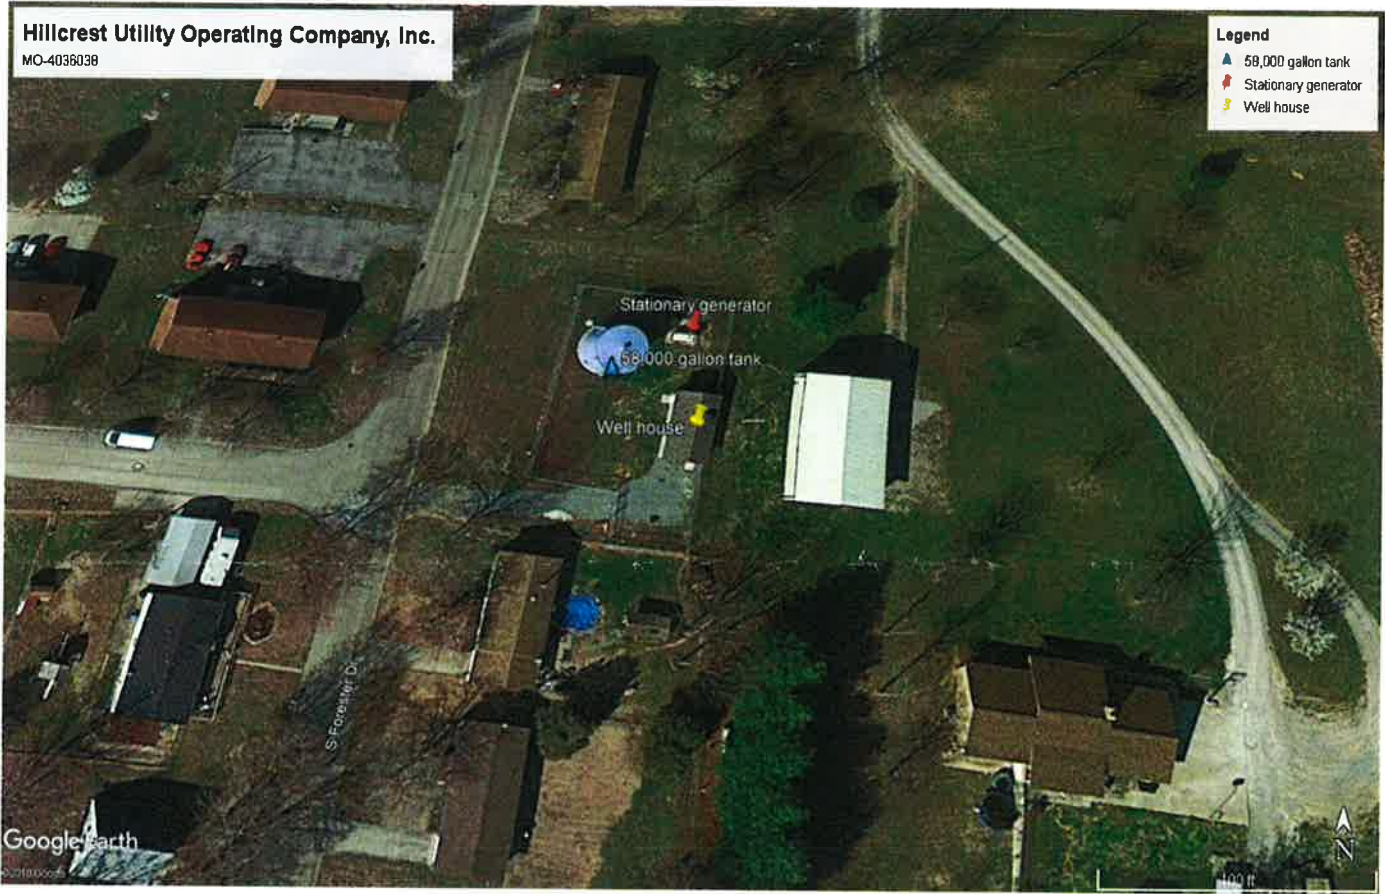
Photo #: 008
Date Taken: 01/24/2018
By: Michael Wyatt
Program: PDWB
File: Hillcrest Utility Operating Co., Inc. – General
Location: Well/tank site
Description: Fenced well house and storage tank.
