# AmerenUE's Storm Outage Planning and Restoration Effort Following the Storms on July 19 and 21, 2006

**Case No. EO-2007-0037**  
**Missouri Public Service Commission Staff**  
**November 17, 2006**

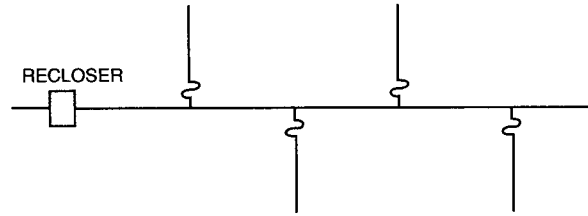
**Figure 1.**  
Reclosers and fuses provide protection against transient and permanent faults.

A combination of a recloser and fuses, as shown in Figure 1, is typically used to provide protection against both transient and permanent faults.

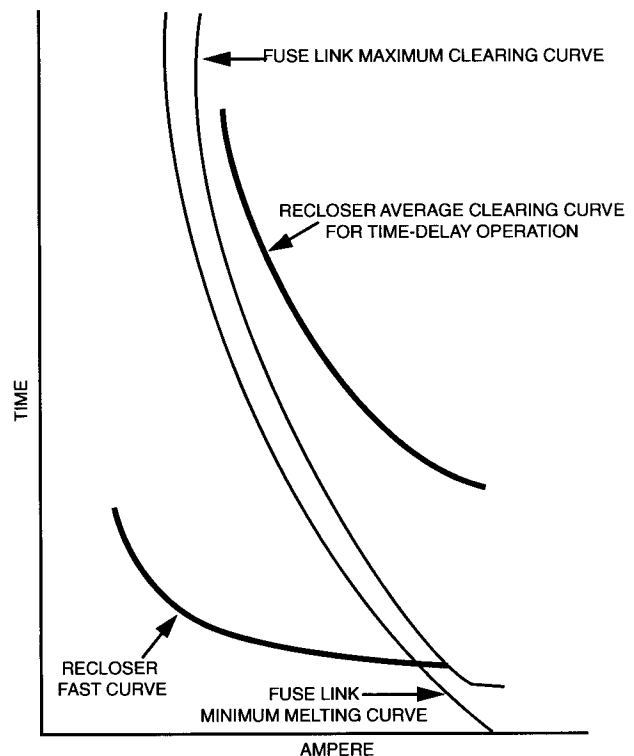
**Figure 2.**  
Recloser/fuse link coordination.

The fast trip curve of the recloser is used to clear all transient faults on the main feeder and taps. For permanent faults on the taps, the recloser time-delay curve allows the tap fuse to clear, resulting in an outage on the tap only as shown in Figure 2.

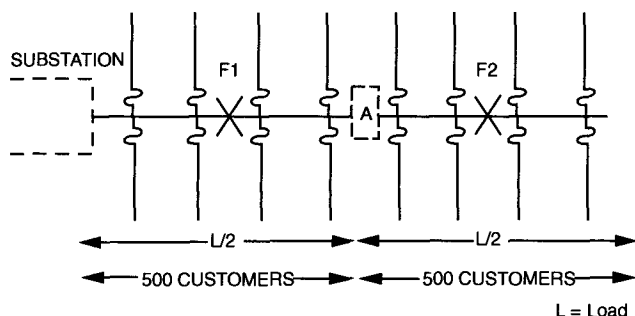
**Figure 3.**  
Calculating reliability.

Investigate outage rates for one fault at F1 and one fault at F2 as shown in Figure 3.

Each outage = 1 hour in length (time required to locate fault and restore service).

Adding a recloser at point A, shown in Figure 3, as a main-line-sectionalizing device will reduce outage rates caused by faults on the main feeder.

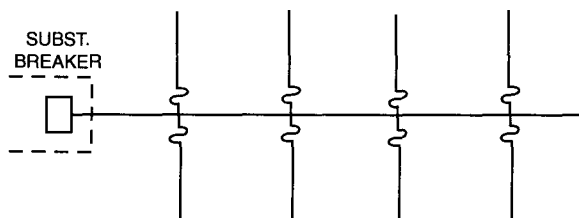
**Figure 4.**  
Substation breaker set on all delay operations to lockout.

#### Circuit Breaker in Substation without Instantaneous Tripping

All faults on taps result in an outage due to fuse operation. Refer to Figure 4.

1. Replace breaker with recloser.

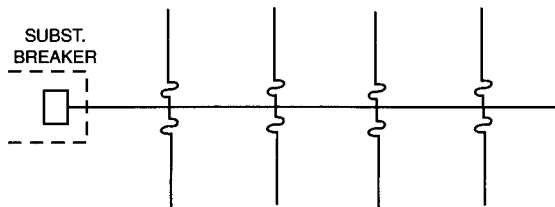
**Figure 5.**  
Substation breaker with typical relay settings.

A breaker utilizing a conventional relay setting of one instantaneous (INST) trip followed by time-delay trip operations, with the INST trip level set typically at 2 1/2 times the basic phase and ground trip settings, as shown in Figure 5.

Phase trip = 800 A, INST at 2000 A

Ground trip = 300 A, INST at 750 A

The 750 A ground trip instantaneous setting generally will not provide reach for faults distant from the substation; thus all transient faults occurring at these locations and all faults below 750 A magnitude on any tap will result in an outage.

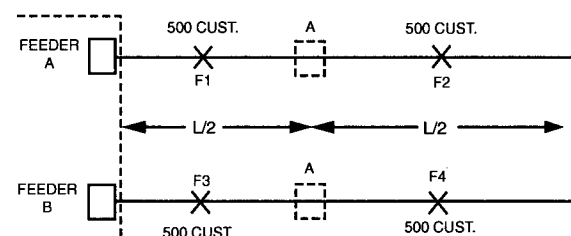
**Figure 7.**  
Typical recloser-protected feeders without midpoint sectionalizing.

Assume one fault at each section, for one hour duration each, as shown in Figure 7.

Fault at F4: 1000 customers x 1 hr. = 1000 cust. hrs.

Outage Total = 4000 cust. hrs.

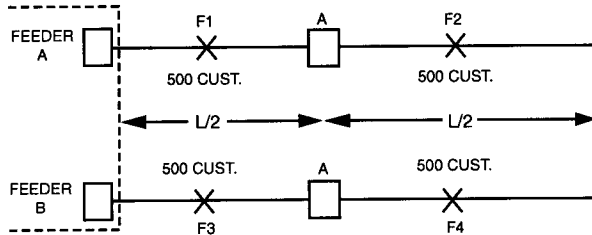
**Figure 8.**  
Reclosers at midpoint of feeders.

Refer to Figure 8 and assume one fault at each section, for one hour duration, to show the effects of midpoint sectionalizing.

Fault at F1: 1000 customers x 1 hr = 1000 cust. hrs.

Outage Total = 3000 cust. hrs. (25% reduction)

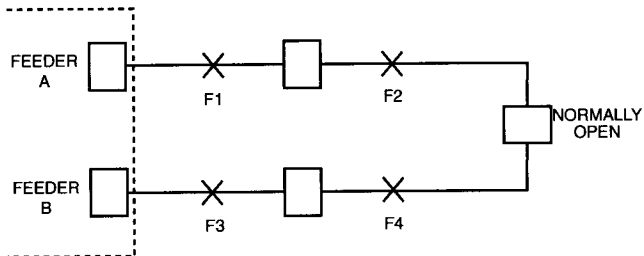
**Figure 9.**  
Normally open tie recloser between feeders.

Fault at F1: 500 customers x 1 hr. = 500 cust. hrs.

Adding a tie recloser as shown in Figure 9 and operating the midpoint reclosers as sectionalizing reclosers has resulted in a 33 1/3% reduction in customer outage:  $(3000-2000)/4000 = 33 \frac{1}{3}\%$ .

Adding the three reclosers as shown in Figure 9 to the two feeders has reduced the outage rate to 50% of the original:  $(4000-2000)/4000 = 50\%$ .

Add a normally open tie recloser between feeders as shown in Figure 9, set to close upon loss of voltage from either side. The midpoint reclosers will be sectionalizing type reclosers, set to automatically open for loss of voltage from their source side.

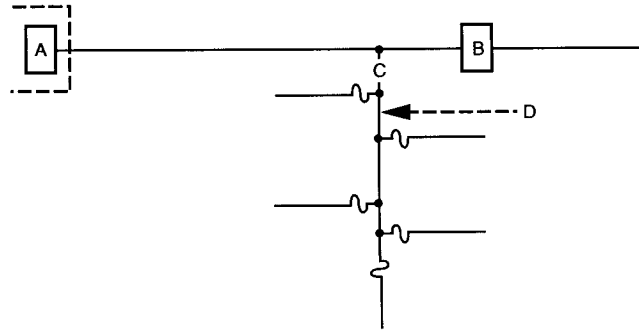
**Figure 10.**  
Feeder tap without recloser protection.

Assume the reach of recloser A extends to point D on the tap as shown in Figure 10.

If a fuse is used at location C:

1. Any transient fault on the main tap line beyond location D will cause the fuse at C to operate, resulting in an outage on the entire tap for a fault that was initially transient.
2. Service restoration can be delayed since crew may spend considerable time looking for a fault that no longer exists.
3. For a transient fault beyond any of the downline fuses, the downline fuse will operate, again resulting in an unnecessary outage for a fault that was initially transient. Use of a recloser at location C can normally be sized to provide reach for the entire tap. The fast trip of the recloser (as shown in Figure 2) will then clear transient faults, the reclosing operation then restoring service to all customers on the tap.

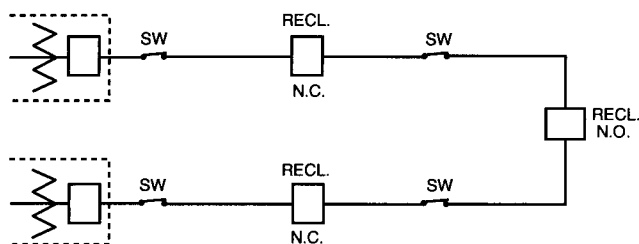
**Figure 11.**  
Automated distribution system.

Figure 11 illustrates a distribution system using both switches and line reclosers that can all be operated remotely.
