The Staff of the Missouri Public Service Commission,)	
)	
)	
Complainant,)	
)	<u>Case No. WC-2008-0030</u>
v.)	
)	
Suburban Water and Sewer Co. and Gordon Burnam,)	
)	
)	
Respondents.)

STAFF’S UPDATED REPORT AND MOTION FOR EVIDENTIARY HEARING

PICTURE REPORT

INSPECTION REPORT

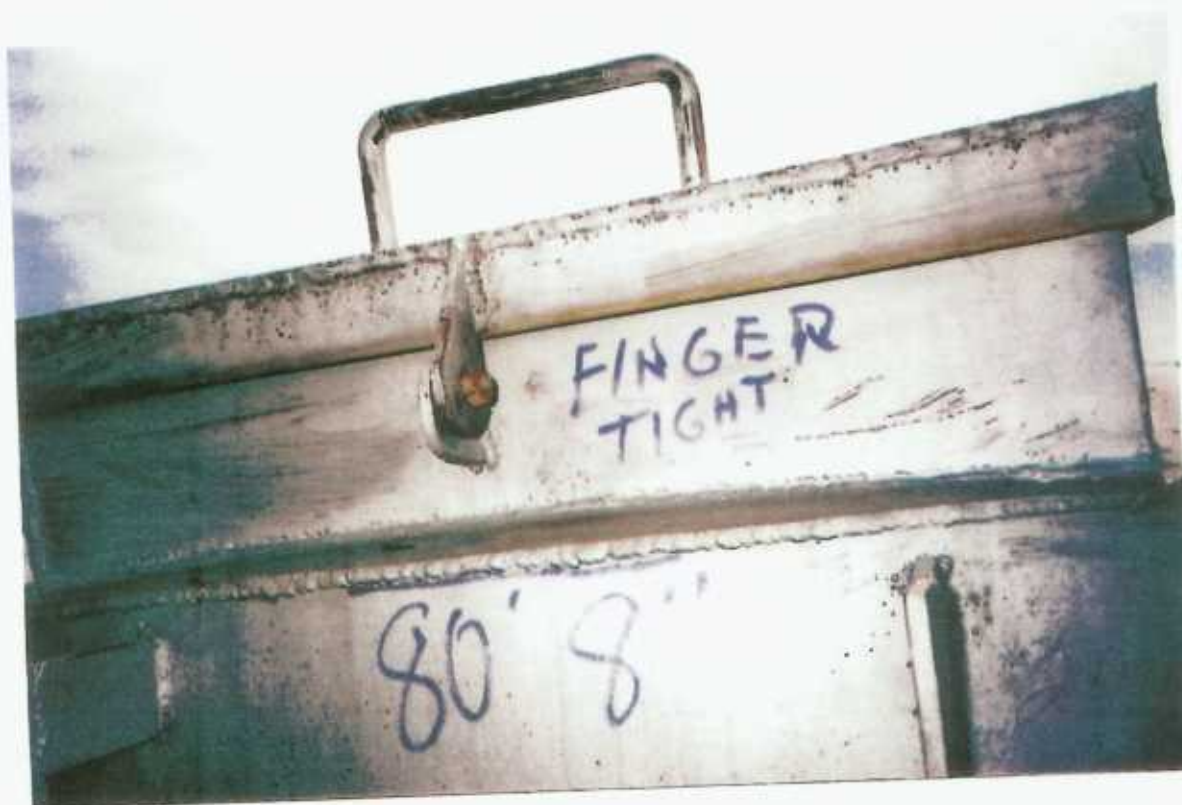
19

19. should be decent repairable 6' tanks out there, that could be moved here and set on this concrete pad.
20. The roof hatch is closed and held with a bolt.
