Kuhle H2O, Incorporated, (Smithview):

**SIGNIFICANT DEFICIENCY
RESPONSE REQUIRED**

Attachment #1
Kuhle H20
February 16, 2017
Page 1

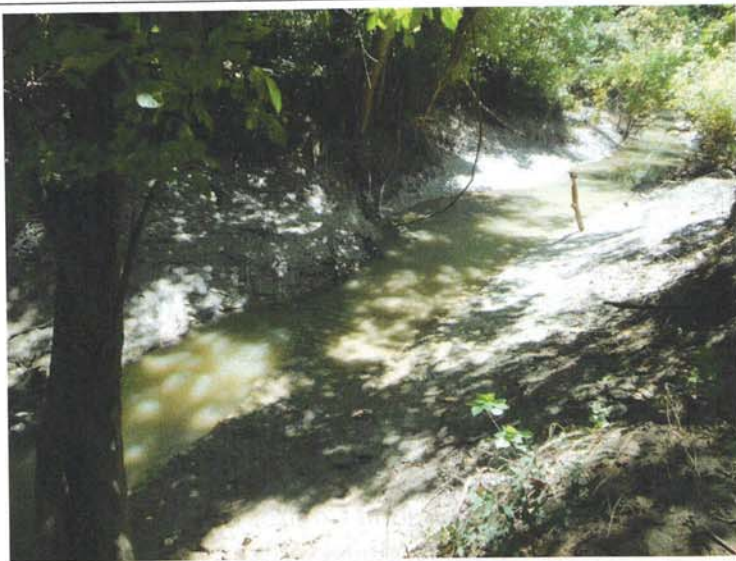
Photo #: 001
By: Christopher Maher
Facility: Castlereagh Estates Subdivision WWTP
Permit: MO-0084484
Location: Western Bank of Mill Creek, East of Wastewater Plant

I conducted water quality field monitoring at the following location for the listed parameters. The receiving stream was flowing steadily and was mildly turbid, both upstream and downstream of the outfall pipe (see Photos #001, #002, and #004). A thick layer of sediment was visible on either side of the water flow; recent flooding on the Missouri River may have contributed to the sediment buildup. The water flowing from the outfall pipe was clear with no visible solids in the discharge (see Photo #003). Upon collection, the wastewater discharge had mild turbidity.

Description: View upstream from outfall pipe; mildly turbid water flowing from south to north; facing southeast.

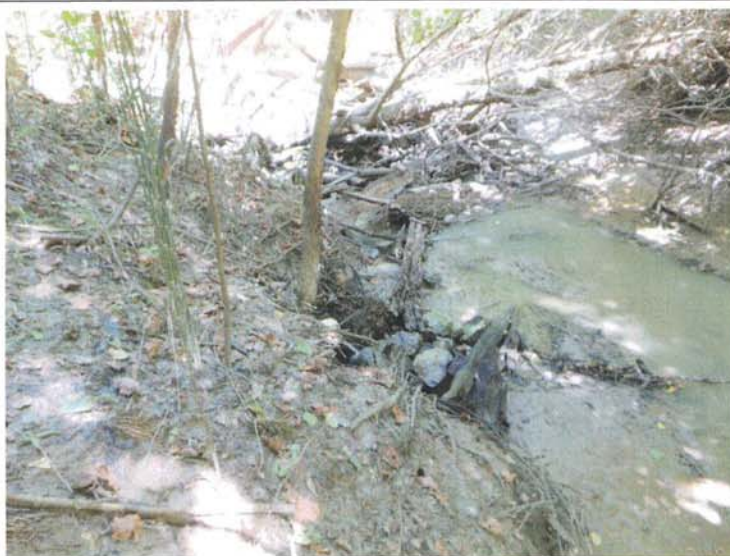
Photo #: 003
By: Christopher Maher
Facility: Castlereagh Estates Subdivision WWTP
Permit: MO-0084484
Location: Western Bank of Mill Creek, East of Wastewater Plant

Description: Outfall pipe discharging at receiving stream (white object in center of photograph); facing northeast.

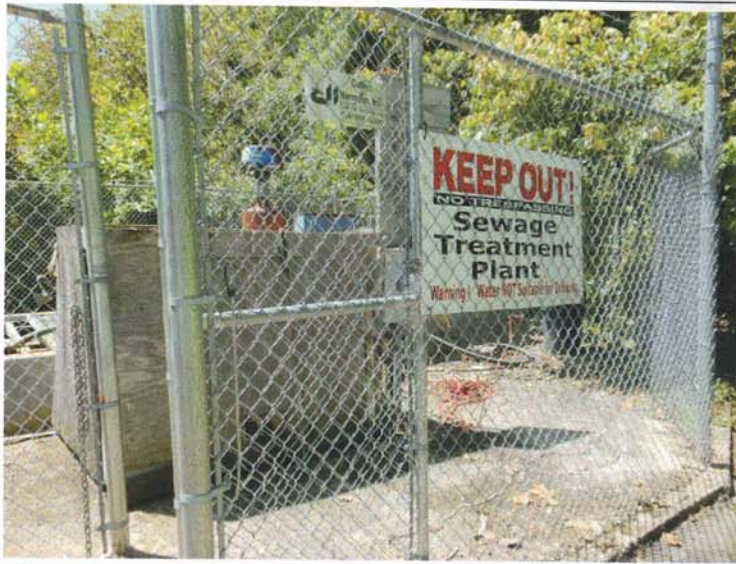
Photo #: 005
By: Christopher Maher
Facility: Castlereagh Estates Subdivision WWTP
Permit: MO-0084484
Location: Wastewater Treatment Plant

Description: Warning sign; fence, barbed wire; facing south.

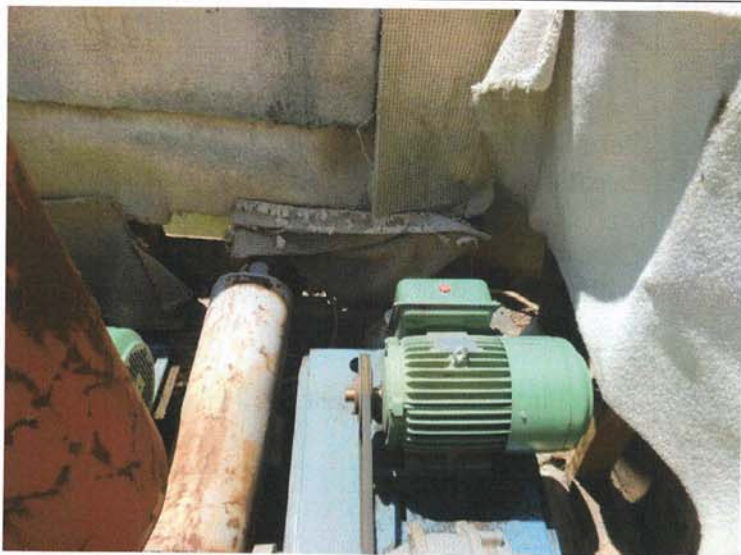
Photo #: 006
By: Christopher Maher
Facility: Castlereagh Estates Subdivision WWTP
Permit: MO-0084484
Location: Wastewater Treatment Plant

We arrived at the facility on August 11 and met with Mr. Nier at about 12:30. We began by collecting the initial grab sample for the modified composite sample (see Sampling and Monitoring section below). Following the sample collection, we conducted the physical inspection of the wastewater treatment plant. The facility had a fence of adequate height, with warning signs, barbed wire, and a locked gate (see Photo #005). We walked in and Mr. Nier showed me the two blowers serving the aeration basin (see Photo #006).

Description: Blower serving wastewater plant; facing south.

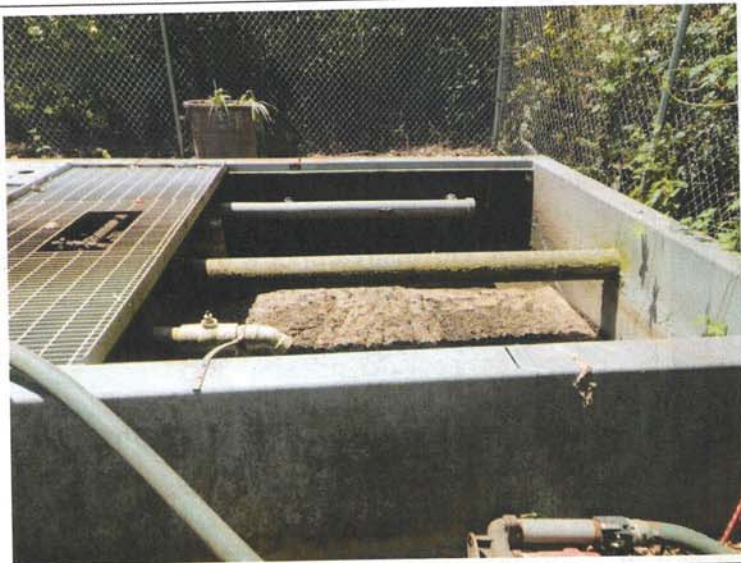
Photo #: 007
By: Christopher Maher
Facility: Castlereagh Estates Subdivision WWTP
Permit: MO-0084484
Location: Wastewater Treatment Plant

Description: Sludge holding tank for facility; facing south.

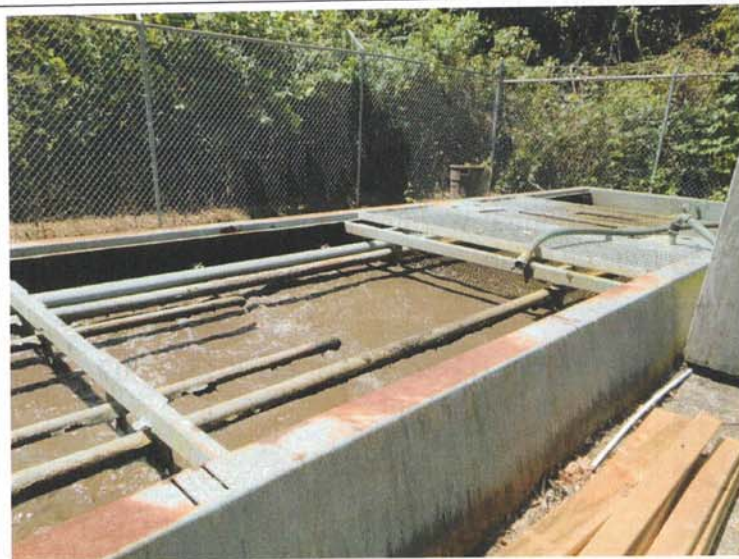
Photo #: 008
By: Christopher Maher
Facility: Castlereagh Estates Subdivision WWTP
Permit: MO-0084484
Location: Wastewater Treatment Plant

The aeration basin was being aerated while we were present. The contents had an even, chocolate-brown color, with little foam, indicating adequate mixing and oxygen levels (see Photo #008). We observed wastewater entering the aeration basin from the skimmers in the secondary clarifier. The blowers were running the whole time that we were on site. The contents of the clarifier on the eastern side of the plant were somewhat turbid with some scum floating on the surface (see Photo #009). The skimmers were functional and removing floating scum. Water flowing over the effluent weirs into the effluent trough was clear, with a small amount of visible solids in the bottom of the trough (see Photo #011). Solids should regularly be cleaned out of the effluent trough to prevent discharge of solids into the receiving stream. The effluent trough had a single chlorine tablet on the northern end of the trough (away from the effluent line). Mr. Nier stated that the tablet was there to limit algae growth (see Photo #012). On the western end of the plant was the sludge holding tank for the facility (see Photo #007). Just to the east of the sludge holding tank was the bar screen (see Photo #010), where influent enters the extended aeration basin. The bar screen was properly installed. Debris should regularly be removed from the bar screen to prevent material from entering the aeration basin and potentially damaging blowers and other equipment.

Description: Extended aeration basin; facing southwest.

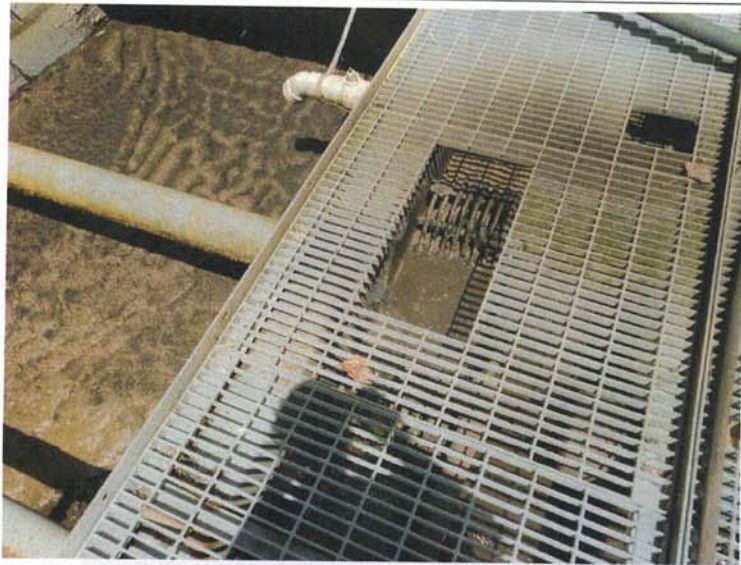
Photo #: 010
By: Christopher Maher
Facility: Castlereagh Estates Subdivision WWTP
Permit: MO-0084484
Location: Wastewater Treatment Plant

Description: Bar screen for removing large material; facing north.

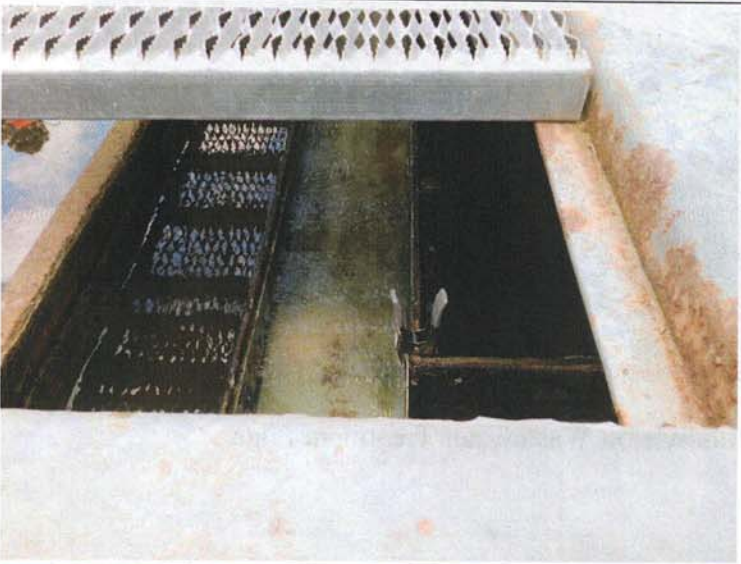
Photo #: 011
By: Christopher Maher
Facility: Castlereagh Estates Subdivision WWTP
Permit: MO-0084484
Location: Wastewater Treatment Plant

Description: Effluent trough; water is clear with some visible solids on bottom; facing north.

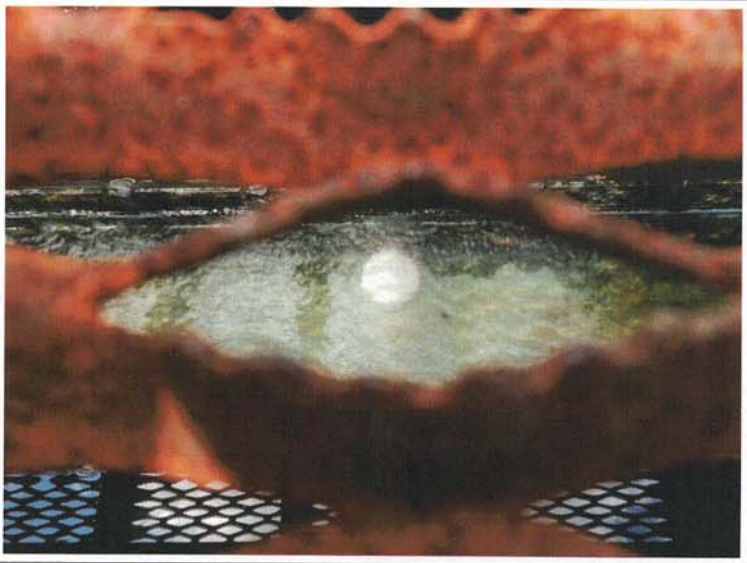
Photo #: 012
By: Christopher Maher
Facility: Castlereagh Estates Subdivision WWTP
Permit: MO-0084484
Location: Wastewater Treatment Plant

Description: Chlorine tablet in effluent trough; facing west.

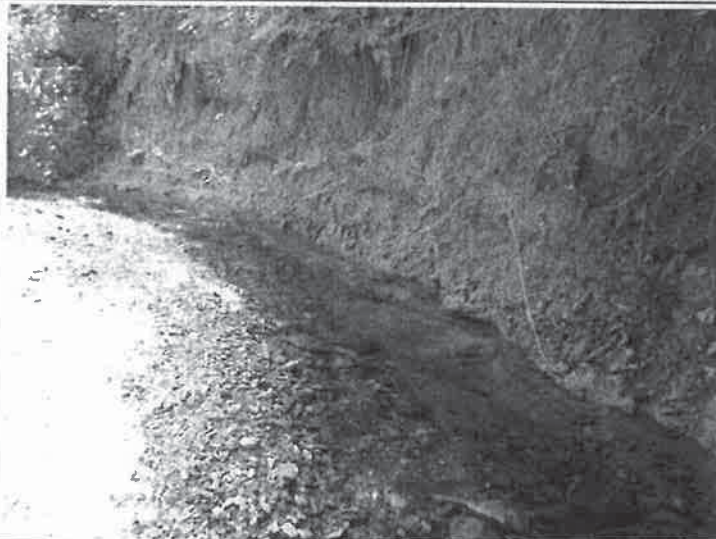
Photograph: #011
Taken By: Christopher Maher
Facility: Villa Ridge Estates
Permit: MO-0038237
Location: Receiving Stream

Description: View upstream of Outfall #001 with no sludge deposits; facing east.

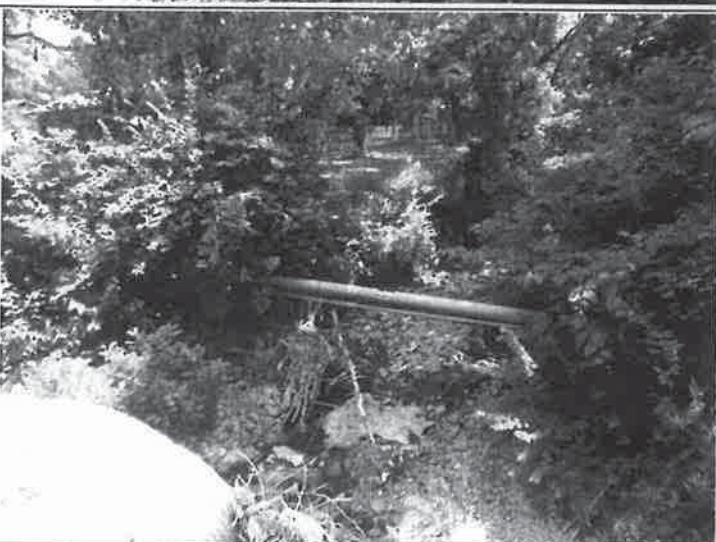
Photograph: #012
Taken By: Christopher Maher
Facility: Villa Ridge Estates
Permit: MO-0038237
Location: Stream Crossing for Rock Bridge Road

At the end of the inspection, I observed the aerial sewer crossing over the stream (Photo #012). The pipe was not leaking, but it still did not meet the requirements for stream crossings in the Chapter 8 Design Guides (10 CSR 20-8.120(9)(D)) (**Notice of Violation item #5**). This stream crossing should not be considered permanent.

Description: PVC pipe installed at stream crossing; no leakage visible from pipe; facing east.

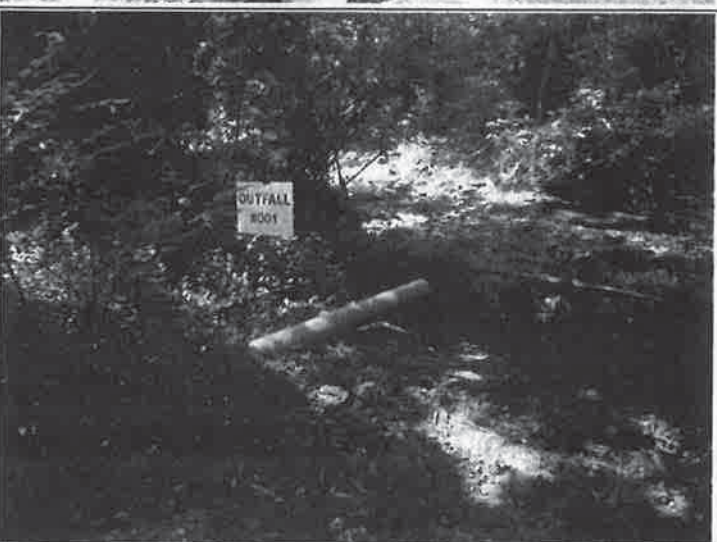
Photograph: #006
Taken By: Christopher Maher
Facility: Villa Ridge Estates
Permit: MO-0038237
Location: Outfall #001

There was a clear path to the outfall for conducting sampling. The outfall pipe was actively discharging. It was properly marked to identify it as an outfall (Photo #006). Water discharging was clear with no visible solids. However, I observed substantial sludge solids in the receiving stream downstream of the outfall pipe (Photos #007 through #010). The receiving stream exhibited bottom deposits, turbidity and floating scum in violation of the general criteria in the Missouri Clean Water Commission regulations (**Notice of Violation item #1 and #2**). I also observed the upstream portion of the receiving stream, which was substantially different with no sludge deposits or signs of impact (Photo #011). I conducted on-site water quality monitoring of the effluent discharging (see "Sampling and Monitoring" section below). The Dissolved Oxygen result was 2.00 mg/L; ideally, it should be in the 5 to 10 mg/L range to indicate proper operation. The Total Residual Chlorine result was 0.01 mg/L (10 µg/L), which is considered to be less than the minimum quantification level (0.13 mg/L). Since I did not observe an installed dechlorination system and our files do not indicate that the facility owners installed one, the lack of chlorine residual suggests that the operator is not adequately disinfecting the wastewater effluent.

Description: Outfall pipe discharging at Outfall #001; facing west.

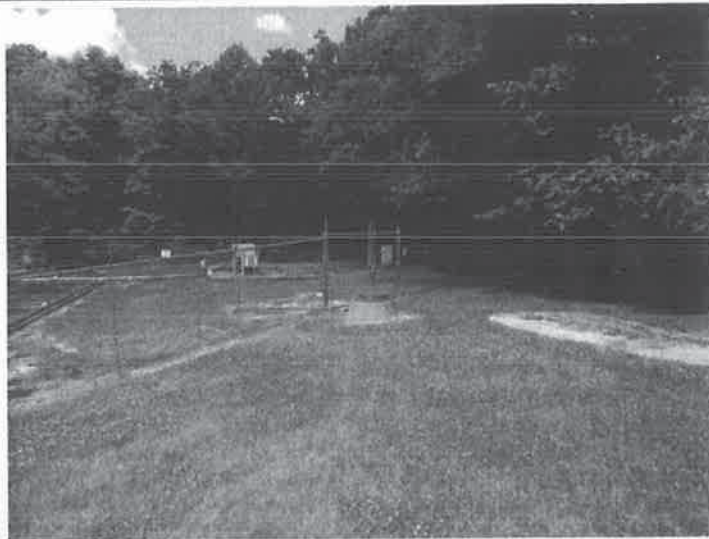
Photograph: #001
Taken By: Christopher Maher
Facility: Villa Ridge Estates
Permit: MO-0038237
Location: Site Entrance to Facility

I arrived at the facility shortly before 11:30. I could hear the blowers operating for the facility. The facility was surrounded by a fence of adequate height and topped with barbed wire (except for the northern side of the fence which did not have barbed wire), and it had warning signs visible from each side of the facility (Photo #001). The front entrance was locked, and I did not enter the fenced portion of the facility.

Description: Entrance to facility; facing west.

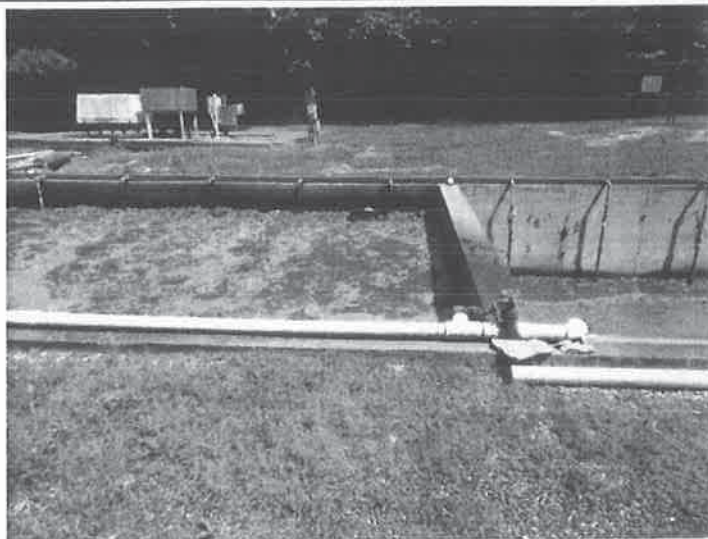
Photograph: #003
Taken By: Christopher Maher
Facility: Villa Ridge Estates
Permit: MO-0038237
Location: Extended Aeration Basins

Description: Western extended aeration basin being aerated with dark, brown color; facing north.

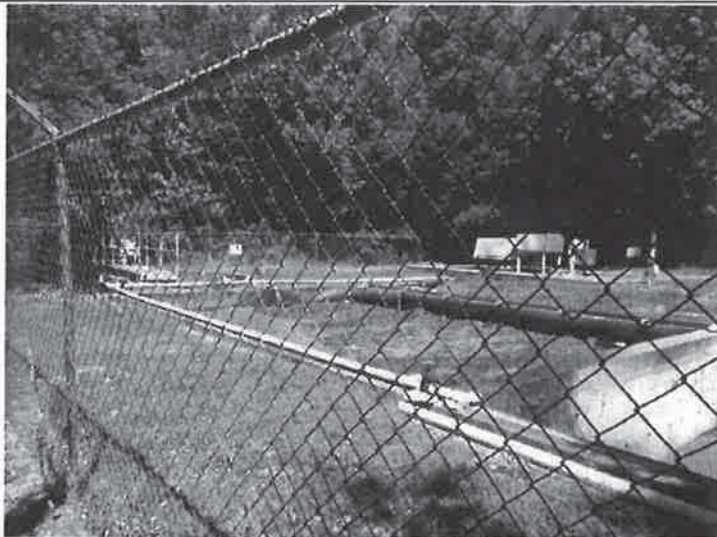
Photograph: #013
Taken By: Christopher Maher
Facility: Villa Ridge Estates
Permit: MO-0038237
Location: Extended Aeration Basin

I returned to the facility on June 6, 2017 to conduct sampling. The facility had the same appearance and deficiencies as during the June 2 site visit. The extended aeration basin was being aerated but had dark brown contents, which should be lighter to indicate proper biological activity (Photo #013). The clarifier still had floating sludge on the water surface (Photo #014). Also, the receiving stream still had sludge deposits below the outfall pipe (Photo #015). There was still sludge visible in the receiving stream. I collected a grab sample for analysis of 5-day Biochemical Oxygen Demand, Total Suspended Solids, Ammonia as N (Ammonia), and Total Coliform/*E. coli*. I called and spoke with Mr. Thomas later in the day to describe the state of the facility.

Description: View of extended aeration basin being aerated with dark brown contents; facing northwest.

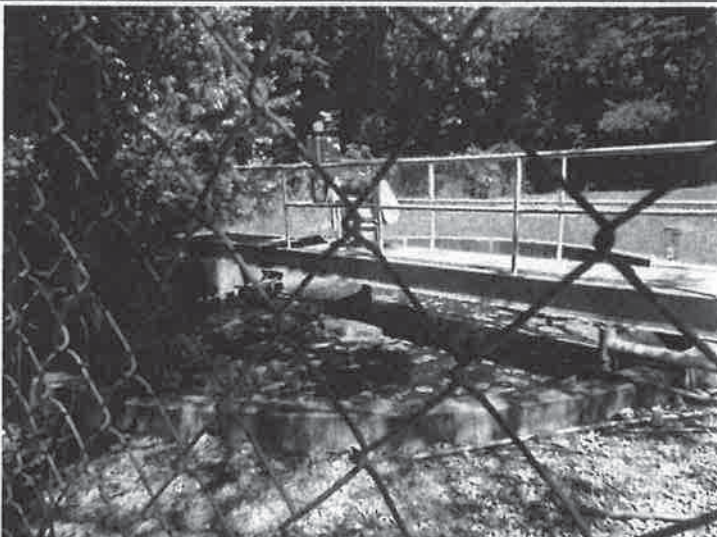
Photograph: #014
Taken By: Christopher Maher
Facility: Villa Ridge Estates
Permit: MO-0038237
Location: Secondary Clarifier

Description: Sludge on surface of secondary clarifier; facing north.

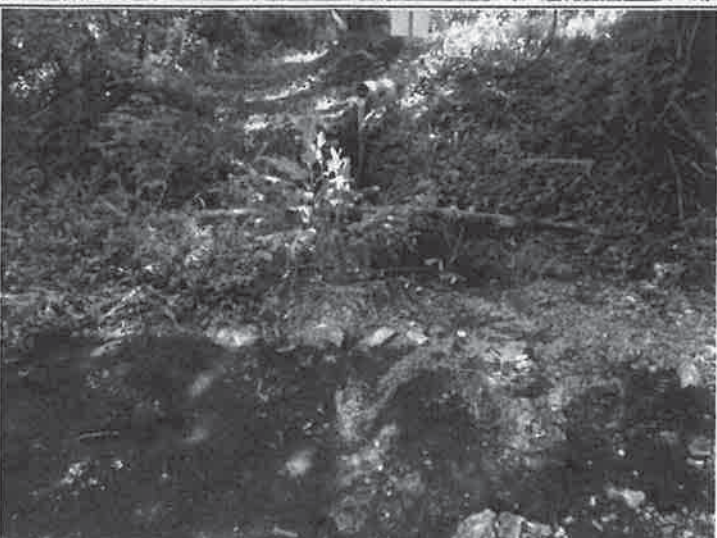
Photograph: #015
Taken By: Christopher Maher
Facility: Villa Ridge Estates
Permit: MO-0038237
Location: Receiving Stream

Description: View of Outfall #001 with sludge in the receiving stream; facing east.

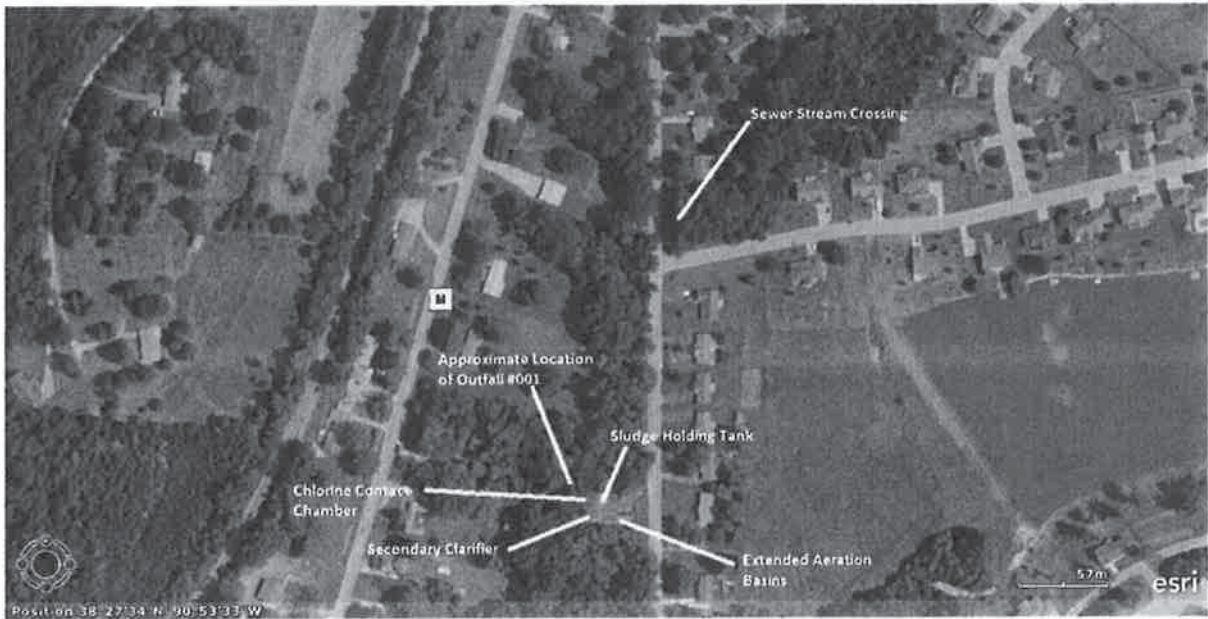
Site Map: General layout of Villa Ridge Estates wastewater treatment facility with location of aerial sewer crossing.
