Missouri-American Water Company – Exhibit 16  
Testimony of Matthew A. Lueders  
Direct  
File No. WR-2024-0320

Exhibit No.:	
Issues:	Water Storage Tank Rehabilitation, Risks of Providing Water & Sewer Service
Witness:	Matthew A. Lueders
Exhibit Type:	Direct
Sponsoring Party:	Missouri-American Water Company
Case No.:	WR-2024-0320 SR-2024-0321
Date:	July 1, 2024

**DIRECT TESTIMONY**

**MATTHEW A. LUEDERS**

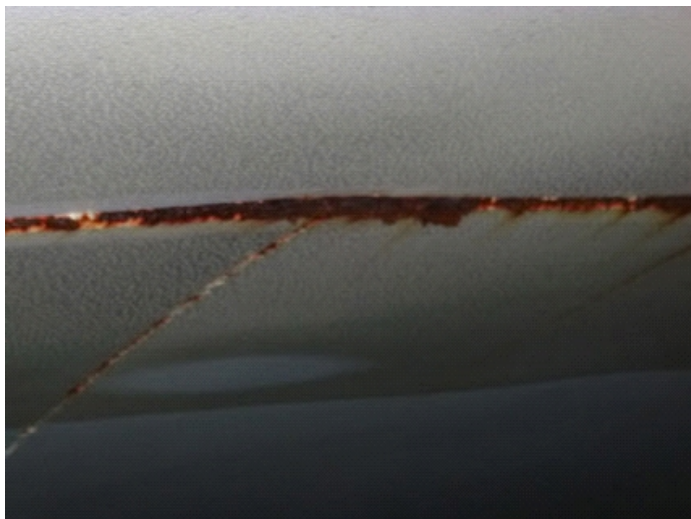
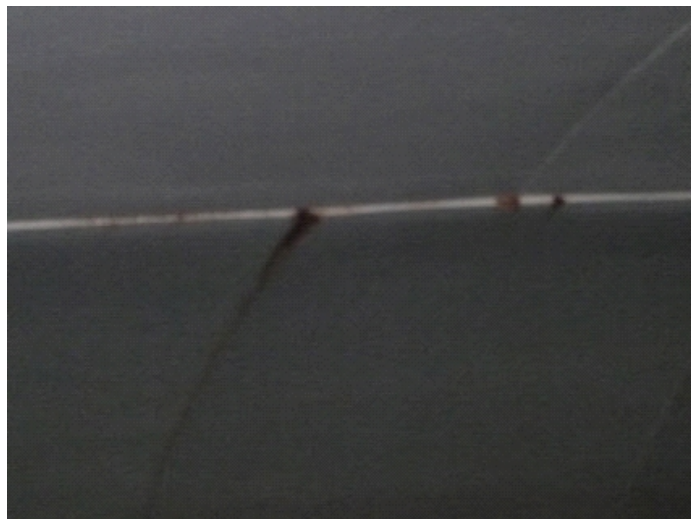
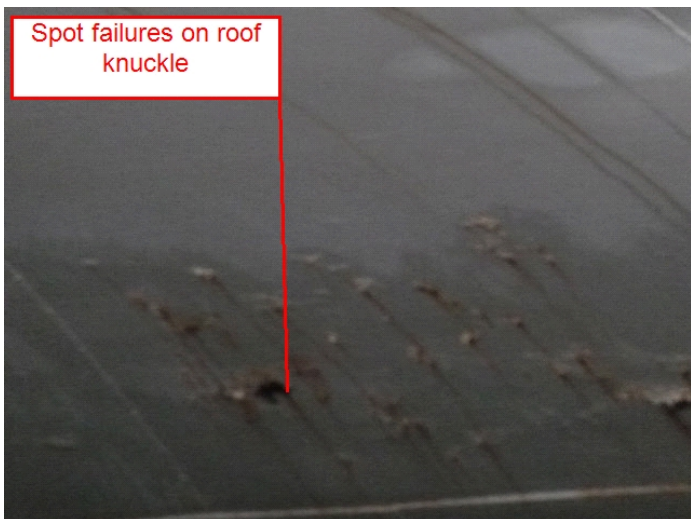
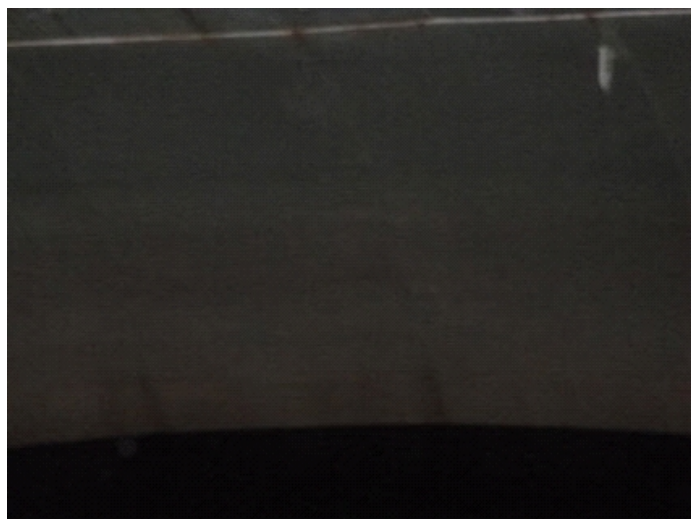
Rusting along  
overlapping roof  
plates

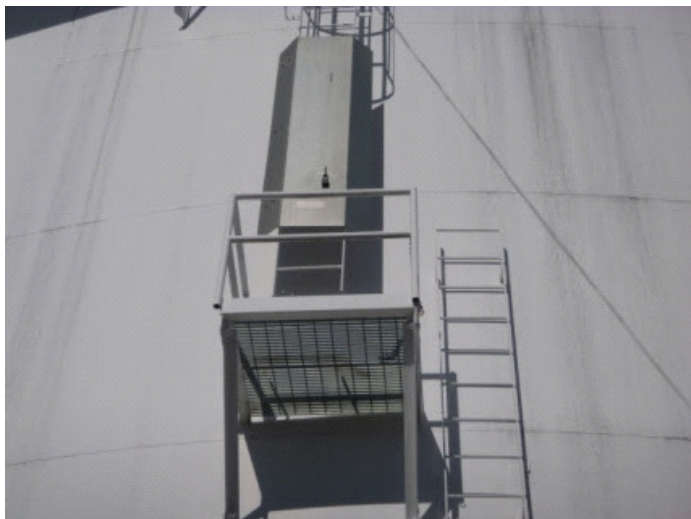
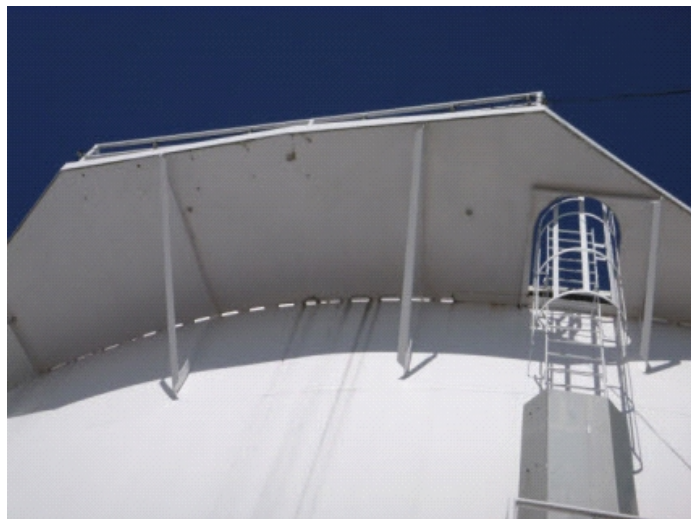
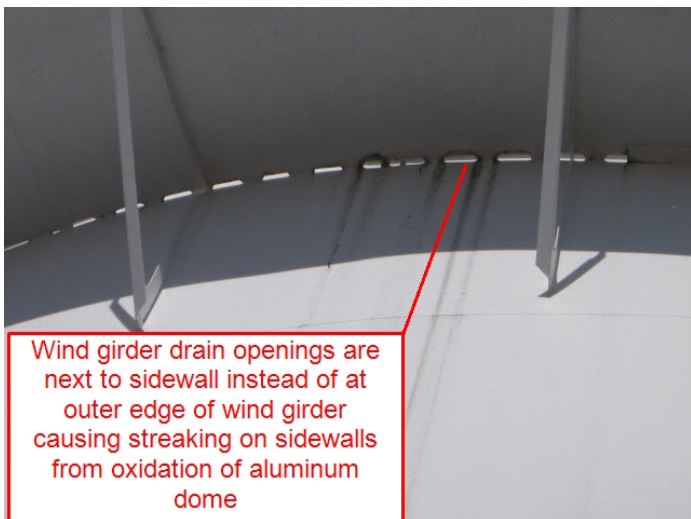
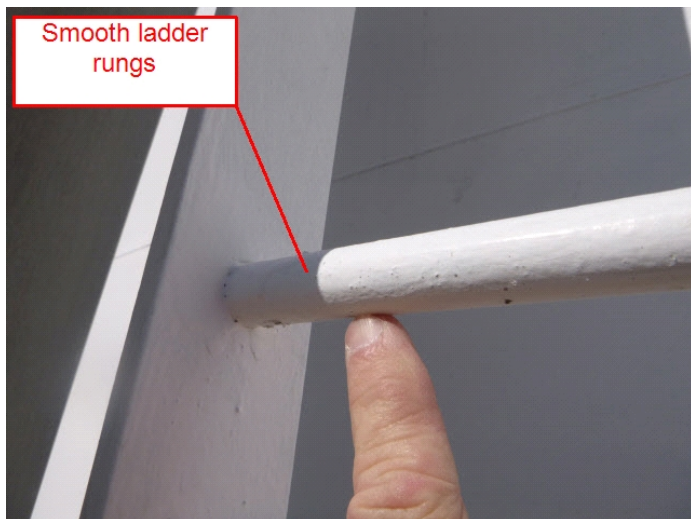
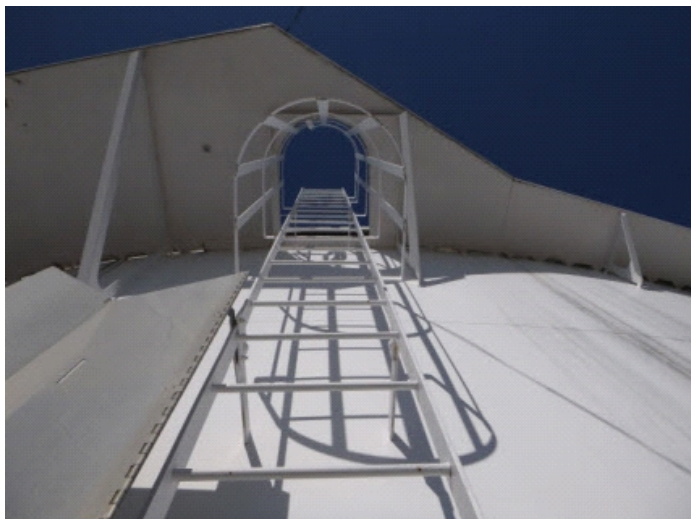
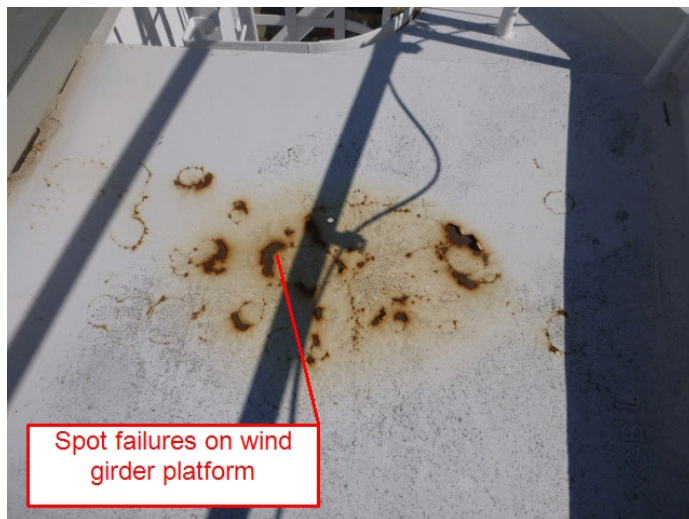
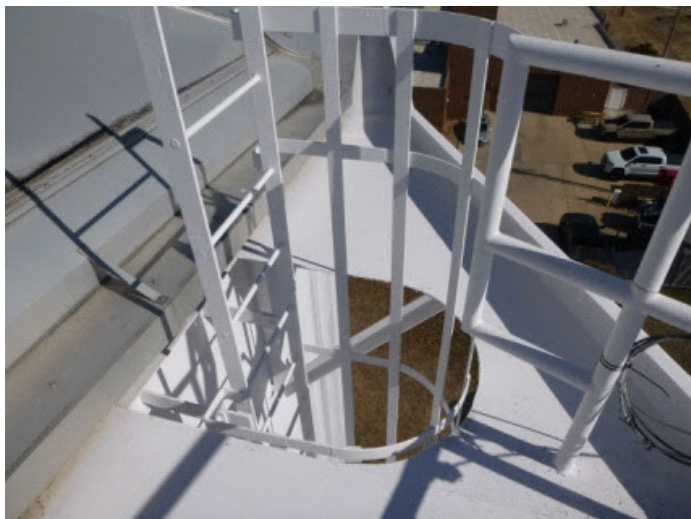
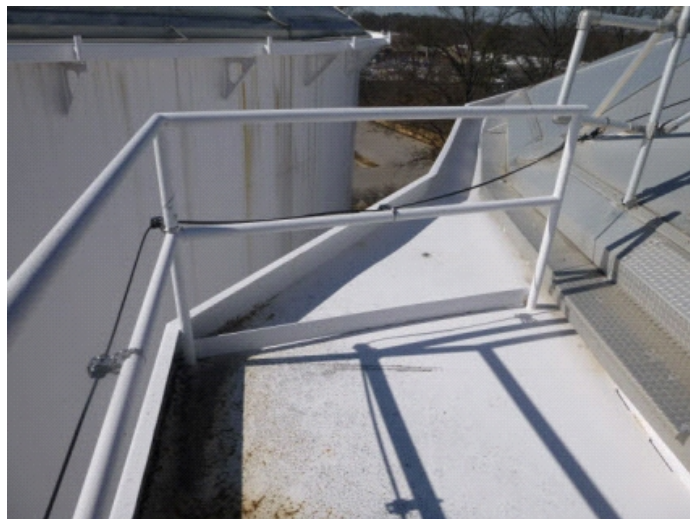
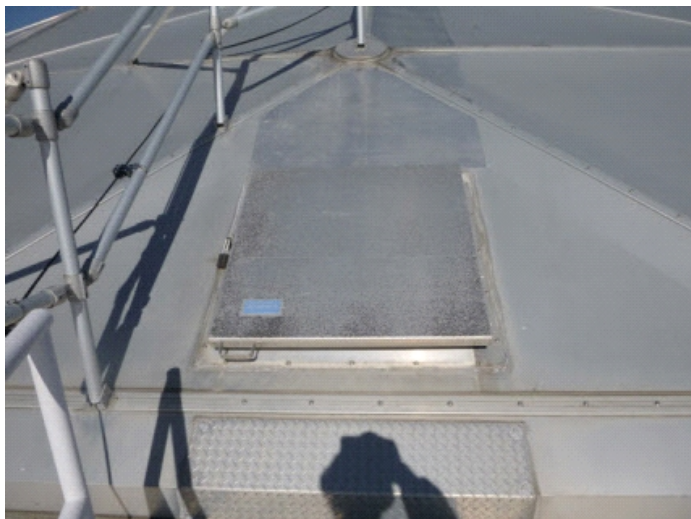
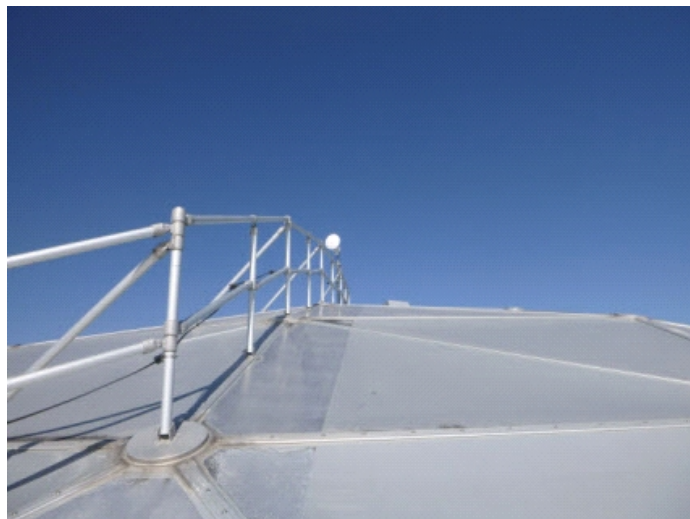
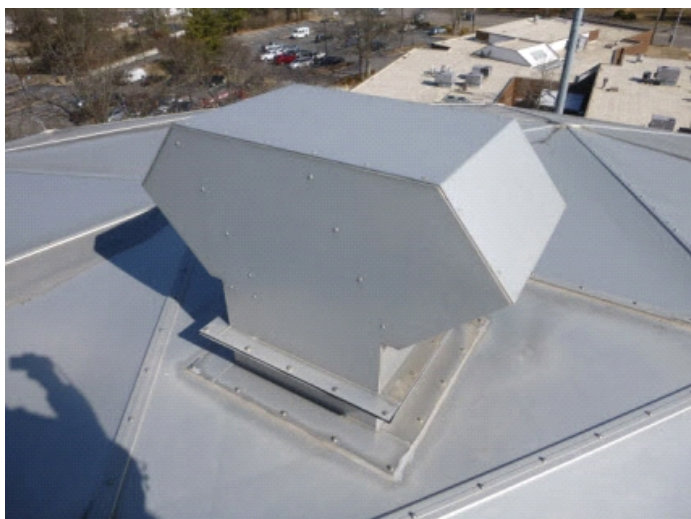
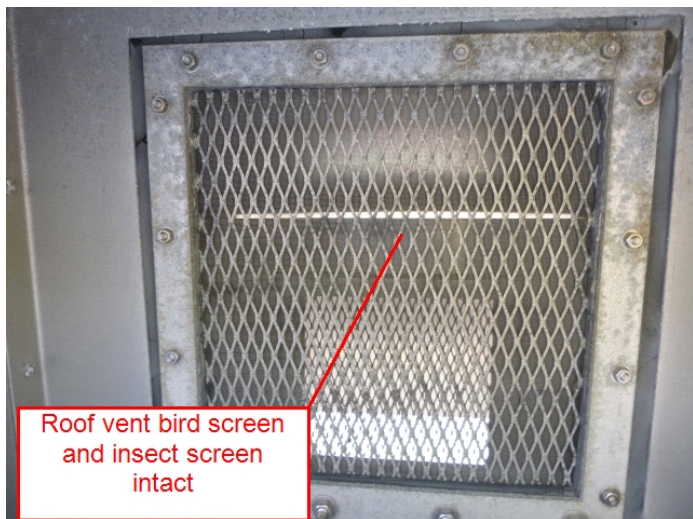
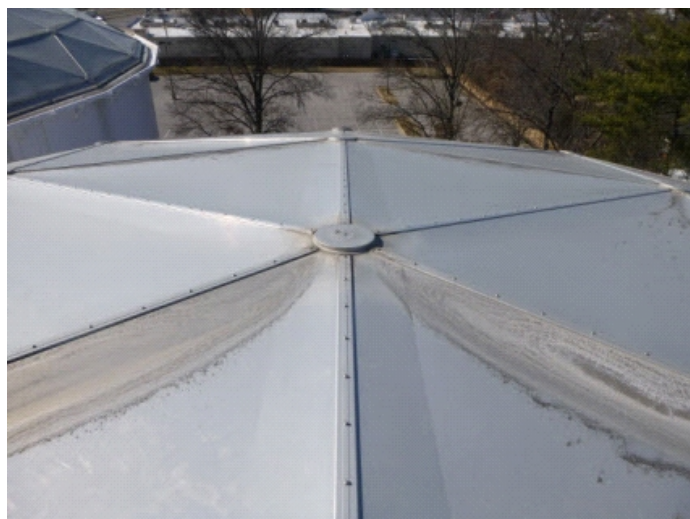
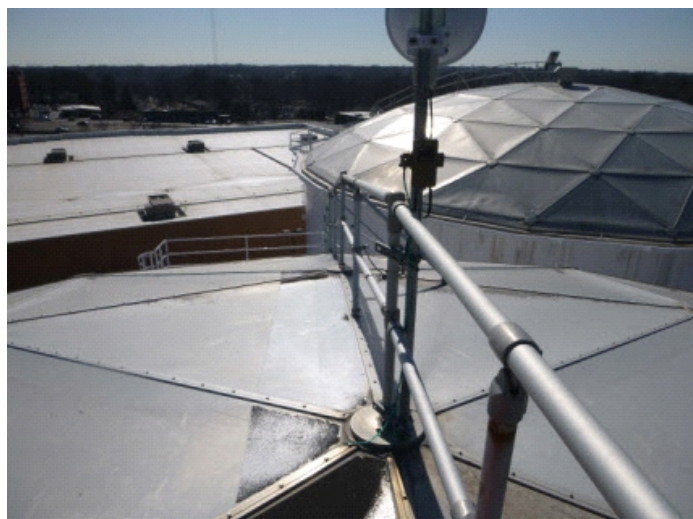
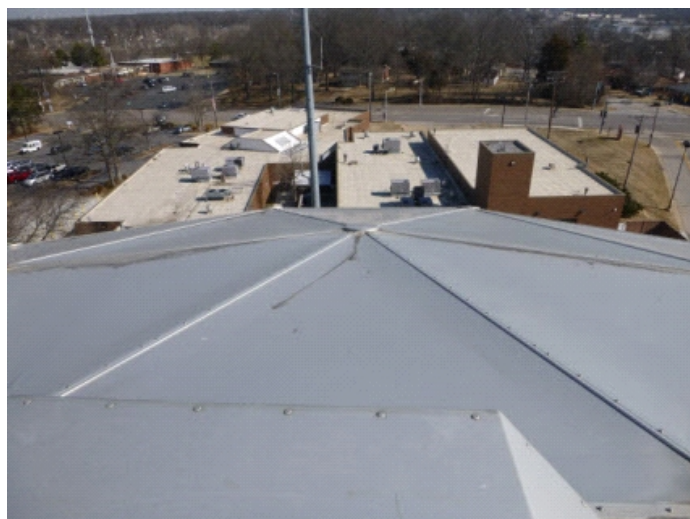
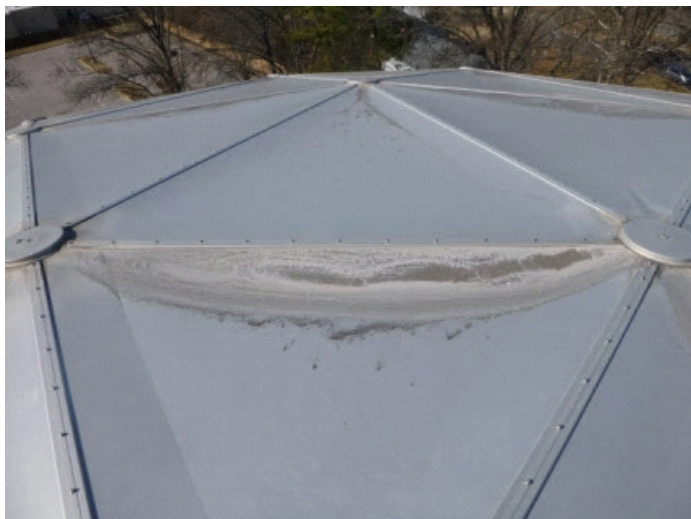
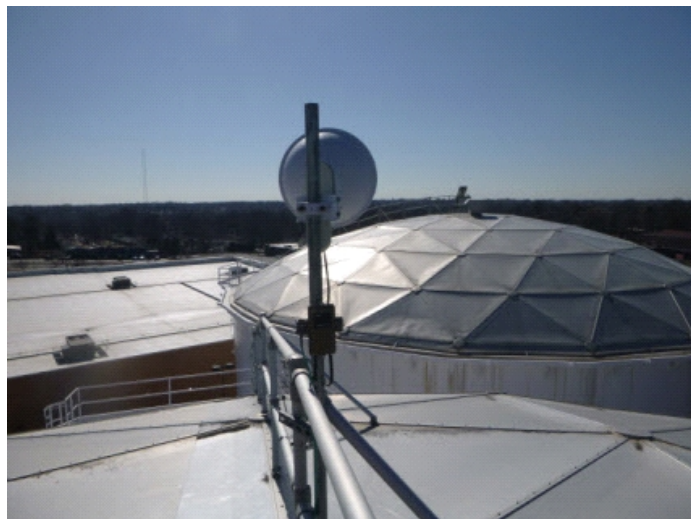
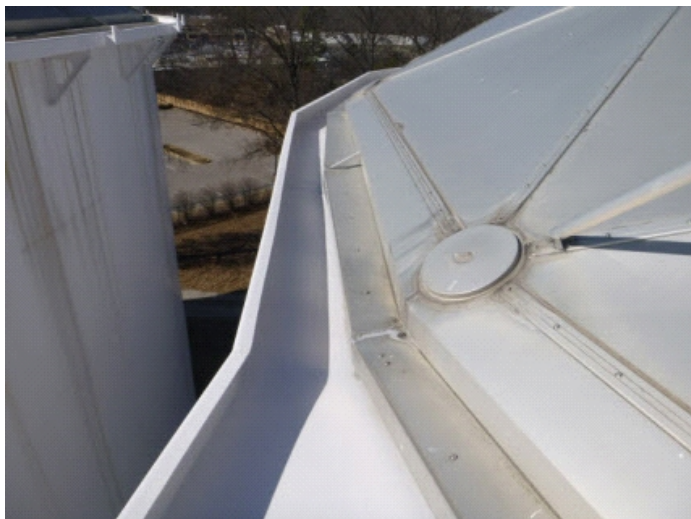
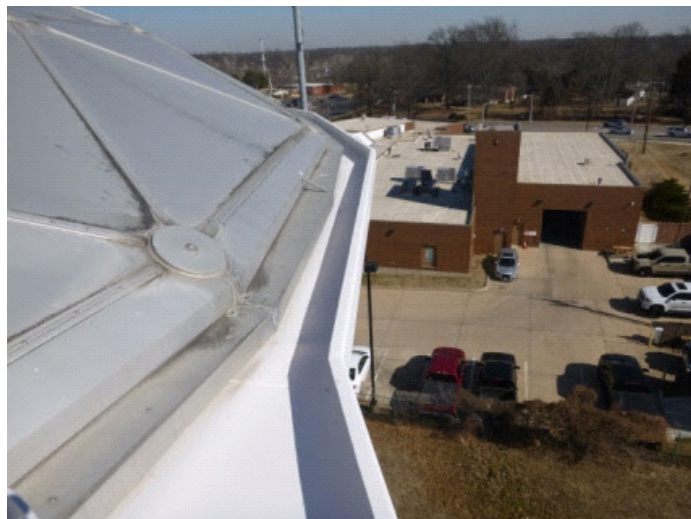
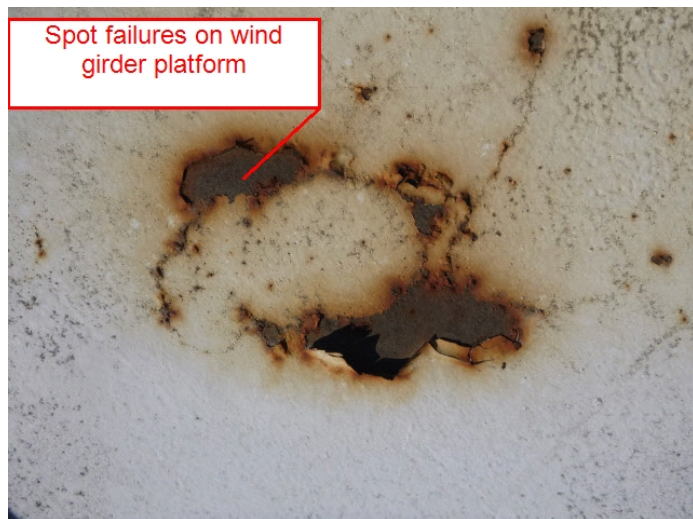
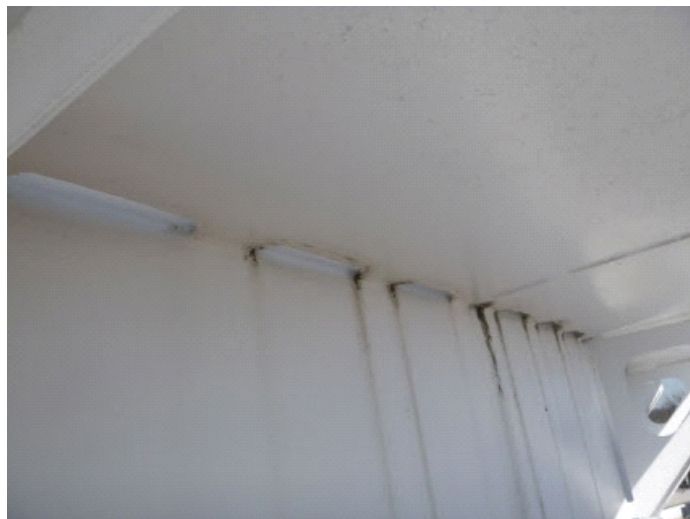
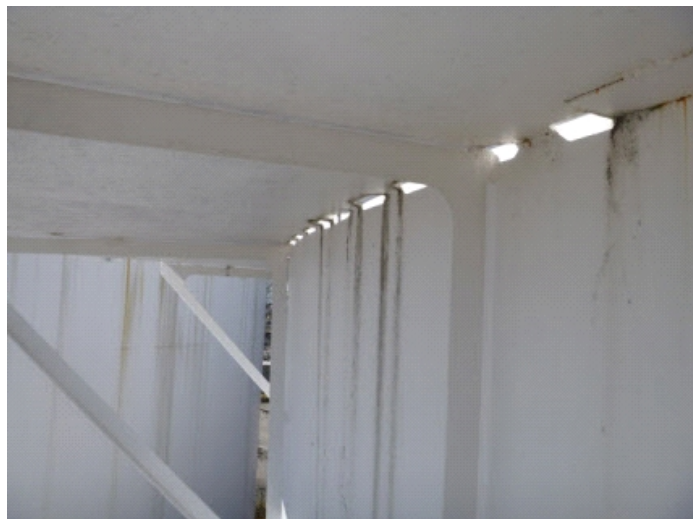
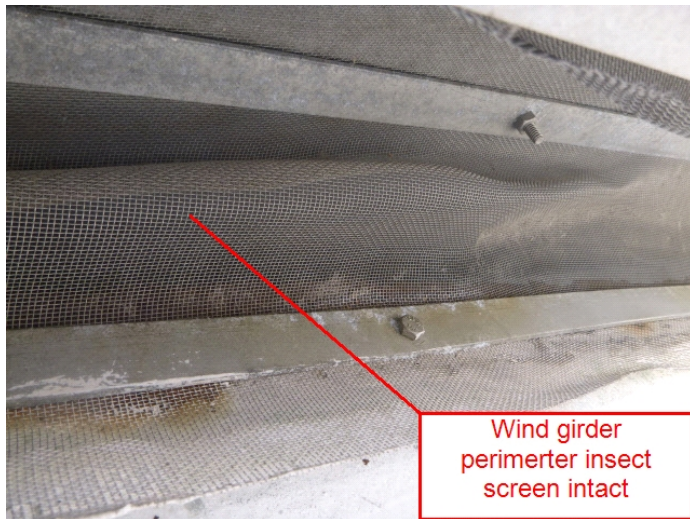
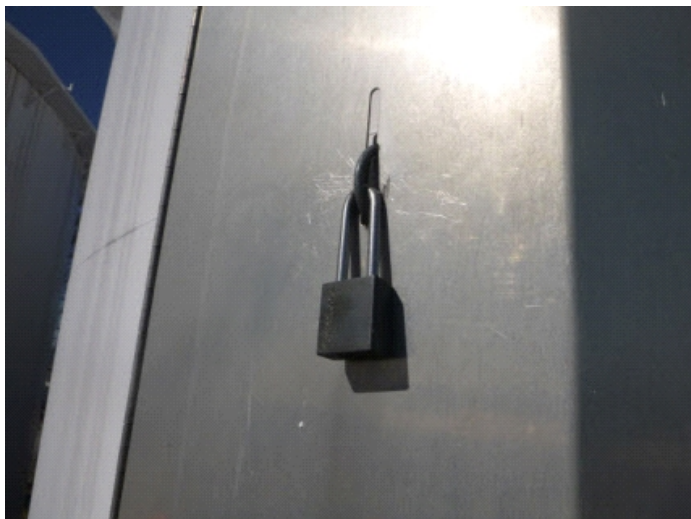
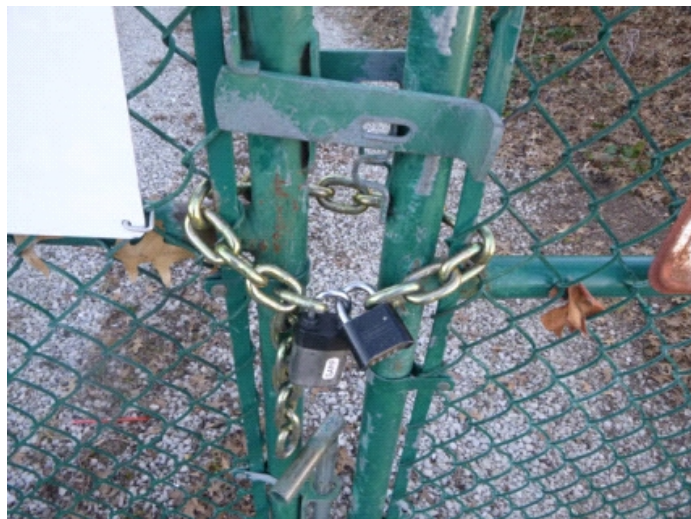
**Exterior coating condition:** Coatings are in fair condition with an average of 15.0-17.0 mils DFT. Isolated spots of top coat delamination where sidewalls meet lower flange. Spot failures with rust on top of wind girder.

- Install additional 30" manway during next tank renovation.
- Replace main ladder or install anti skid compound on ladder rungs.
- Install safety cable on main ladder.
- Pressure wash tank to remove mold and mildew.
- Consider complete interior and exterior renovation in the next two years, remove outer dome panels to access rusted dome mounts and top edge of sidewalls.

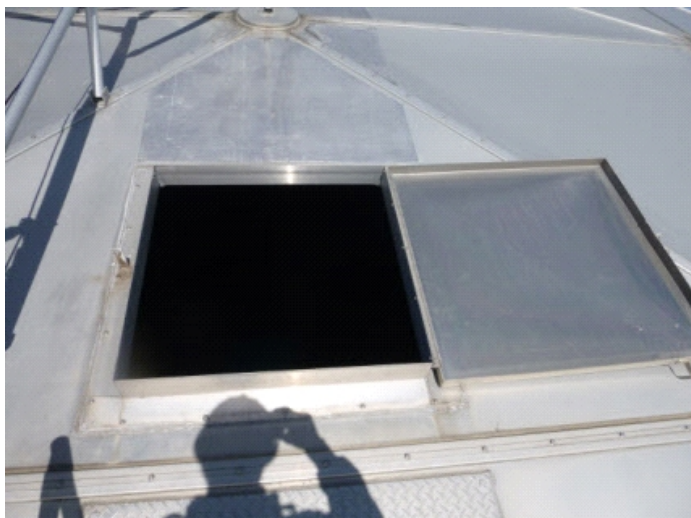
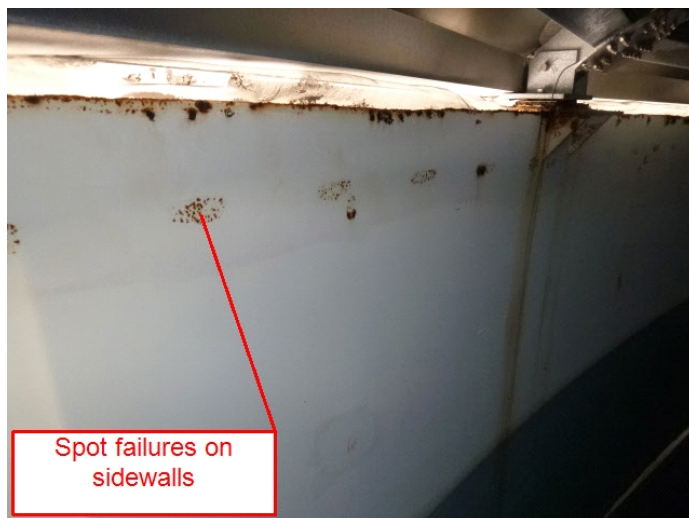
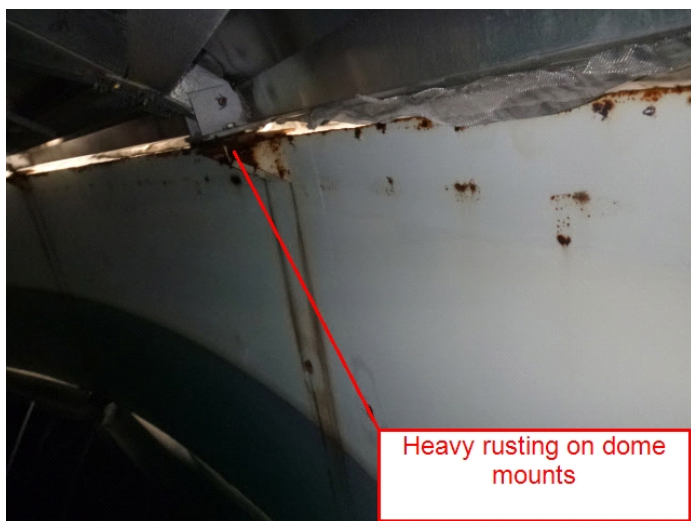
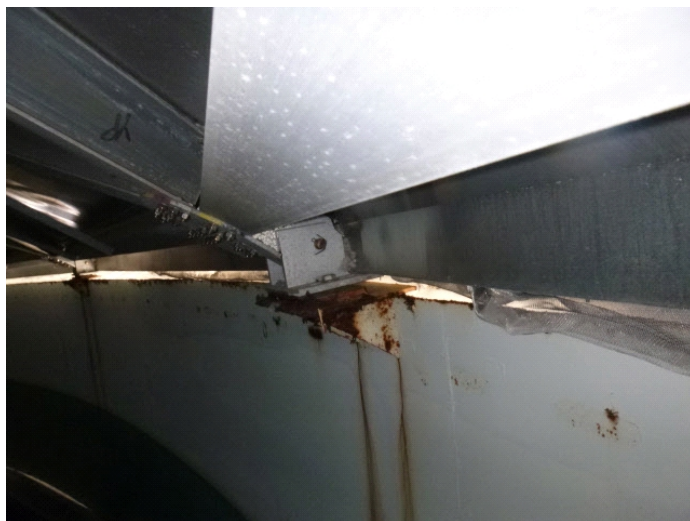
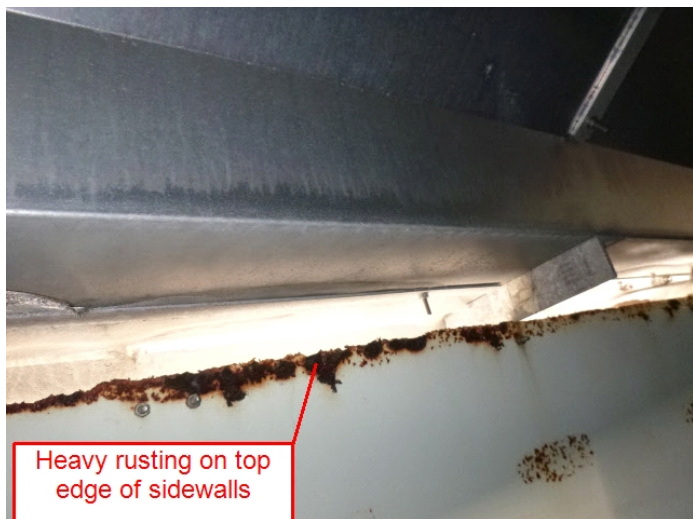
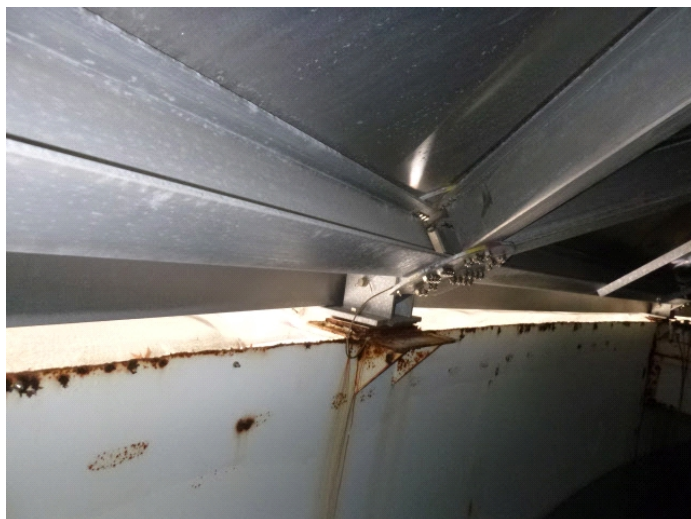
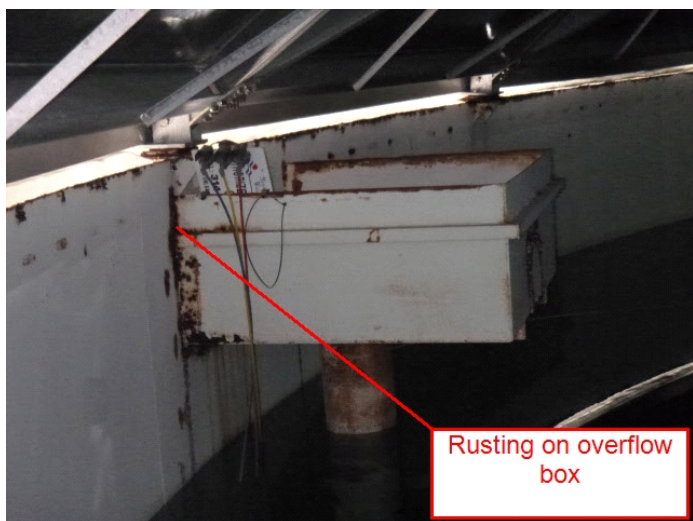
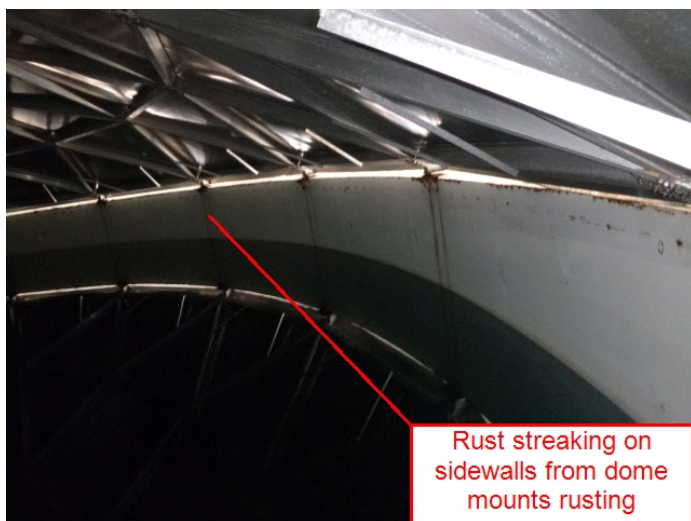
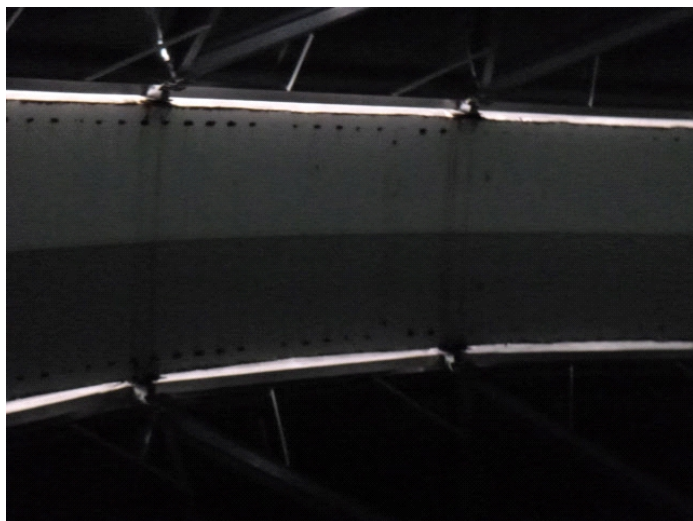
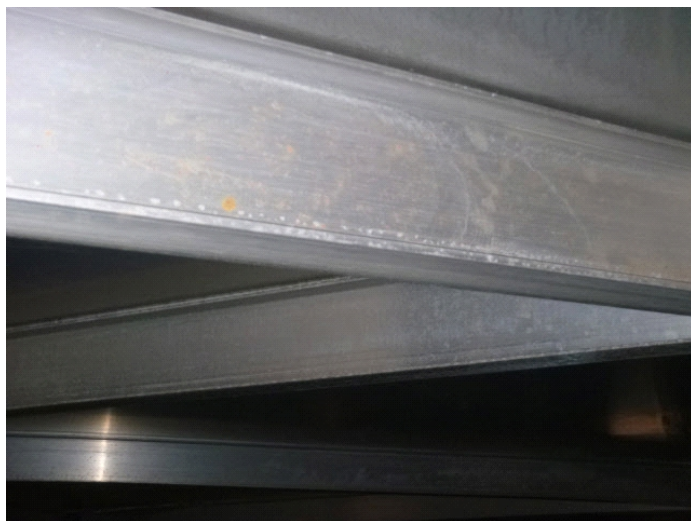
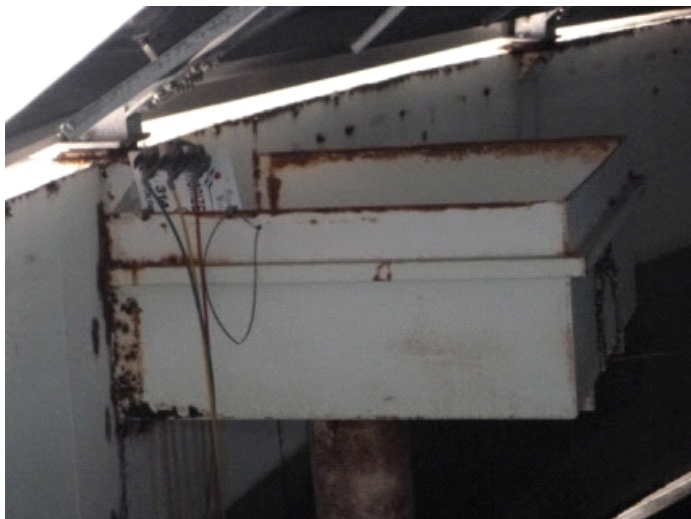
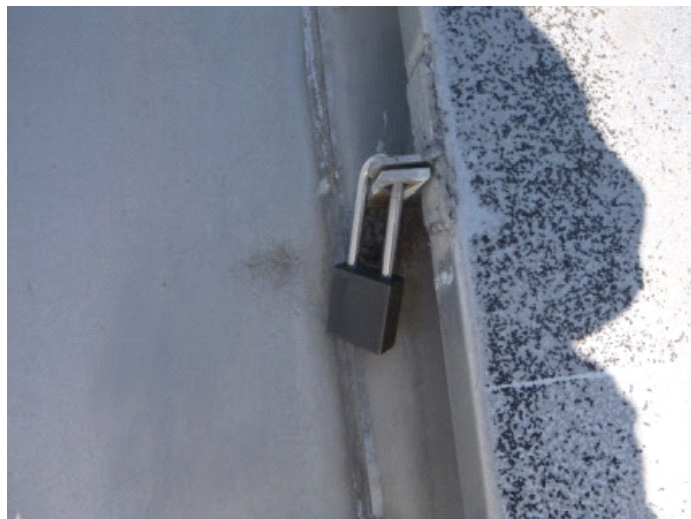
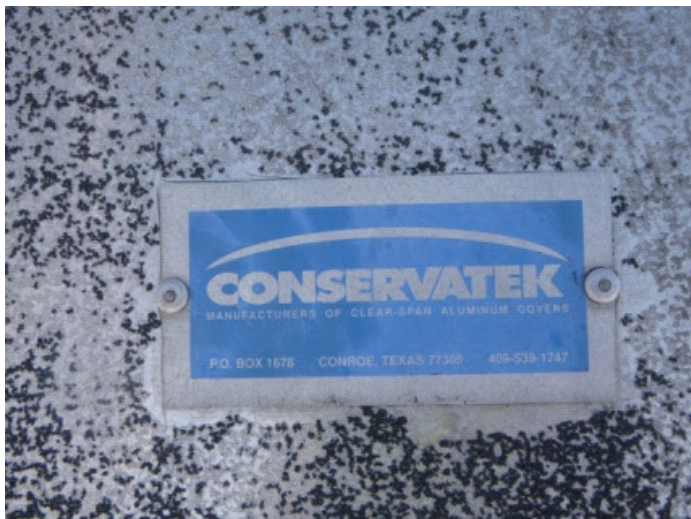
## Interior Coating Photos

**Interior Coating Condition:** Coatings are in fair condition with heavy rusting on overflow box and around dome mounts. Rusting on top edge of sidewall. Surface rusting visible on overflow pipe. Isolated spot failures on sidewalls. Minimal sediment visible on tank floor.

Component	Score	Comments
Exterior Roof	1	Aluminum Dome
Exterior Sidewall	2	Peeling paint
Interior Roof	1	Aluminum Dome
Interior Sidewall	4	Heavy rusting around dome mounts and along top edge of sidewall
Base/Floor	3	Spot failures on floor
