Exhibit No.:
Issues: Capital Investment Program,
Description of Plant Additions, Water
Storage Tank Rehabilitation, Risk
Associated with Providing Public
Water and Wastewater Services
Witness: Rebecca B. Losli
Exhibit Type: Direct
Sponsoring Party: Missouri-American Water Company
Case No.: WR-2022-0303
SR-2022-0304
Date: July 1, 2022

DIRECT TESTIMONY

REBECCA B. LOSLI

MISSOURI-AMERICAN WATER COMPANY

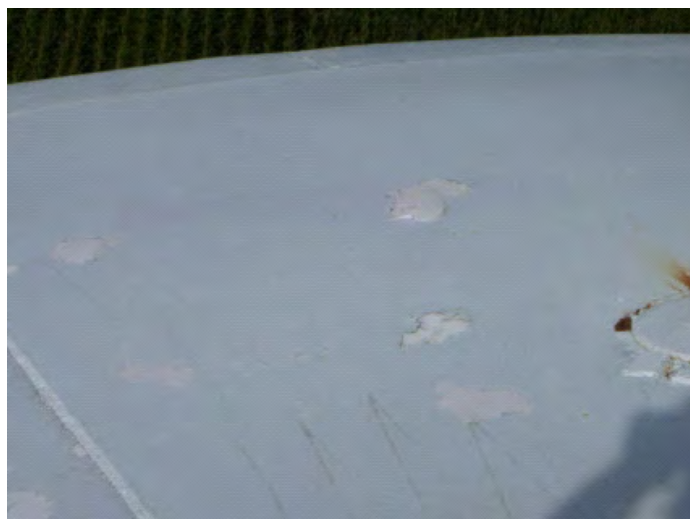
Top coat delamination on roof
