## STAFF'S GAS INCIDENT REPORT

Grandview Road  
Kansas City, MO  
April 22, 2025

**Spire Missouri, Inc.**

**Case No. GS-2025-0295**

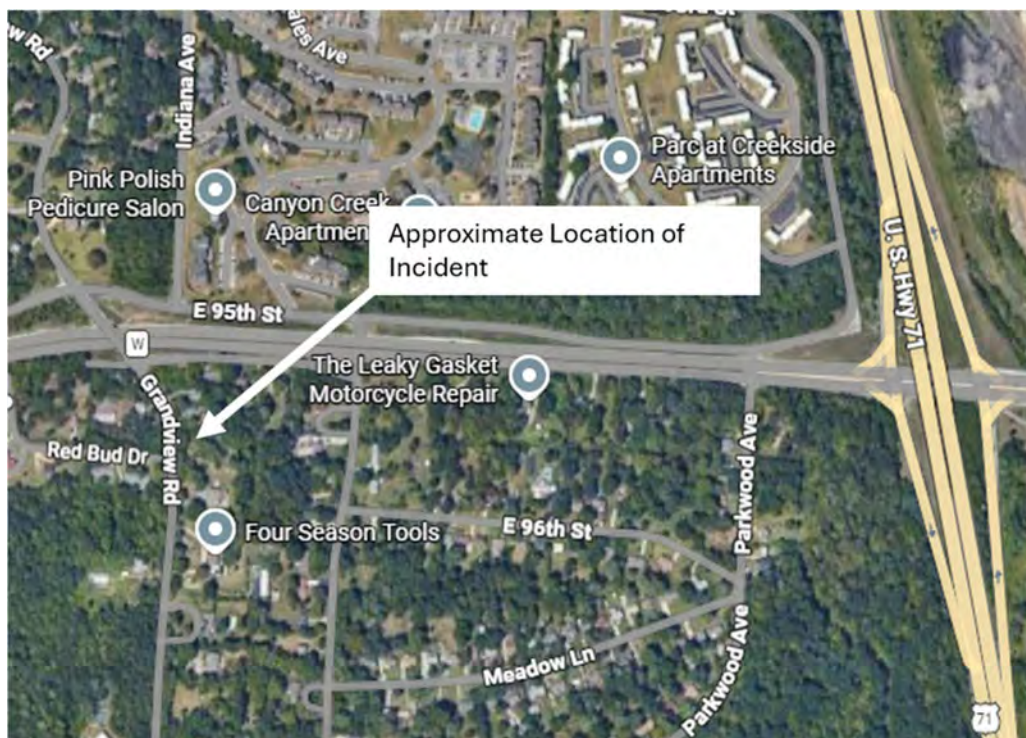
**Figure 1: Approximate Location of Incident, 9509 Grandview Rd, Kansas City, MO**  
(Source: Google Maps, Staff added arrow and text box)

The excavation occurred on April 22, 2025. A Spire Civic Improvement Inspector (\*\* [REDACTED] \*\*) was on-site to observe the excavation work but departed at about 5:06 pm at the start of backfilling work. At approximately 5:10 pm during the backfilling work, a 1-inch nipple welded onto the 12:00 position (top of) the 10-inch steel natural gas pipeline was bent during backfill work, causing a fracture in the 10-inch pipeline at a location close to where the nipple had been welded onto the pipeline. Figure 1 shows the approximate location where the incident occurred.
