Exhibit No. \_\_\_\_\_  
Issues: System Condition and Improvements  
Witness: Jacob Freeman  
Type of Exhibit: Direct Testimony  
Sponsoring Party: Confluence Rivers Utility  
Operating Company, Inc  
File Nos.: WR-2023-0006 / SR-2023-0007  
Date: December 21, 2022

**Missouri Public Service Commission**

**Direct Testimony**

**Confluence Rivers Utility Operating Company, Inc**

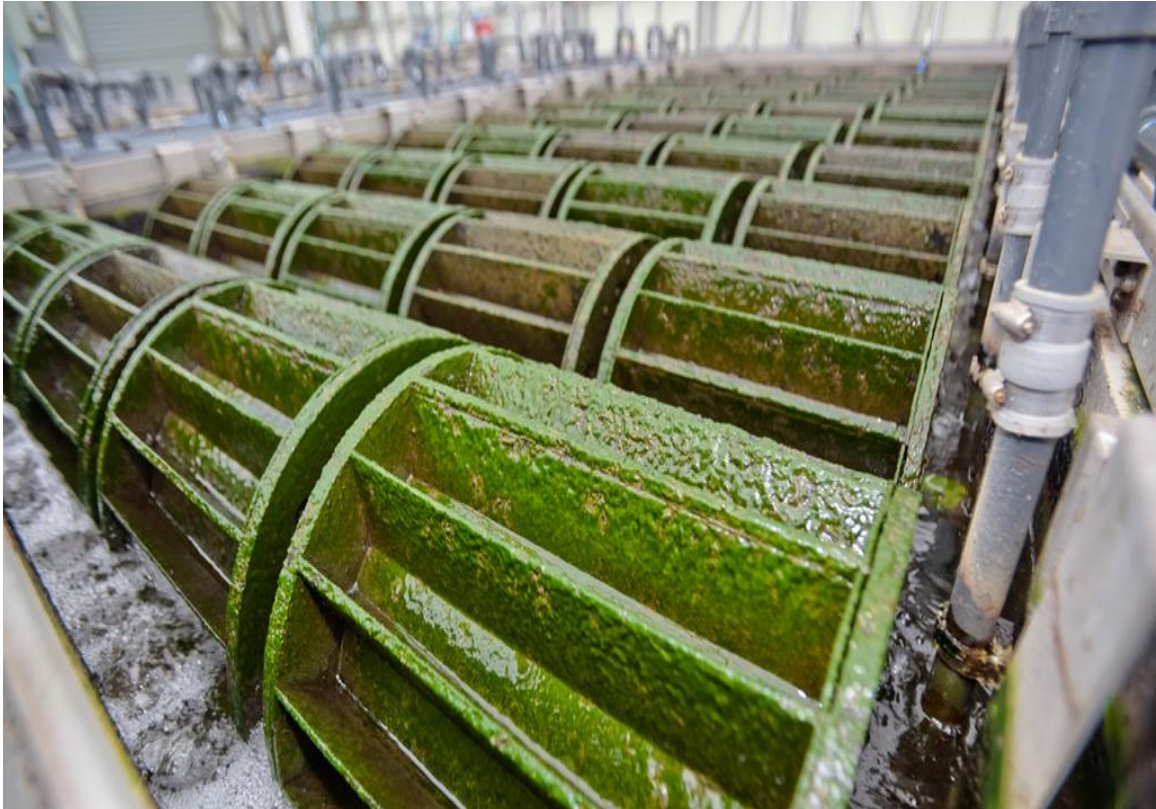
5 The process improvement plans at the Three-Cell lagoon consist primarily of the  
6 additions of an attached growth treatment system called an Algae Wheel<sup>®</sup> and an alum  
7 sulfate feed as a coagulant. As planned, the three-cell facility will continue to be  
8 configured with flow entering the facility from the current influent points (two gravity  
9 lines into the first cell of the lagoon) and then proceeding through the three cells. The  
10 process change will be implemented by adding a wet well at the end of the third cell with  
11 a duplex pumping station. Flow from this wet well will be pumped to the South end of  
12 the lagoon (by the Southeast corner of the first cell) to two Algae Wheel<sup>®</sup> systems  
13 running in parallel. The Algae Wheel<sup>®</sup> is an attached growth treatment system running in  
14 shallower tanks relative to those used in a traditional MBBR/IFAS system. Aeration

15 applied below the Algae Wheel<sup>®</sup> provides air for biofilm to form on the media, and the  
16 system is designed to encourage algae growth on the fins and drums. This algal growth  
17 produces additional dissolved oxygen to the biology of the biofilm, reducing the amount  
18 of aeration needed to achieve effective treatment. The Algae Wheel<sup>®</sup> system is both  
19 operationally cheaper than a traditional MBBR/IFAS in that it uses less energy, but also  
20 from a capital standpoint in that it requires shallower tanks and smaller blowers to run the  
21 system. The system must be located at the south end of the lagoon in order to keep it out  
22 of the flood plain.

1  
2 *Multiple Algae Wheels<sup>®</sup> running in parallel, algae growth on fins and aeration piping*  
3

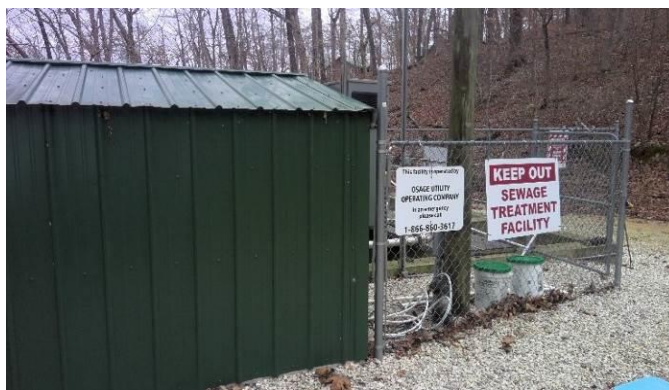
14 Following the basic cleanup of the facility, Confluence Rivers overhauled the  
15 entire aeration system. This included replacing the power service to the site and  
16 expanding the fencing to provide security for a new power supply, control system, and  
17 blower housing structure. The housing structure was also replaced and now consists of a  
18 3-sided steel structure with a roof to provide adequate protection for the blower  
19 equipment as well as additional space for storing disinfection chemicals and operations  
20 equipment which had previously been strewn haphazardly around the site.

*New blower housing and fence area*

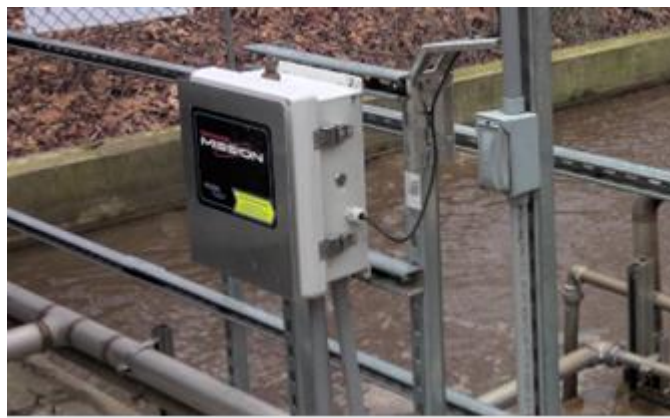
1  
2  
3           Confluence Rivers also installed remote monitoring equipment at the facility. As  
4 with Freeman Hills and Terre du Lac, the remote monitoring equipment allows  
5 operations staff to remotely track the status of treatment equipment and to receive  
6 immediate notification of any abnormal operating condition. Immediate notification of  
7 abnormal operating conditions enables operators to quickly respond to any emergency  
8 condition before damage to the environment, interruption of proper treatment process,  
9 damage to equipment, backups that can damage customers property, or service  
10 interruptions to customers.

*Newly installed remote monitoring system*

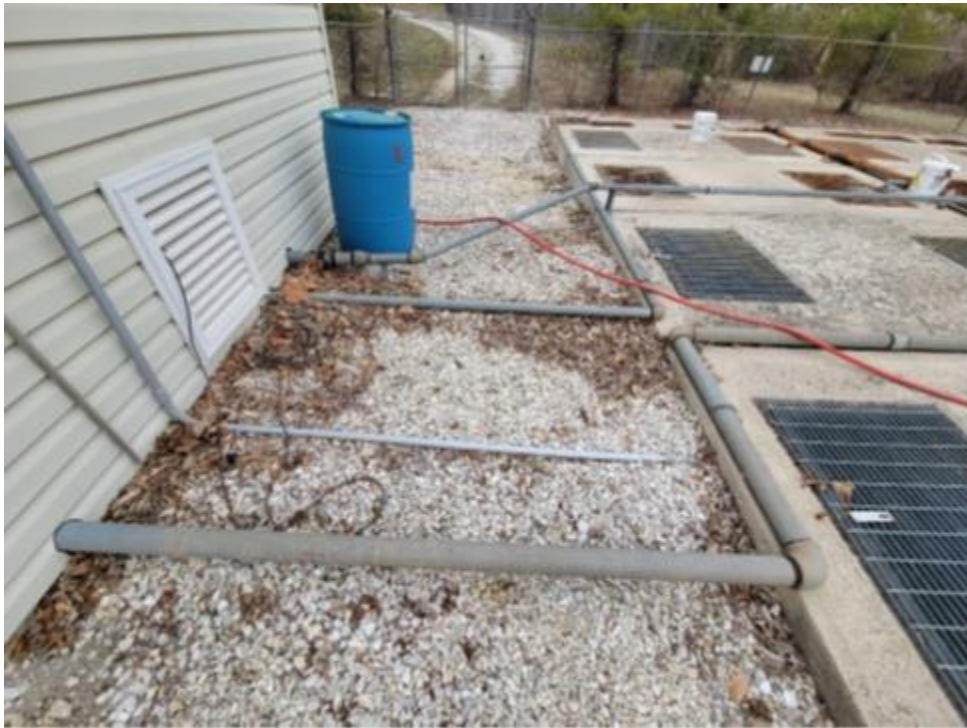
1 Discussion with the existing facility operator revealed that the primary treatment  
2 issues were related to difficulty maintaining proper DO level in the aeration basins at a  
3 minimum of 2 mg/l. This is particularly an issue for the train situated furthest from the  
4 blowers. The facility blowers appear to be properly sized for the size of the plant, which  
5 indicates that the issue is with the sizing of the air headers preventing adequate air from  
6 reaching the furthest train.

7  
8 *Undersized air headers causing issues with DO levels in portions of the aeration basins (3" piping to*  
9 *aeration basins / 1.5" piping to the flow equalization basins)*

10  
11 While this has not resulted in effluent exceedances historically, it does indicate the  
12 facility is not operating to its full treatment potential. The issue is further exaggerated by  
13 the system having fewer diffusers installed than would be appropriate for the aeration  
14 tankage. In addition to reduced treatment effectiveness, the lower levels of DO  
15 encourage filamentous bacteria which thrive in the lower DO environment and lead to  
16 sludge bulking and retention, gradually reducing the treatment capacity of the facility.

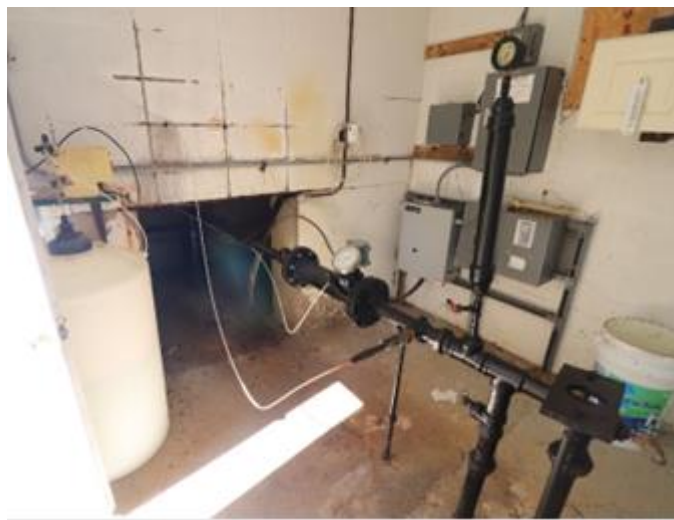
*Interior of Well #2 well house.*

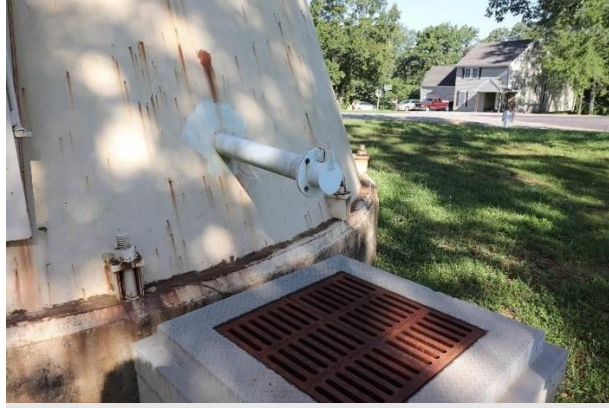
The storage facilities at the Terre du Lac water system consist of two elevated storage tanks: one at the well #1/office site and one at the site of well #4. The two elevated storage tanks are both single pedestal type elevated tanks with a globe tank at the top of the pedestal. The tank near well #1 is a 50,000-gallon tank and the tank near well #4 is a 100,000-gallon tank. The tanks are designed to provide adequate storage for 24 hours of water usage and maintain pressure in the distribution system. The tanks are in fair condition with significant rust on the tank structure being the primary issue that must be addressed to extend the useful lives of the tanks. The interior piping of both tanks shows significant rust and will require repairs sometime in the next several years to avoid leaking inside the tank pedestals.

*Base of tank near well #4*

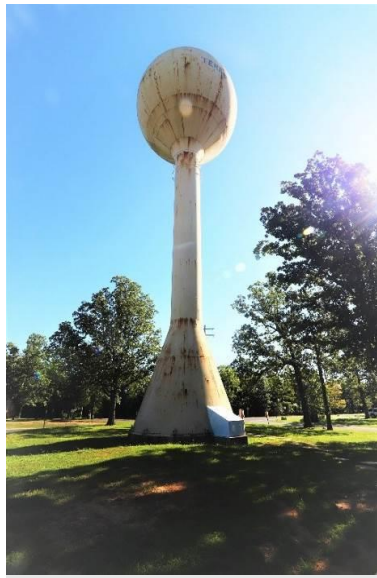
*Tank near well #4*

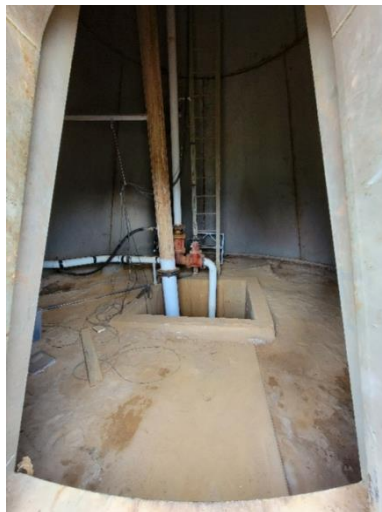
*Interior tank near well #4*

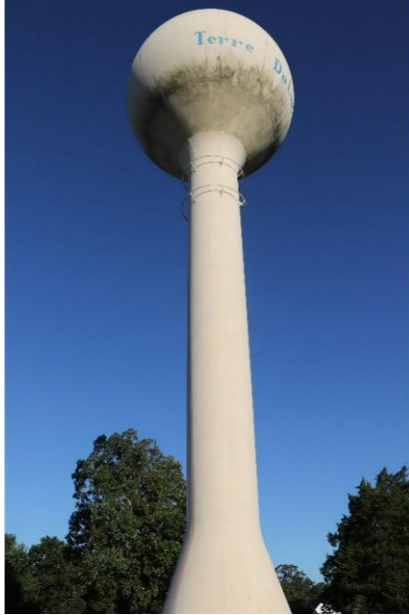
*Tank near well #1*

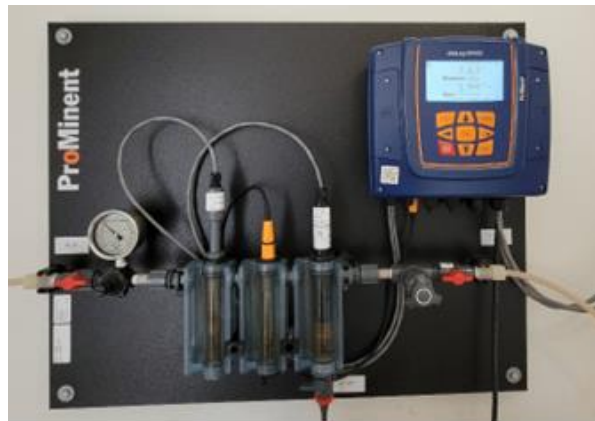
13  
14 *Chlorine Analyzer at Terre du Lac drinking water system*  
15

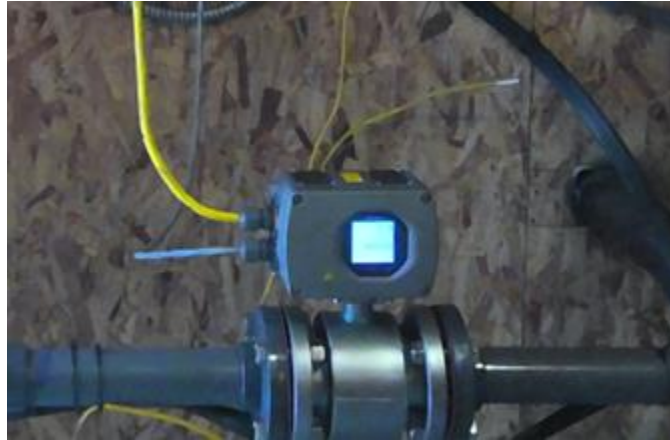
4  
5 *Magnetic Flow Meter at Cedar Glen Drinking Water system*  
6

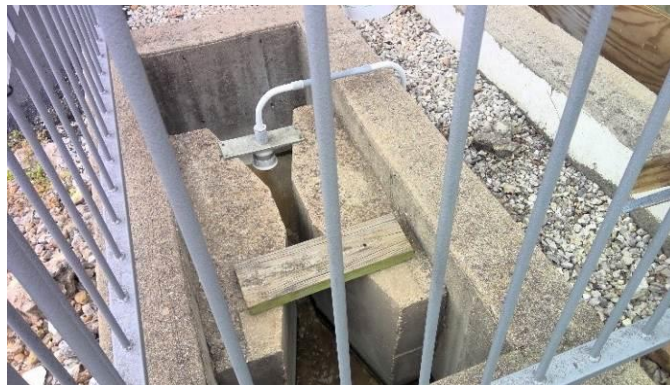
7  
8 *Ultrasonic Flow Meter at Cedar Green*

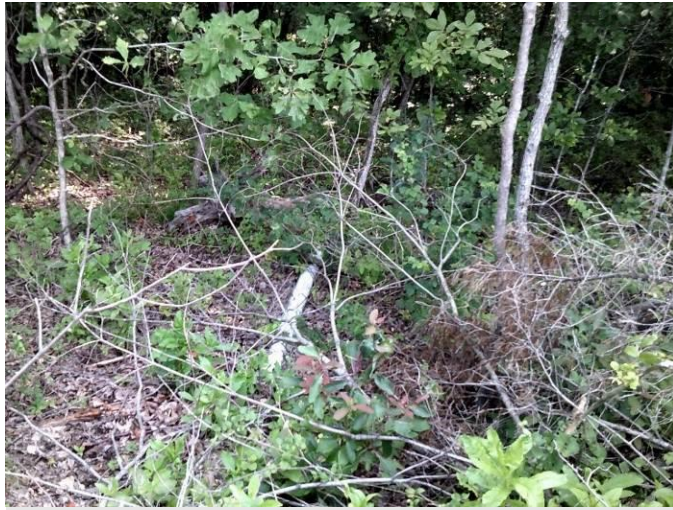
*Inaccessible outfall at Port Perry lagoon*

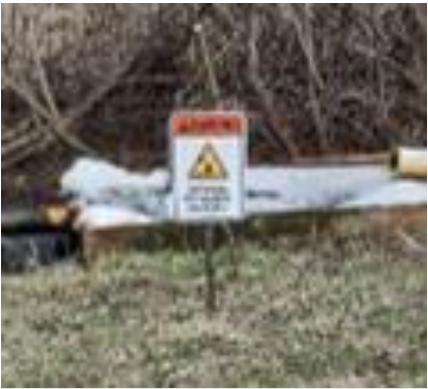
4 A. The lagoon systems Confluence Rivers has acquired typically have had issues with  
5 disinfection equipment. Upon acquisition, the Company routinely discovers that these  
6 plants have no chlorine tablets in the tablet feeders and have been exceeding limits  
7 simply because previous owners failed to properly operate the disinfection system. In  
8 addition, there is typically sludge accumulation in chlorine contact chambers, which  
9 reduces the contact time between effluent and chlorine leading to reduced effectiveness in  
10 disinfection. In some cases, tablet feeders were damaged from a lack of maintenance.  
11 Confluence Rivers has also found that some of these systems had no disinfection systems  
12 installed or lacked disinfection components called for in the permit (dechlorination). In  
13 such cases, Confluence Rivers removes sludge from the contact chambers and repairs or  
14 replaces missing and damaged disinfection equipment.

*Overwhelmed disinfection system at Terre du Lac three-cell lagoon*

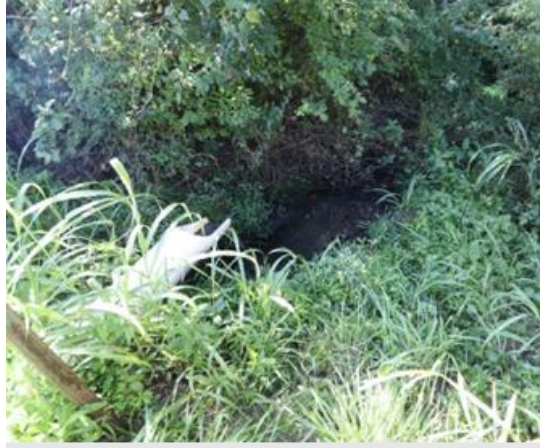
*No disinfection present at Terre du Lac single-cell lagoon*

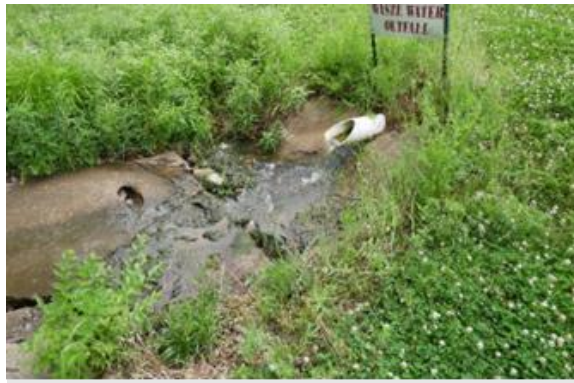
*No disinfection present at Freeman Hills*

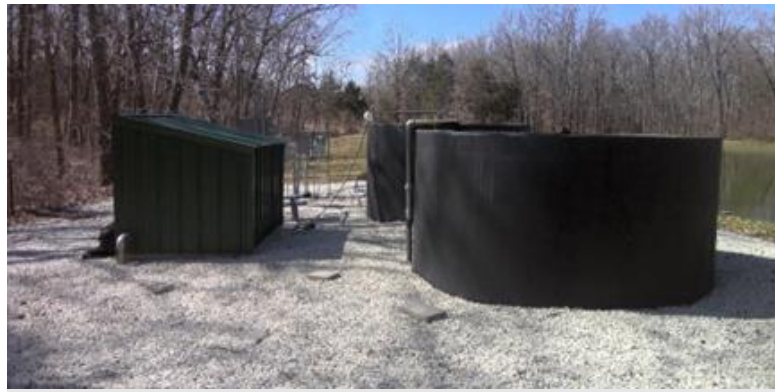
9 A. While some lagoon treatment systems that Confluence Rivers acquires have adequate  
10 treatment capacity to comply with permitted limits once rehabilitative efforts have been  
11 undertaken, others cannot adequately treat to permitted limits without significant process  
12 improvements. Where such process improvements are needed, an engineer is contracted  
13 to design effective improvements. These improvements include the addition of  
14 traditional lagoon aeration with floating aerators; installation of baffles dividing existing  
15 lagoon cells into multiple treatment cells; and/or the installation of MBBR or other  
16 attached growth treatment equipment to improve BOD and ammonia removal. Such

*MBBR system added to Roy-L lagoon*

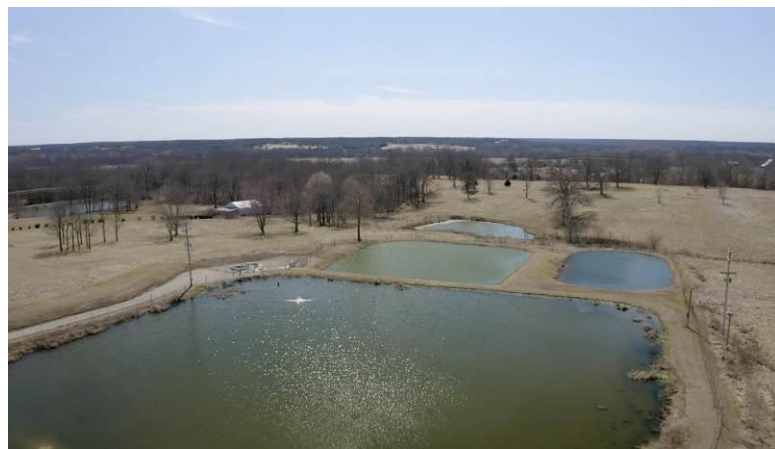
*MBBR added to MO Utilities Lagoon*

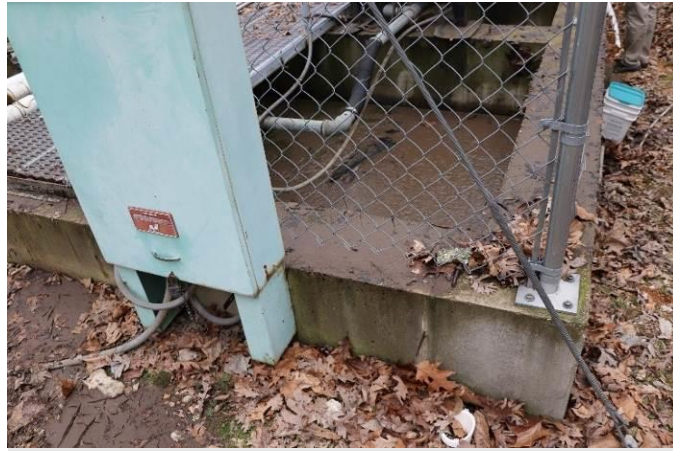
1 A. Nearly all activated sludge facilities were found to have significant sludge accumulation  
2 in treatment components, including influent lift stations, aeration chambers, clarifiers,  
3 and contact chambers. Excessive sludge accumulation indicates operational neglect by  
4 the previous owners.

3  
4  
5 *Completely full and overflowing digester at Chelsea Rose*

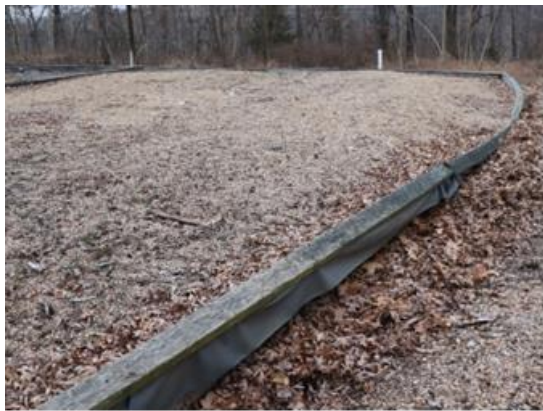
14  
15 *Vegetation debris on surface of Cimarron Bay filter beds.*

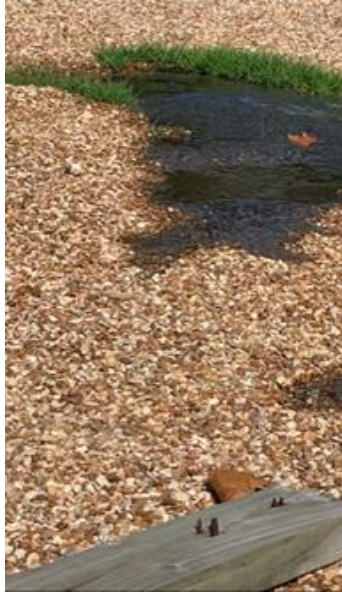
*Sludge accumulation causing ponding on Cimarron Bay sand filter bed*

20 Confluence Rivers does several things to resolve these issues where they are  
21 discovered and take steps to prevent this sort of sludge accumulation from recurring.  
22 First, where sludge has clogged filter media, the media is raked out to break up sludge  
23 blocks; sludge is removed from the septic and recirculation tanks; and in some cases

1 where sludge impact is too severe, portions of the media are hauled off and replaced.  
2 Should issues be identified with pump configuration pulling sludge from the bottom of  
3 the septic tank, pumps are reconfigured to reduce solids flow. The final and perhaps  
4 most significant improvement that reduces these issues and prevents recurrence are  
5 improved process improvements including either the installation of an MBBR alongside  
6 the facility or installation of drop in micro MBBR units in the facility recirculation tanks.  
7 While the primary purpose of these improvements is to allow facility to meet permit  
8 limits (especially ammonia limits), a secondary effect is generally improved  
9 microbiology in the facility improving the breakdown of the organic components in  
10 wastewater solids and reducing sludge volume. The reduced volume is more easily  
11 washed out of the filters becoming less likely to accumulate again in the future.

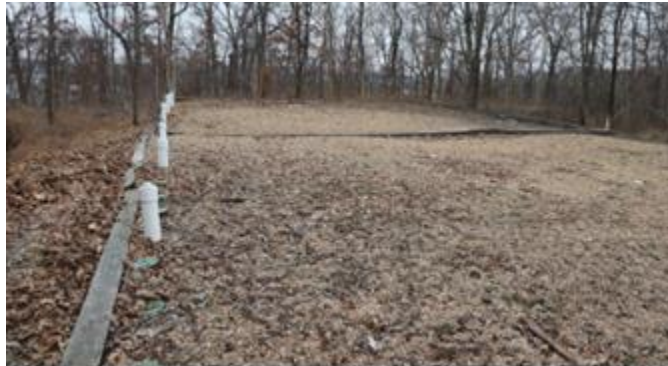
4 A. While this issue is not unique to the sand filter plants, Confluence Rivers has encountered  
5 many issues with the general site conditions at this group of facilities. Some sites lacked  
6 any fencing (for example the Cimarron Bay facility) or exhibited significant damage to  
7 site fencing. These sorts of failures in site security can allow members of the public to  
8 trespass on wastewater treatment sites, potentially exposing them to dangerous  
9 wastewater or wastewater treatment equipment, and potentially leading to damage to  
10 treatment facilities. In such cases, Confluence Rivers has repaired/installed fencing.  
11 Several of these facilities have also lacked adequate access roads. All weather access  
12 roads are essential so that operations staff can reach the facility in any condition both for  
13 regular maintenance activities and to respond to any emergency situations at a treatment

*No fencing present at the Cimarron Bay treatment plant*

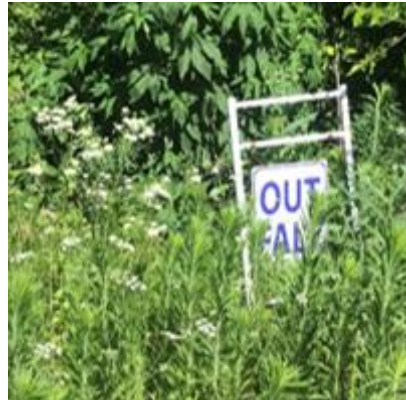
*Outfall inaccessible at Country Hill Estates due to vegetation overgrowth.*

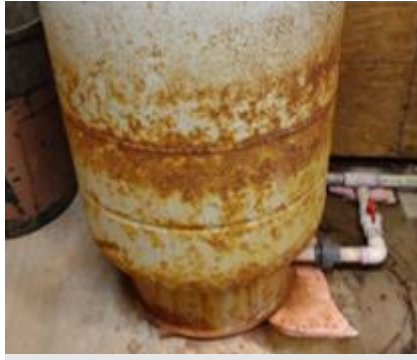
*Rusting bladder tank at Missing Well system*
