Ameren Missouri 4 CSR 240-23.010 Electric Utility System Reliability Monitoring and Reporting Submission Requirements – Annual Reliability Report

This report details Union Electric (dba Ameren Missouri) Company's annual reliability metrics and worst performing circuits for calendar year 2017 as required by Missouri Public Service Commission Rule 4 CSR 240-23.010, Electric Utility System Reliability Monitoring and Reporting Submission Requirements (referred to in the remainder of this document as "the Rule"). This report is required by Sections (2), (7), and (8) of the Rule which state, *"The information required by section (1) shall be filed annually by the last business day of April of the calendar year following the calendar year for which the information was accumulated.... The information developed in accordance with section (6) shall be reported as part of the annual report required by section (2).... If on or after the time the annual report required by section (7) for calendar year 2011 is filled, a circuit has been on the worst performing circuit list for two (2) of the three (3) most recent consecutive calendar years the electrical corporation shall include detailed plans

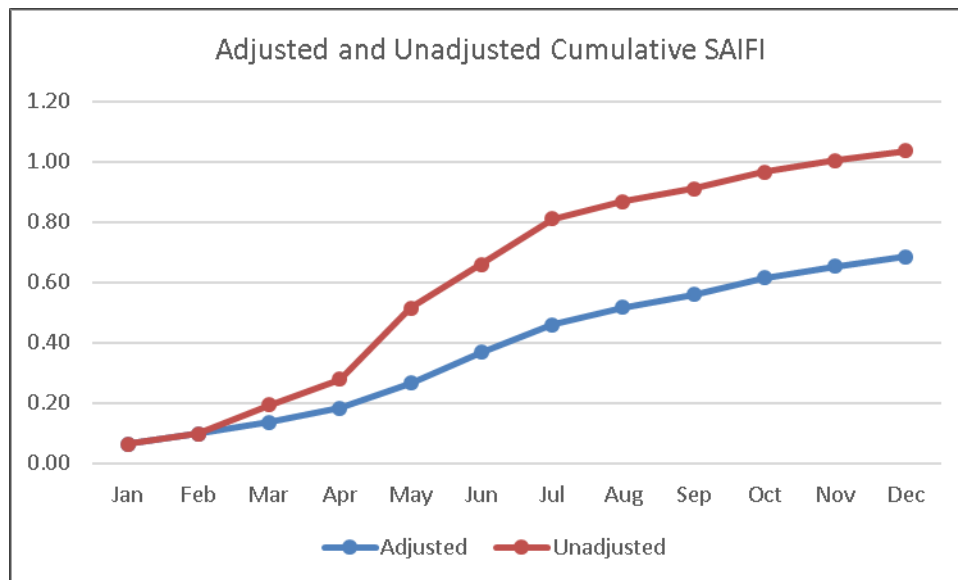
SAIFI:

MONTH	Adjusted Value	Unadjusted Value
Jan	0.06	0.06
Feb	0.10	0.10
Mar	0.14	0.19
Apr	0.18	0.28
May	0.26	0.51
Jun	0.37	0.66
Jul	0.46	0.81
Aug	0.52	0.87
Sep	0.56	0.91
Oct	0.62	0.97
Nov	0.65	1.00
Dec	0.68	1.04

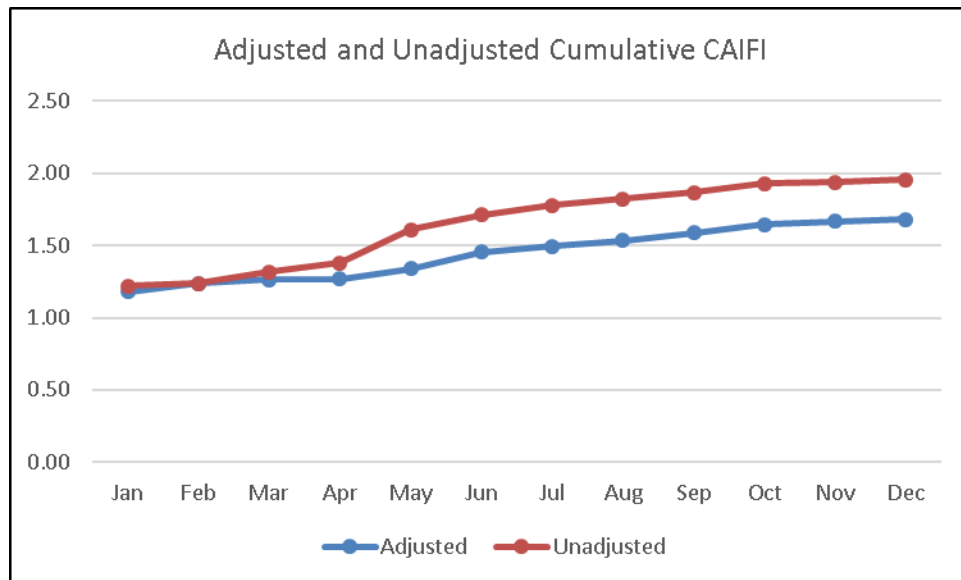
CAIFI:

MONTH	Adjusted Value	Unadjusted Value
Jan	1.18	1.22
Feb	1.24	1.24
Mar	1.26	1.32
Apr	1.27	1.38
May	1.34	1.61
Jun	1.46	1.71
Jul	1.49	1.78
Aug	1.54	1.82
Sep	1.59	1.87
Oct	1.65	1.93
Nov	1.67	1.94
Dec	1.68	1.96

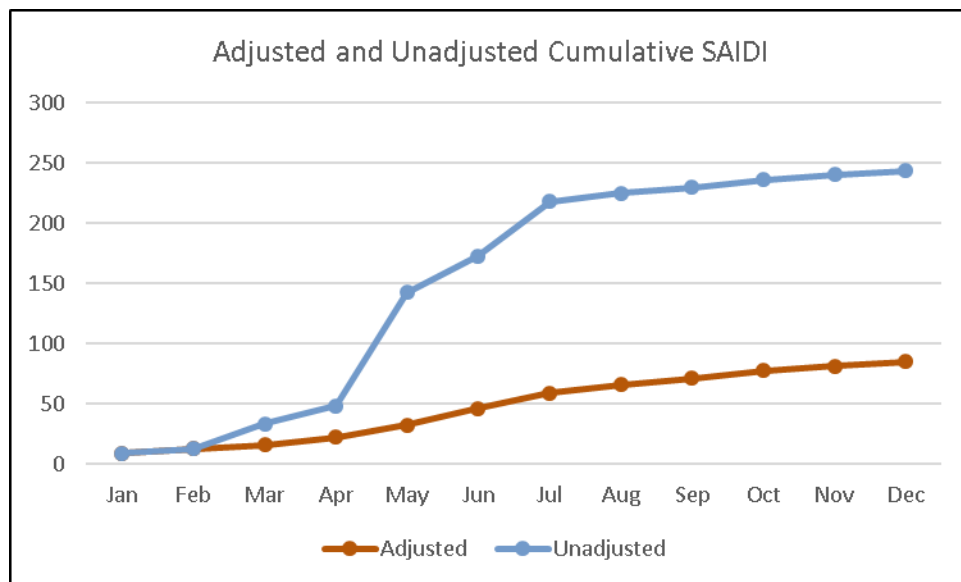
SAIDI:

MONTH	Adjusted Value	Unadjusted Value
Jan	9	9
Feb	12	12
Mar	16	33
Apr	22	48
May	32	143
Jun	46	173
Jul	59	218
Aug	66	225
Sep	71	230
Oct	78	236
Nov	81	240
Dec	85	244

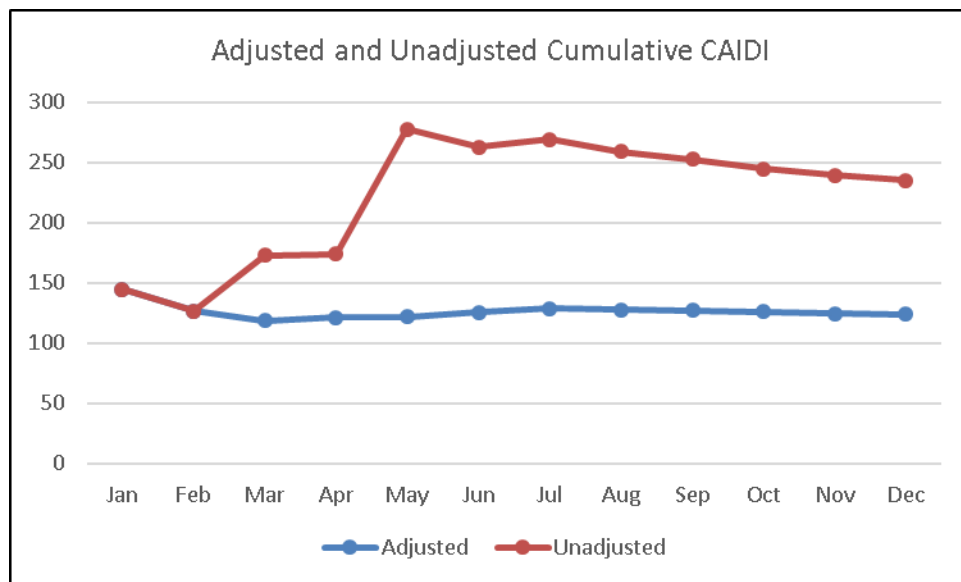
CAIDI:

MONTH	Adjusted Value	Unadjusted Value
Jan	145	145
Feb	127	127
Mar	119	173
Apr	121	174
May	122	278
Jun	125	263
Jul	129	269
Aug	128	259
Sep	127	253
Oct	126	245
Nov	125	239
Dec	124	235
