Grain Belt Express HVDC System Impact Study

Final Report for
Southwest Power Pool

Prepared by:
Excel Engineering, Inc.

September 6, 2013

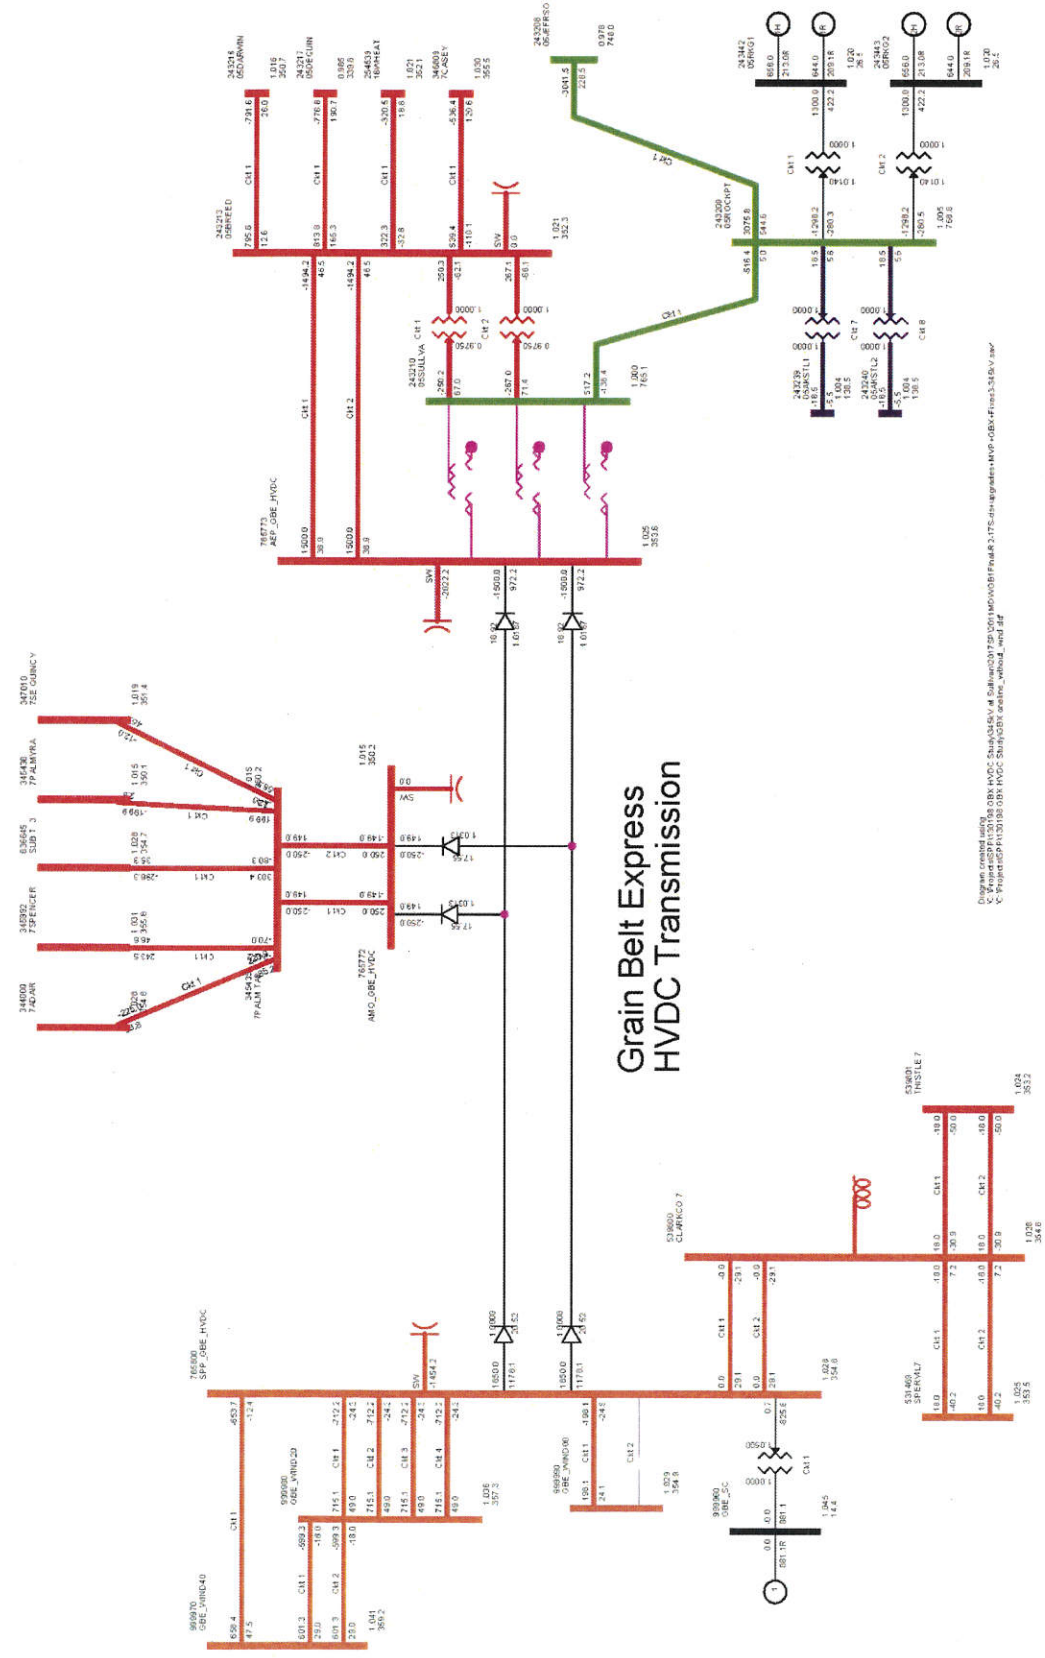
Figure 3-1. Power Flow One-line of GBX HVDC with 345 kV Option at Sullivan – 2017 Summer Peak

Figure 3-1 and Figure 3-2 show power flow one-lines for the 2017 Summer Peak case with the 345 kV option at Sullivan and the GBX wind generation model, respectively. One-line diagrams of GBX and the full SPP 345 kV system for all three seasons are provided in Appendix E.

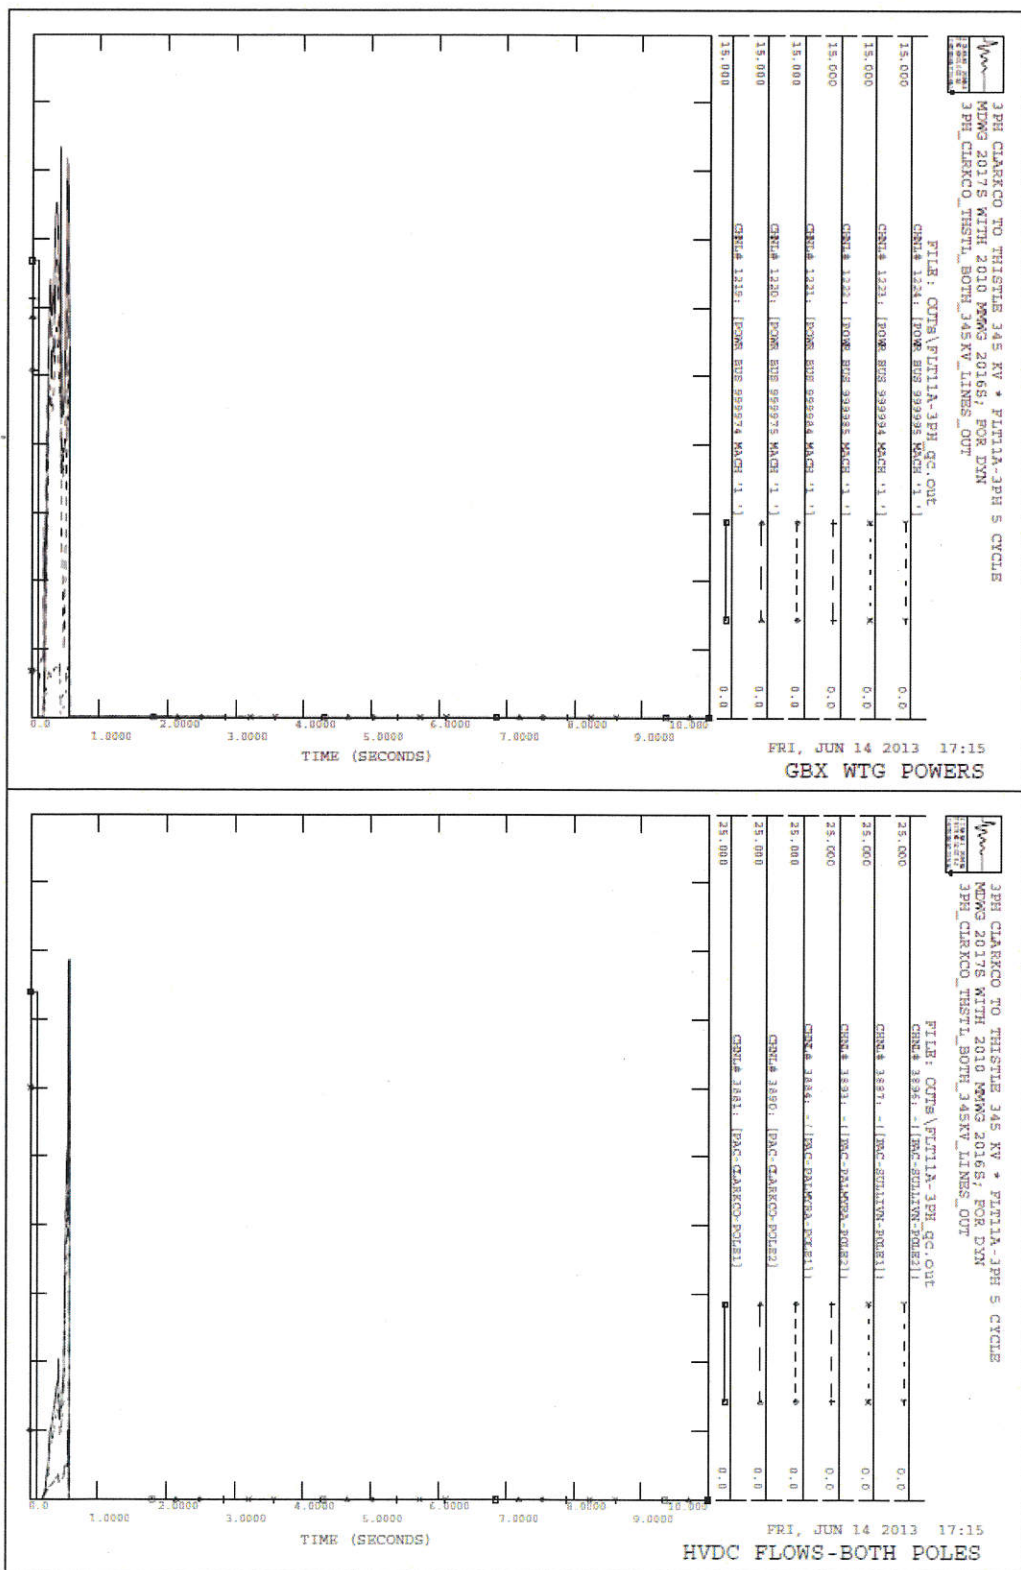
Figure 4-1. Wind and HVDC Powers for FLT11A, 3ph fault on Clark Co – Thistle 345 #1 with prior outage of #2

All of the NERC Category B faults in SPP were stable. Some of the NERC Category C faults were unstable, including the N-1-1 (aka NERC Category C3) faults on the Clark Co. – Spearville 345 kV lines (FLT12A, FLT12B) and the Clark Co. – Thistle 345 kV lines (FLT11A, FLT11B). If one of the lines is out of service and the parallel line has a fault, the GBX wind generators trip on over-frequency (see plot of FLT11A in Figure 4-1). To fix this problem, the PTI report proposes tripping some of the wind generation (760-877 MW) at the same time as the faulted line. This solution is confirmed to work and allows the remaining GBX wind generation to stay on-line and stable (Figure 4-2). However, generation tripping will require a Special Protection System (SPS) that may not be acceptable to SPP or the transmission owner.

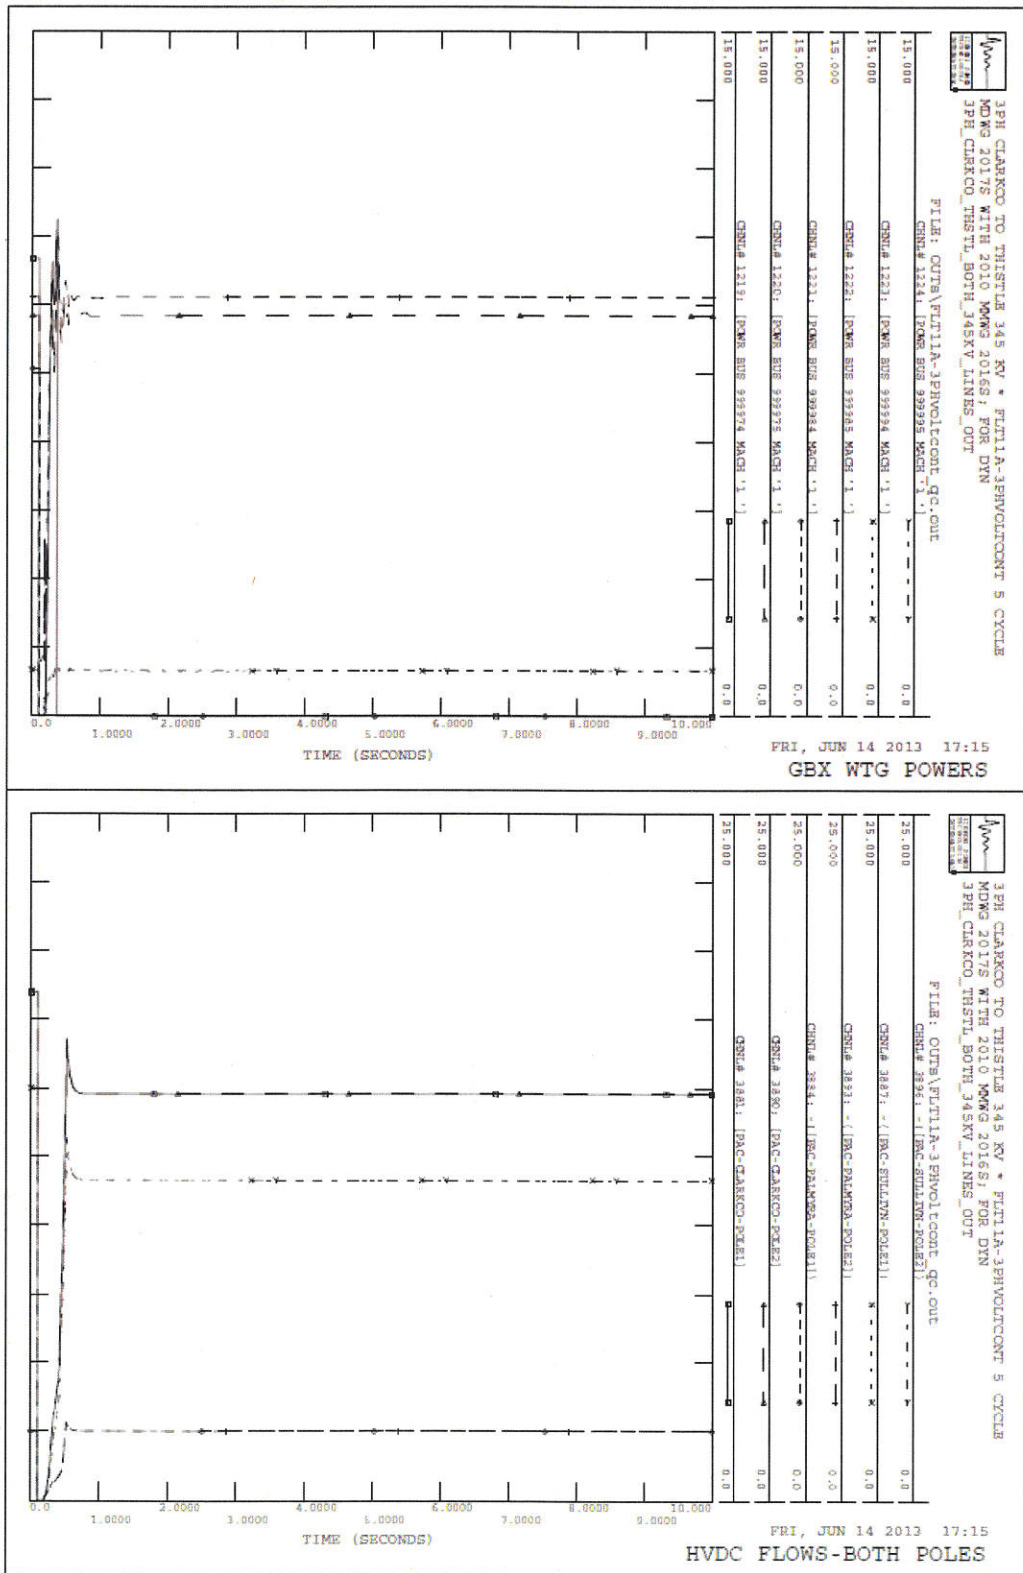
Figure 4-2. Wind and HVDC Powers for FLT11A_voltcont, 3ph fault on Clark Co - Thistle 345 #1 with prior outage of #2, trip some wind generation post-fault

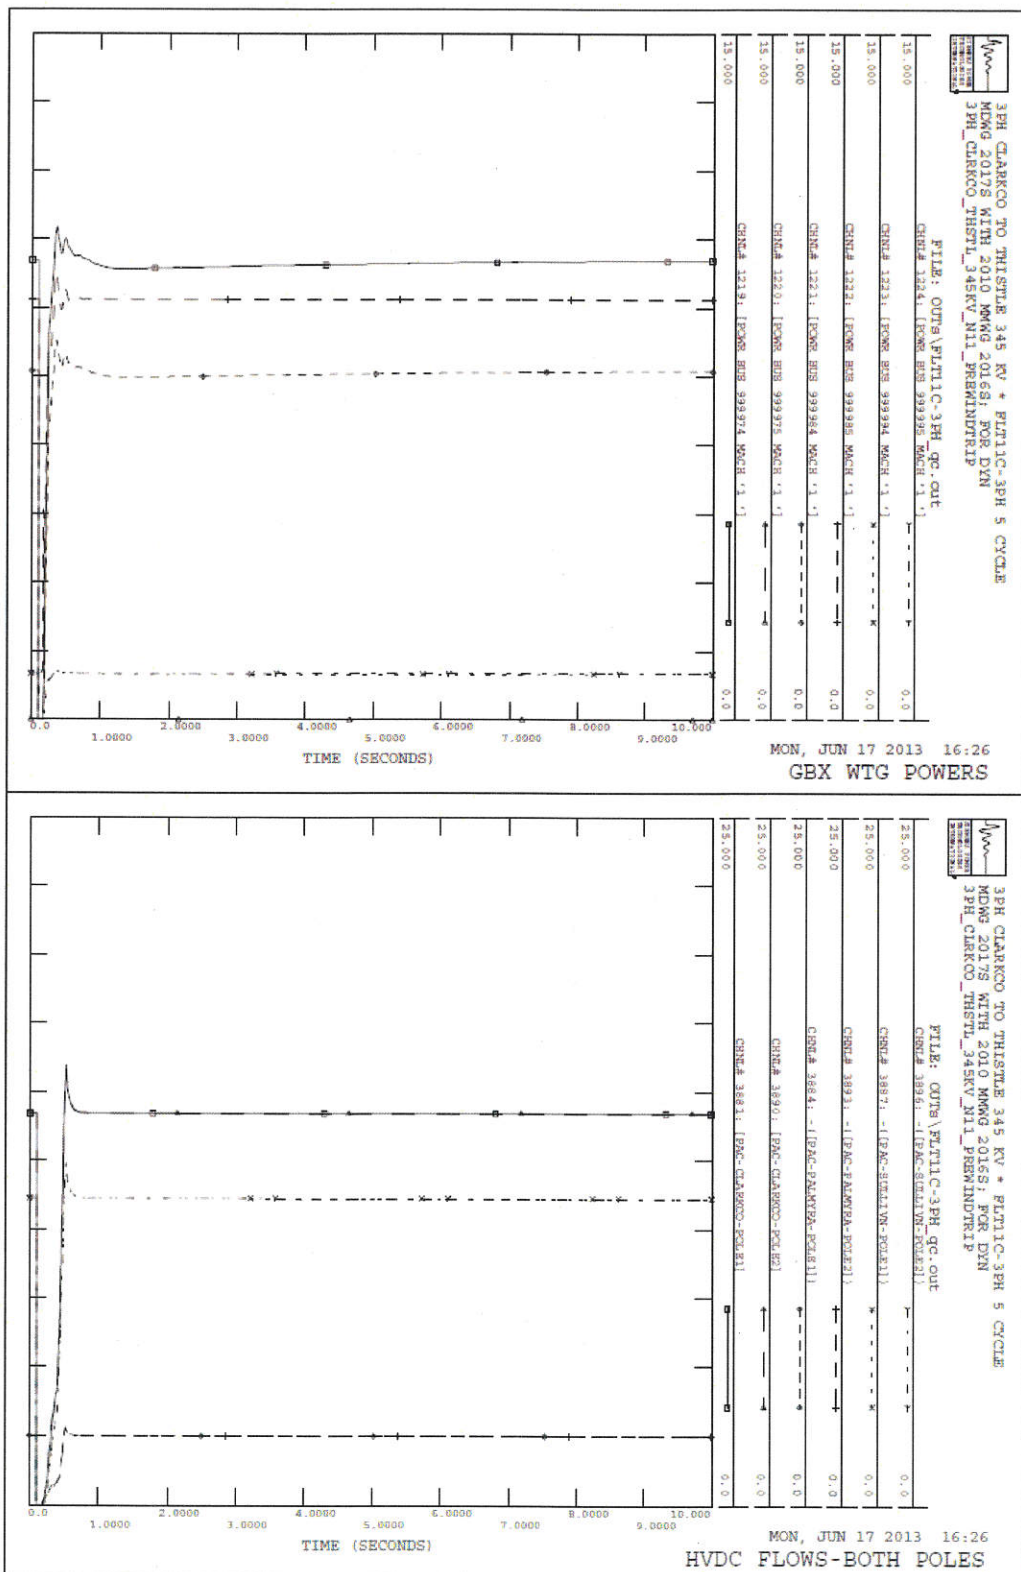
Figure 4-3. Wind and HVDC Powers for FLT11C, 3ph fault on Clark Co – Thistle 345 #1 with prior outage of #2, trip some wind generation PRE-fault

Another option is to reduce wind generation after the first contingency occurs but before the second contingency. This option was tested in PSS/E as FLT11C and FLT12C, and the results were stable but without the need for an SPS (Figure 4-3).

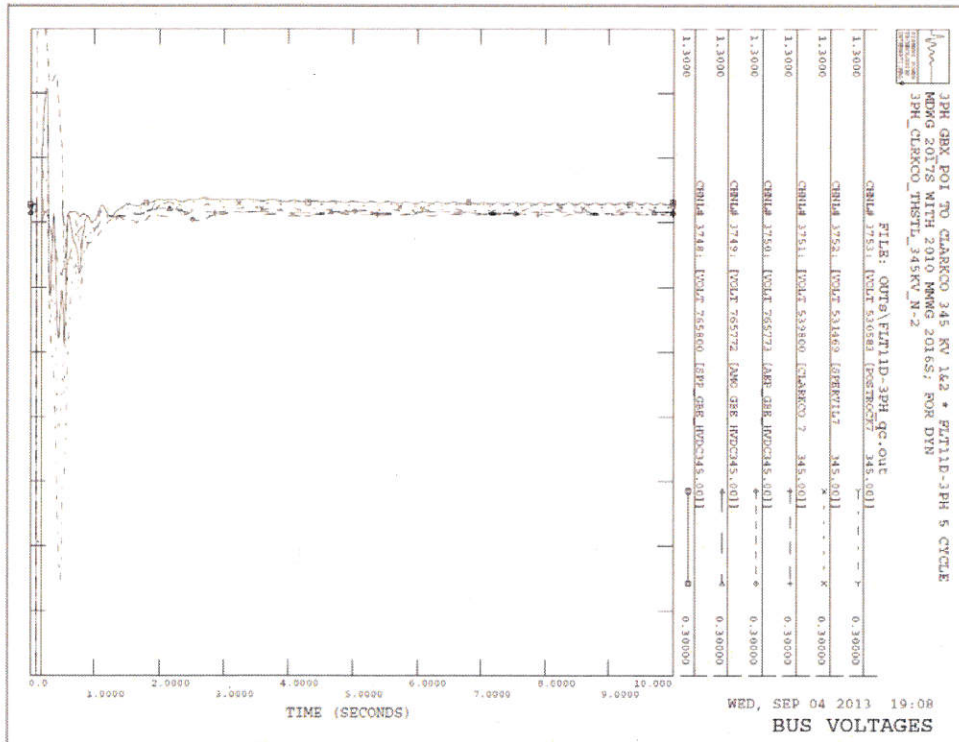
Figure 4-4. Transmission Voltages for FLT11D, 3ph fault on GBX POI – Clark Co 345 #1 and #2 double circuit

Most of the results are the same as with the previous POI. The most notable difference is that faults 11A and 11D are stable **in the 2017SP case** with the new POI (but still unstable in the 2017LL and 2022SP cases). Losing the lines toward Thistle may not be quite as severe now that the POI is closer to Spearville. However, while the fault 11A and 11D results are officially stable in the 2017SP case, they are not acceptable. After fault clearing, transmission voltage dips as low as 45% at the Post Rock 345 kV bus (Figure 4-4). The solution to trip up to 877 MW of wind generation following faults 11A and 11D continues to work for the new POI, providing both stability and keeping post-fault voltages above 70% (Figure 4-5).

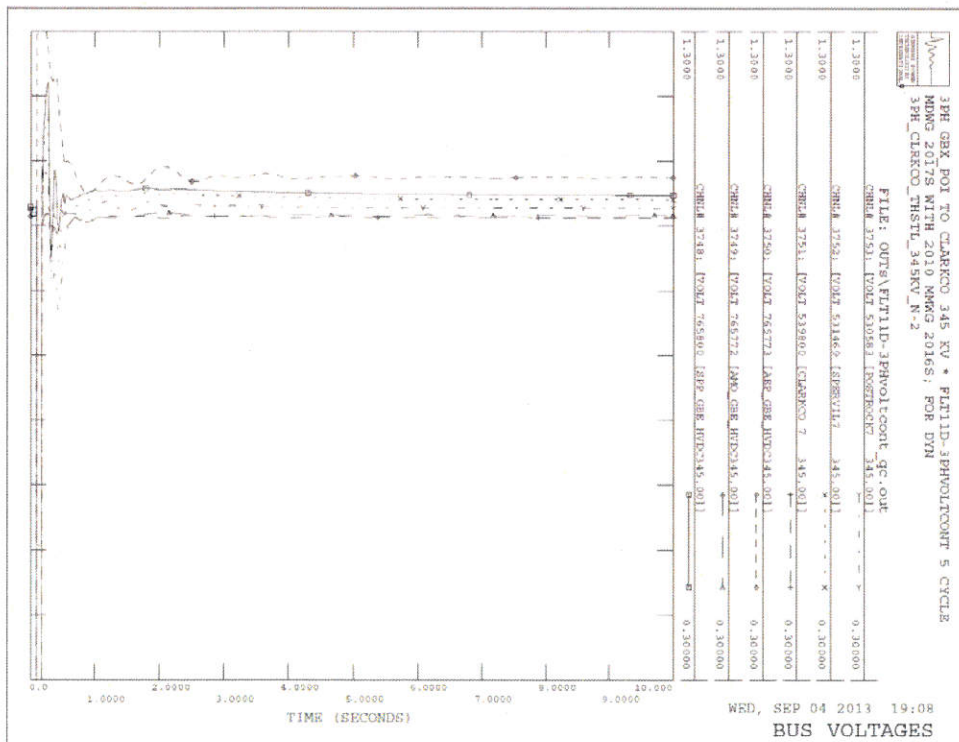
Figure 4-5. Transmission Voltages for FLT11D, 3ph fault on GBX POI – Clark Co 345 #1 and #2 double circuit, trip some wind generation post-fault

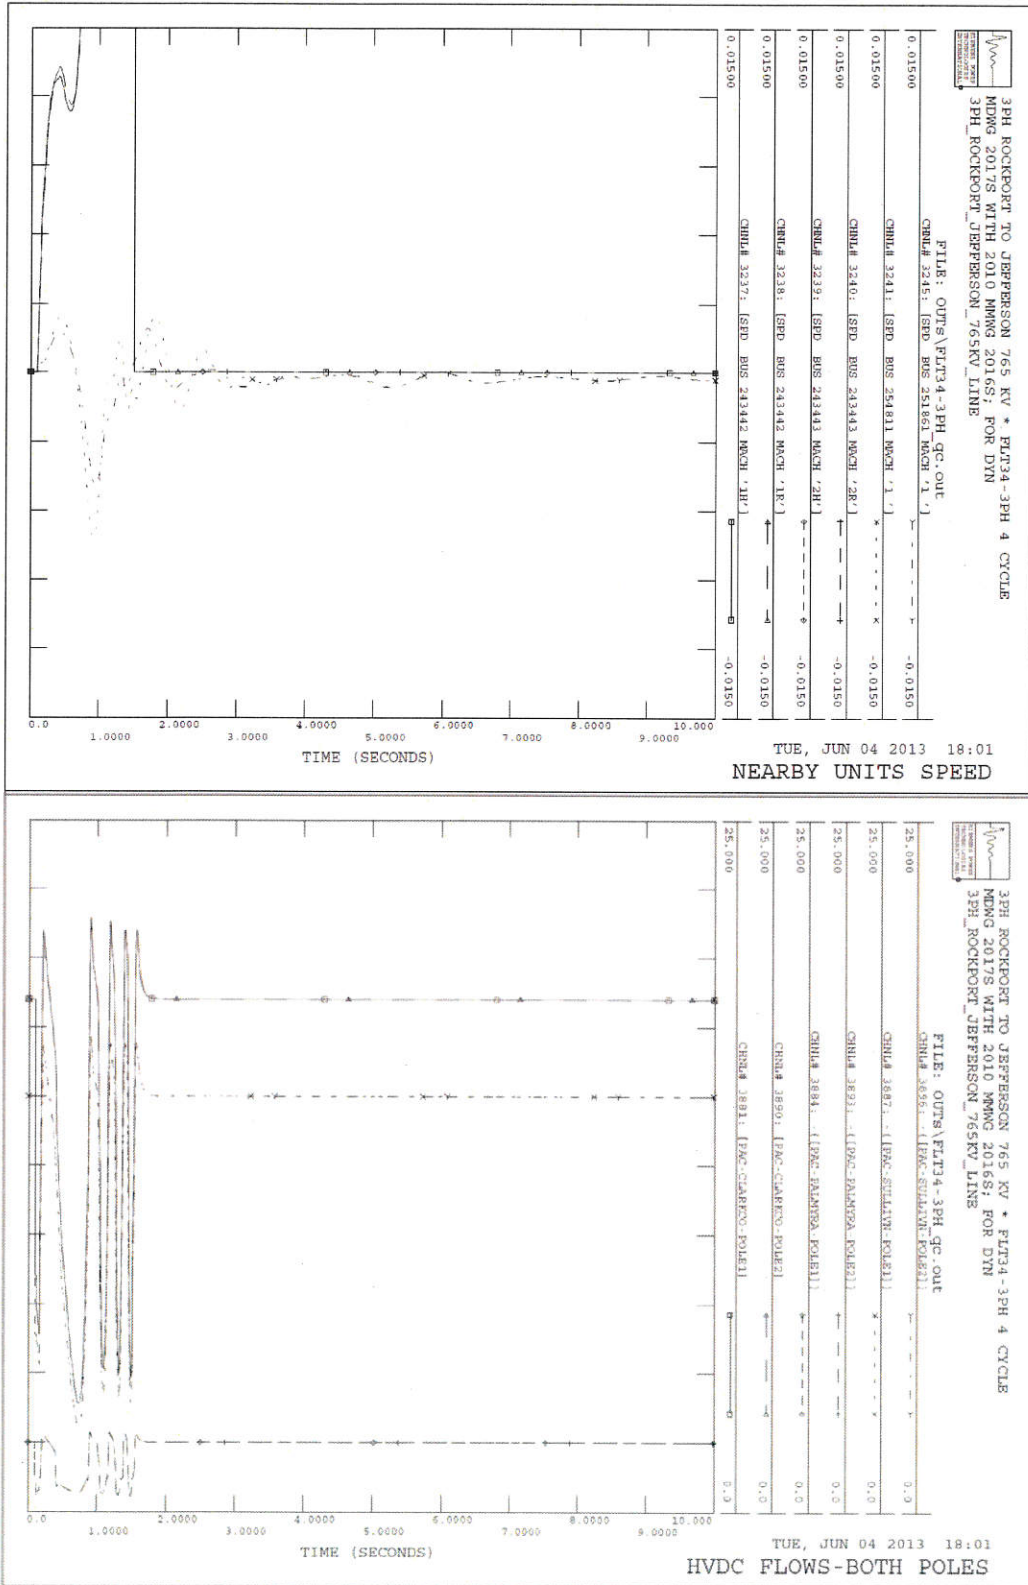
Figure 4-6. Rockport Speeds and HVDC Powers for FLT34, 3ph fault on Rockport – Jefferson 765

The most severe fault near Sullivan was on the Rockport – Jefferson 765 kV line. Loss of this line results in all 2600 MW from the Rockport plant feeding into Sullivan 765 and Breed 345 stations, the same place where 3000 MW is injected from the GBX project. The Rockport generators go unstable and trip off-line in the 2017SP (Figure 4-6) and 2022SP cases. This problem did not show up in the 2017LL case because Rockport was dispatched at a lower level of 1760 MW.

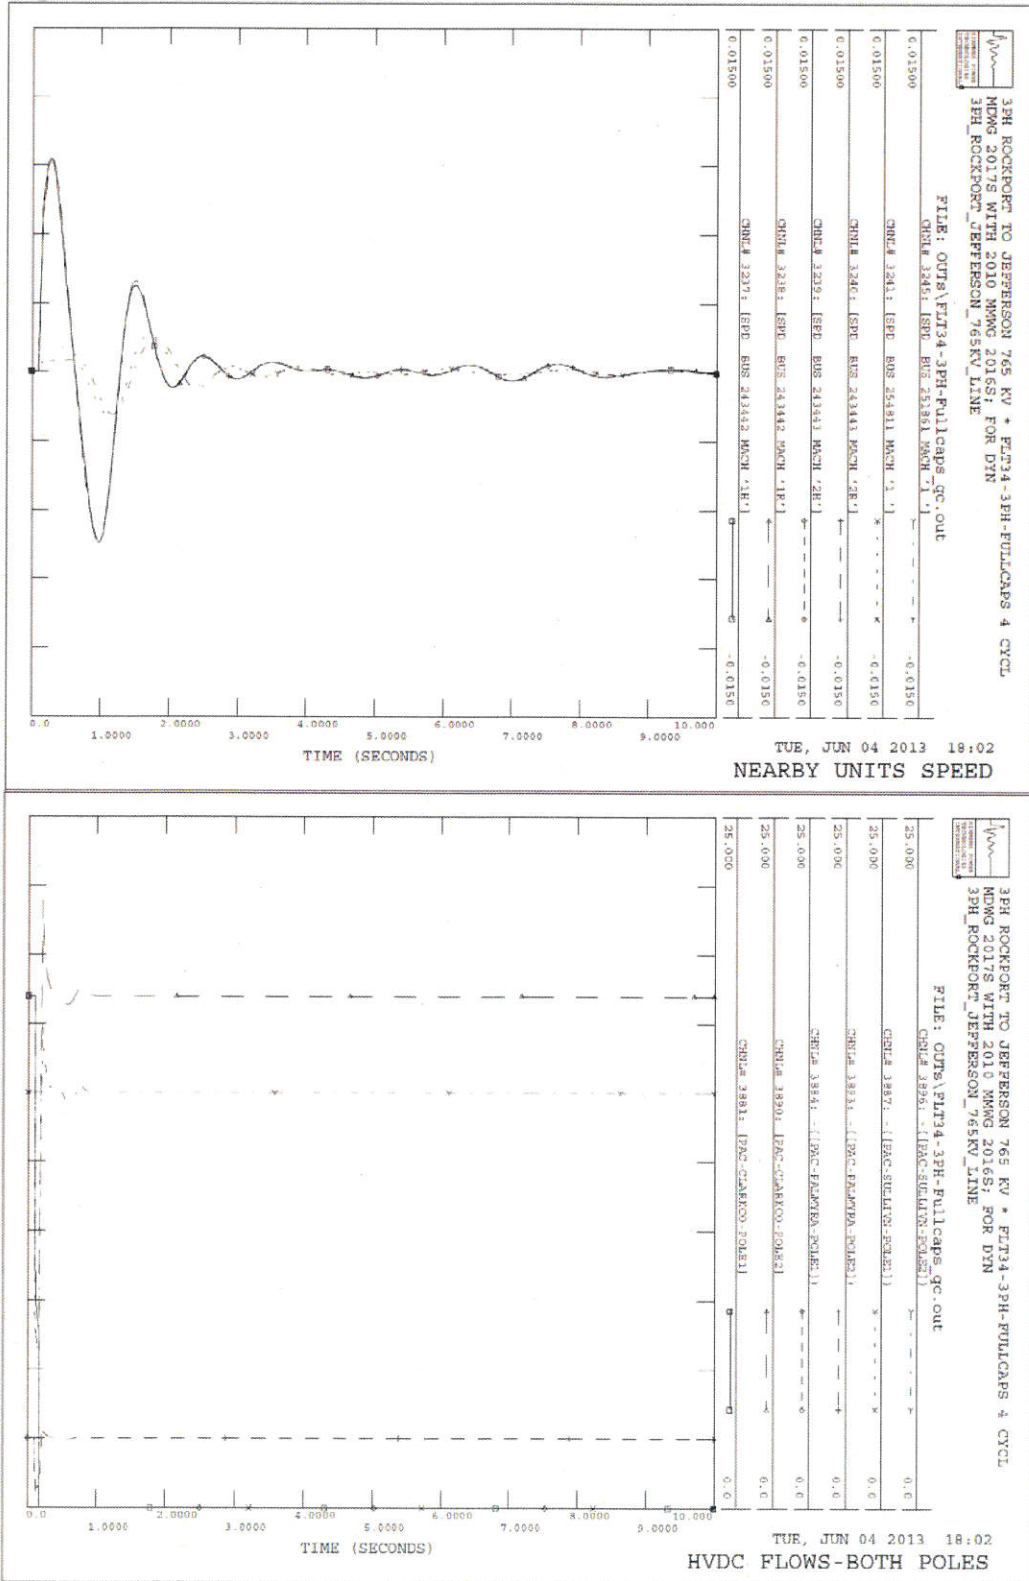
Figure 4-7. Rockport Speeds and HVDC Powers for FLT34, 3ph fault on Rockport – Jefferson 765, tripping one GBX HVDC pole post-fault

The PTI report showed that reducing HVDC power injection at Sullivan to 1500 MW by tripping one pole following the Rockport – Jefferson 765 kV fault allowed the Rockport units to remain stable. This solution was confirmed in dynamics (Figure 4-7) and was also stable in power flow. However, this solution would require an SPS that may not be allowed by AEP. If an SPS is not acceptable, then a major transmission upgrade, such as a new line, may be needed near Sullivan or Rockport, or the project size may need to be reduced.

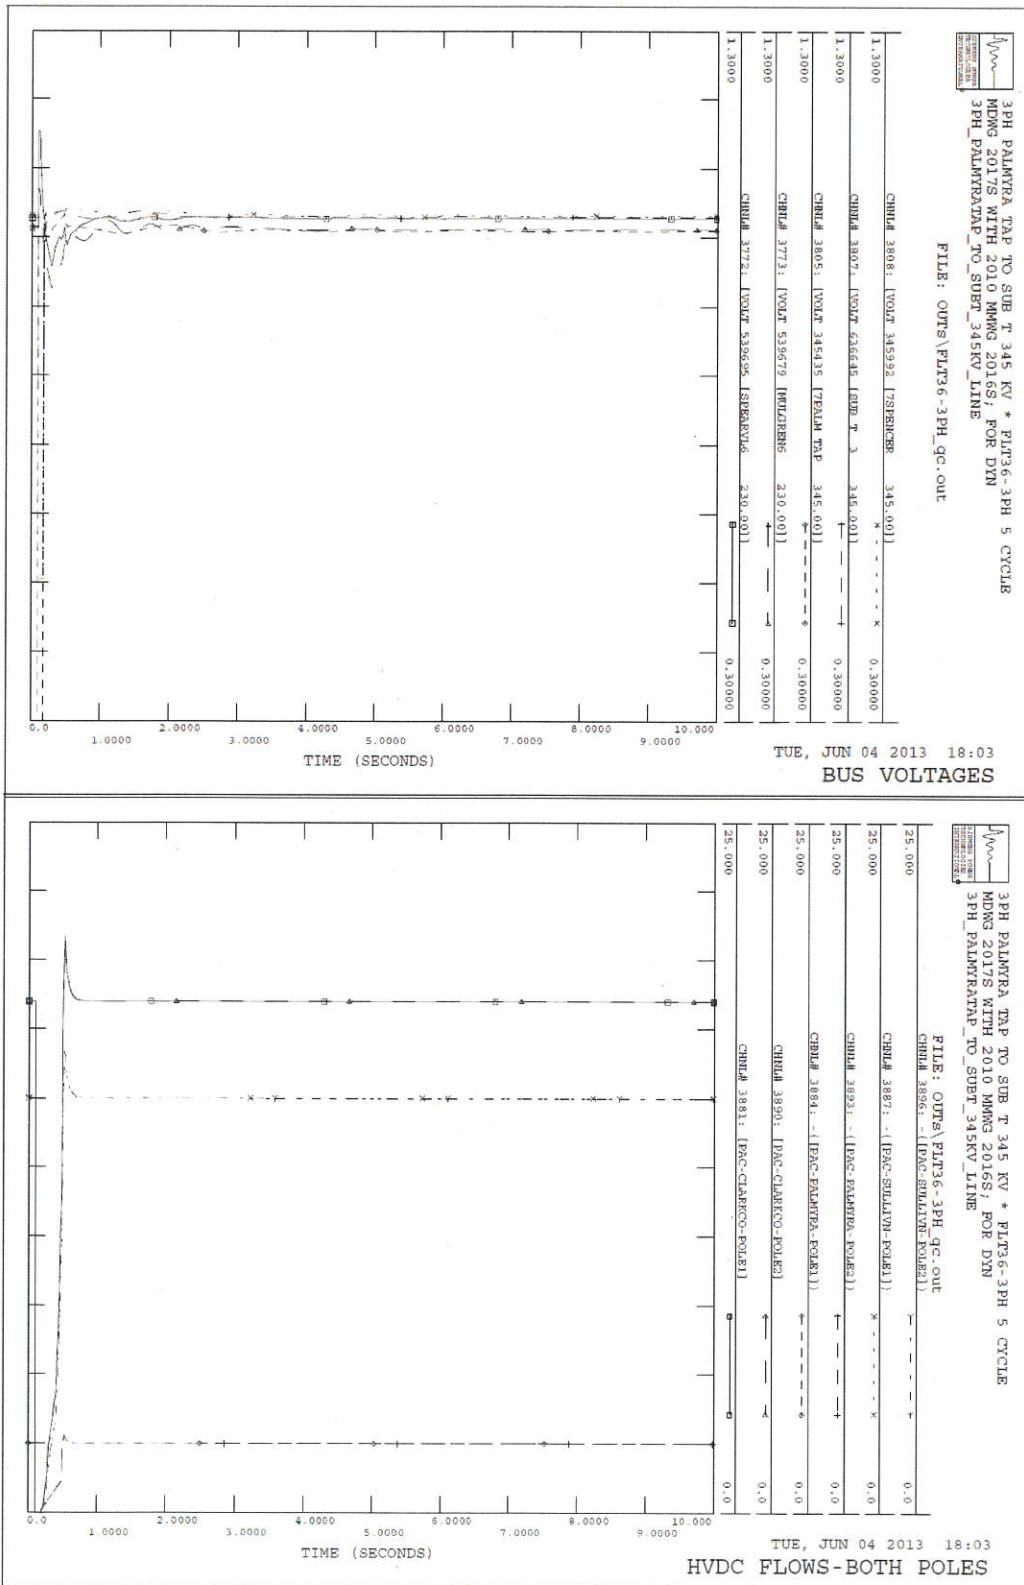
Figure 4-8. Bus Voltages and HVDC Powers for FLT36, 3ph fault on Palmyra Tap – Sub T 345

All faults near the AMMO Palmyra Tap station were stable. The GBX HVDC project only injects 500 MW at this 345 kV station that includes five (5) 345 kV transmission lines. Figure 4-8 shows example plots for a three-phase fault on the Palmyra Tap – Sub T 345 kV transmission line. Voltages are stable and the HVDC recovers to pre-contingency power flows.

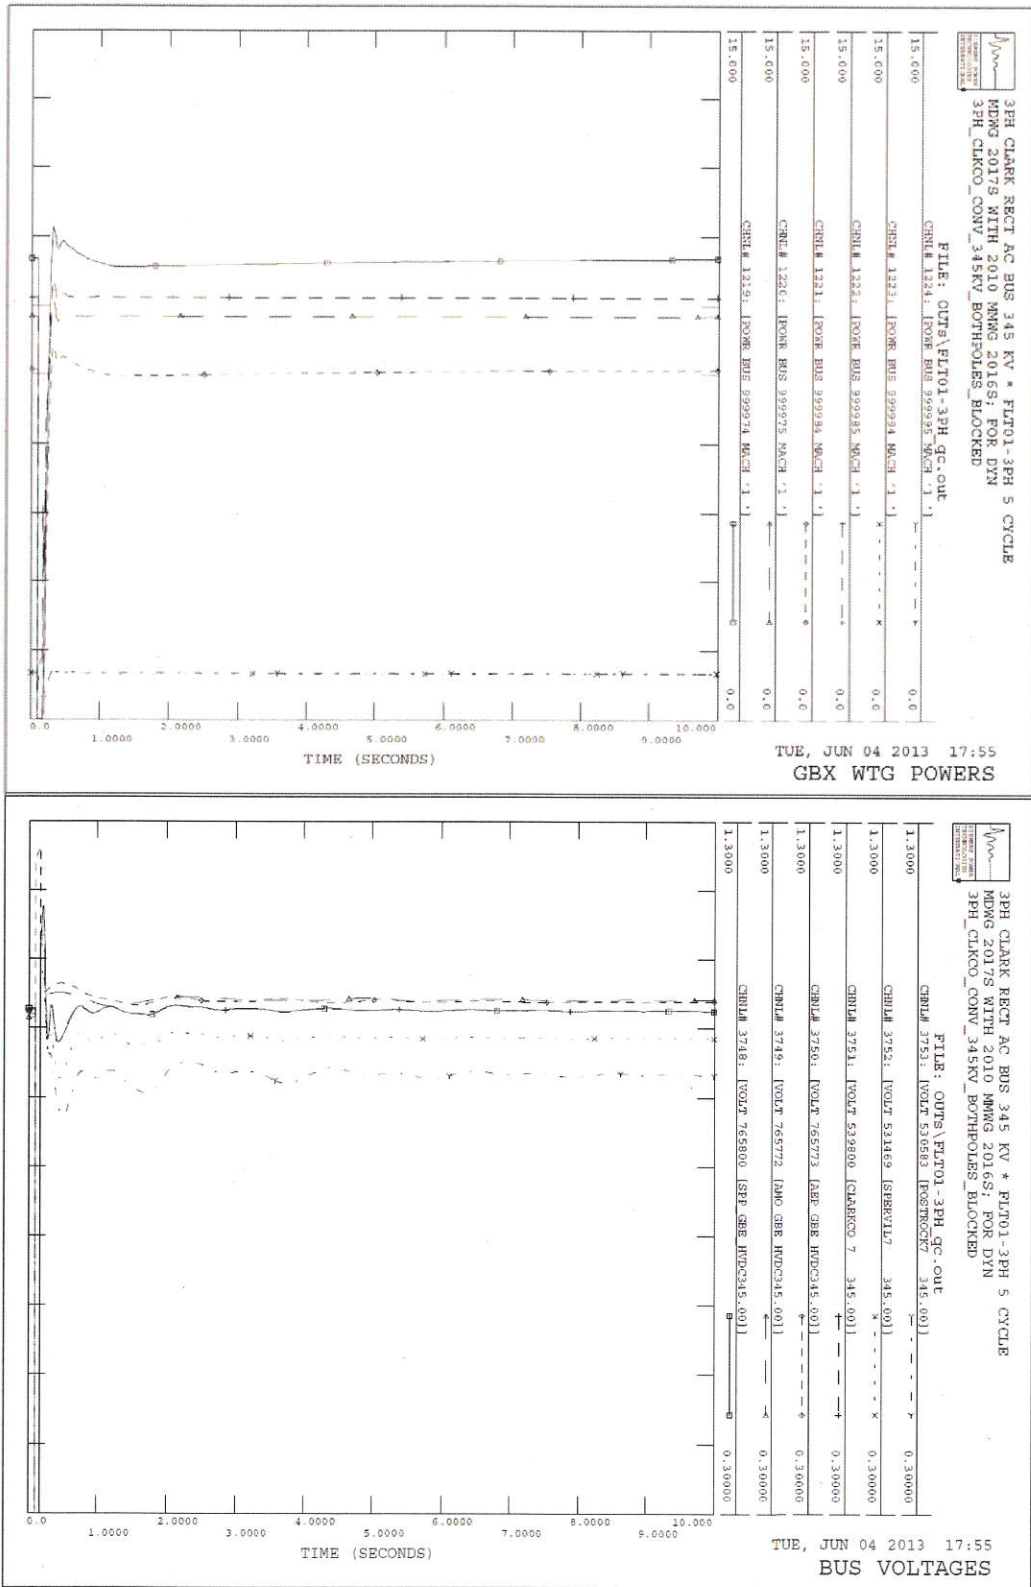
Figure 4-9. GBX Wind Power and Bus Voltages for FLT01, 3ph fault at GBX SPP converter AC bus, tripping both GBX HVDC poles

For stable faults, there were frequent excursions above 120% in the time from fault clearing until the HVDC poles were ramped back up to full power. During this time, the HVDC capacitors were on line but the converters were consuming little to no reactive power. Among the initial fault runs, the highest voltage found was 134.5% at the AEP HVDC converter bus following a fault on the Sullivan-Rockport 765 kV line. The highest voltage seen at an existing bus was 128.7% at Breed 345 for the same fault. During the generation-tripping solutions for some of the N-1-1 faults, up to 136% voltage was seen near the AEP HVDC converter and up to 125.5% near the SPP converter bus.

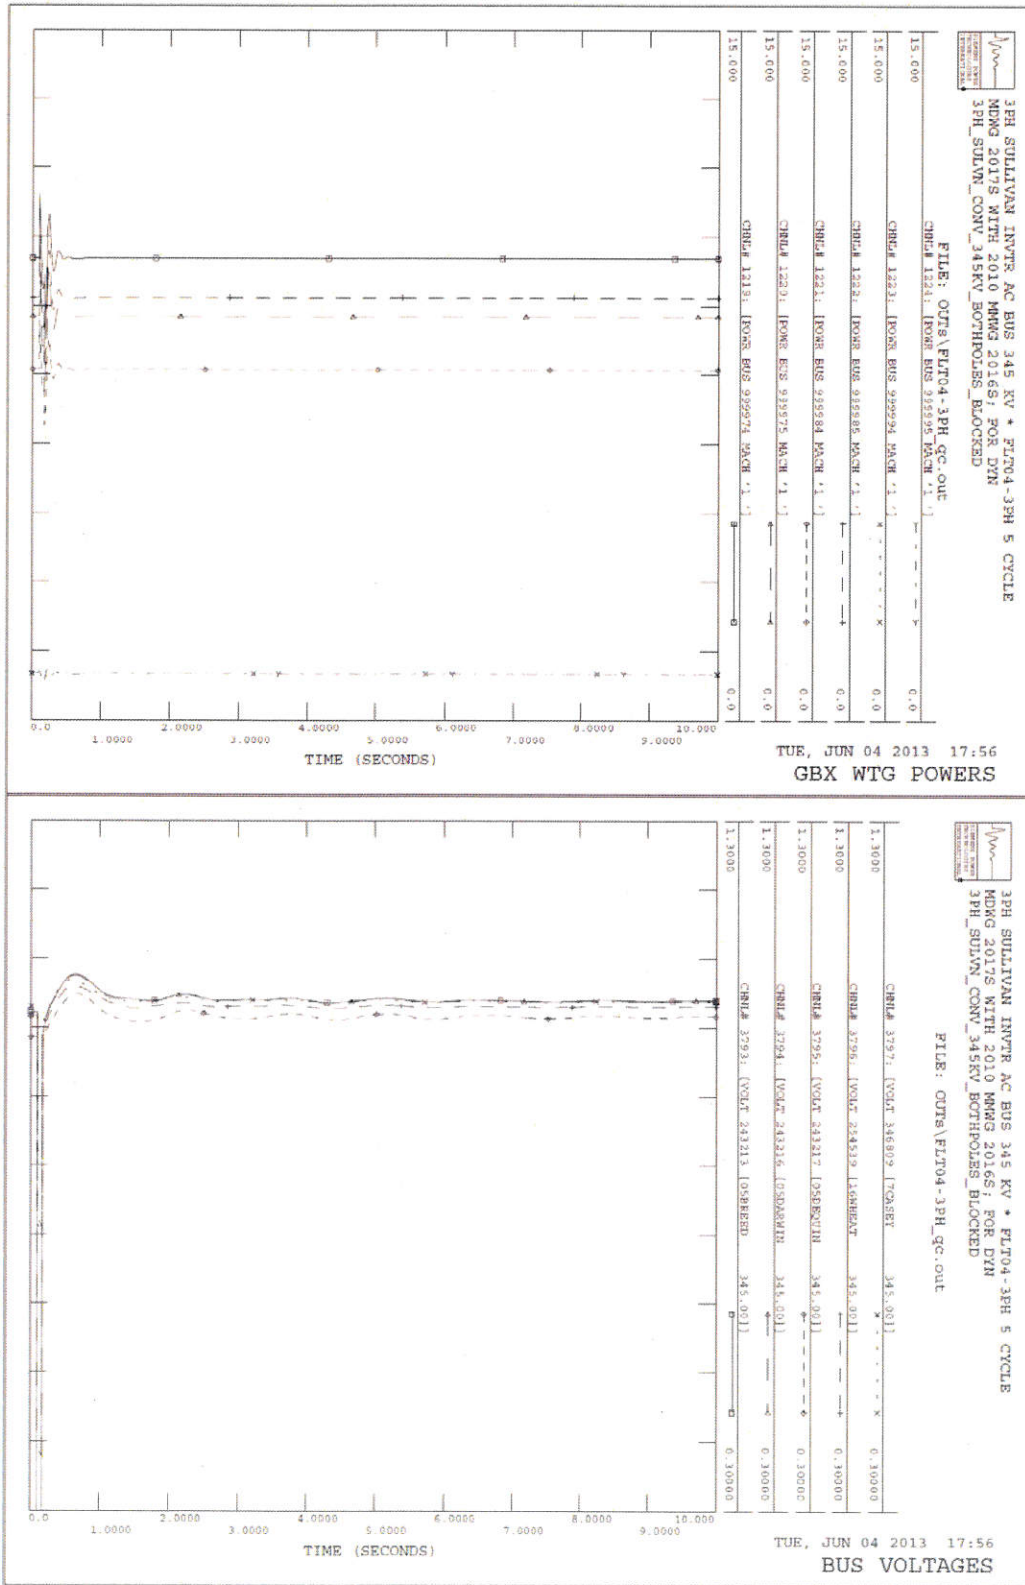
Figure 4-10. GBX Wind Power and Bus Voltages for FLT04, 3ph fault at GBX AEP converter AC bus, tripping both GBX HVDC poles

For faults at the AEP Sullivan and AMMO Palmyra converters resulting in loss of both HVDC poles, simulation results were also stable (Figure 4-10, Figure 4-11).

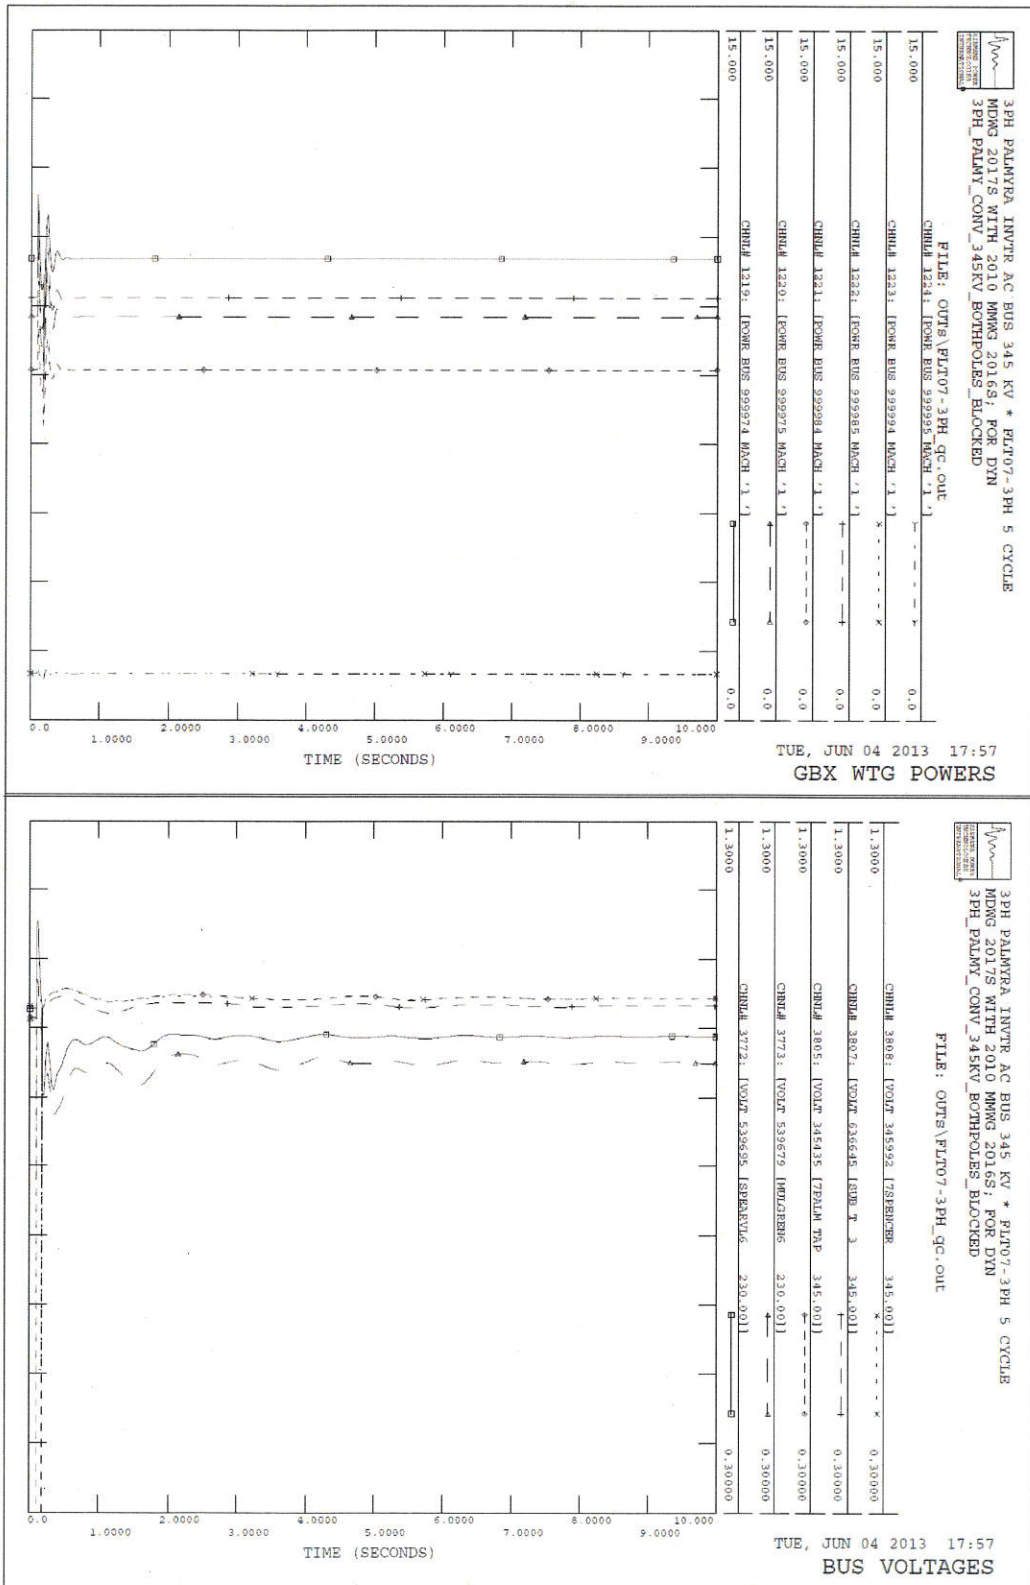
Figure 4-11. GBX Wind Power and Bus Voltages for FLT07, 3ph fault at GBX Palmyra converter AC bus, tripping both GBX HVDC poles
