## Ameren Missouri 20 CSR 4240-23.010 Electric Utility System Reliability Monitoring and Reporting Submission Requirements – Annual Reliability Report

This report details Union Electric (dba Ameren Missouri) Company's annual reliability metrics and worst performing circuits for calendar year 2020 as required by Missouri Public Service Commission Rule 4 CSR 240-23.010, Electric Utility System Reliability Monitoring and Reporting Submission Requirements (referred to in the remainder of this document as "the Rule"). This report is required by Sections (2), (7), and (8) of the Rule which state, *"The information required by section (1) shall be filed annually by the last business day of April of the calendar year following the calendar year for which the information was accumulated.... The information developed in accordance with section (6) shall be reported as part of the annual report required by section (2).... If on or after the time the annual report required by section (7) for calendar year 2011 is filed, a circuit has been on the worst performing circuit list for two (2) of the three (3) most recent consecutive calendar years the electrical corporation shall include detailed p

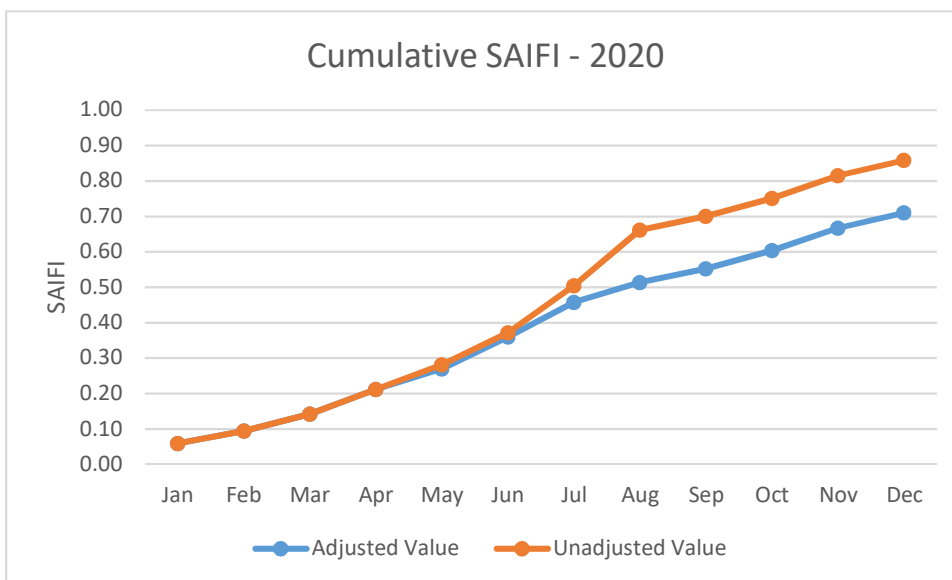
SAIFI:

MONTH	Adjusted Value	Unadjusted Value
Jan	0.06	0.06
Feb	0.09	0.09
Mar	0.14	0.14
Apr	0.21	0.21
May	0.27	0.28
Jun	0.36	0.37
Jul	0.46	0.50
Aug	0.51	0.66
Sep	0.55	0.70
Oct	0.60	0.75
Nov	0.67	0.82
Dec	0.71	0.86

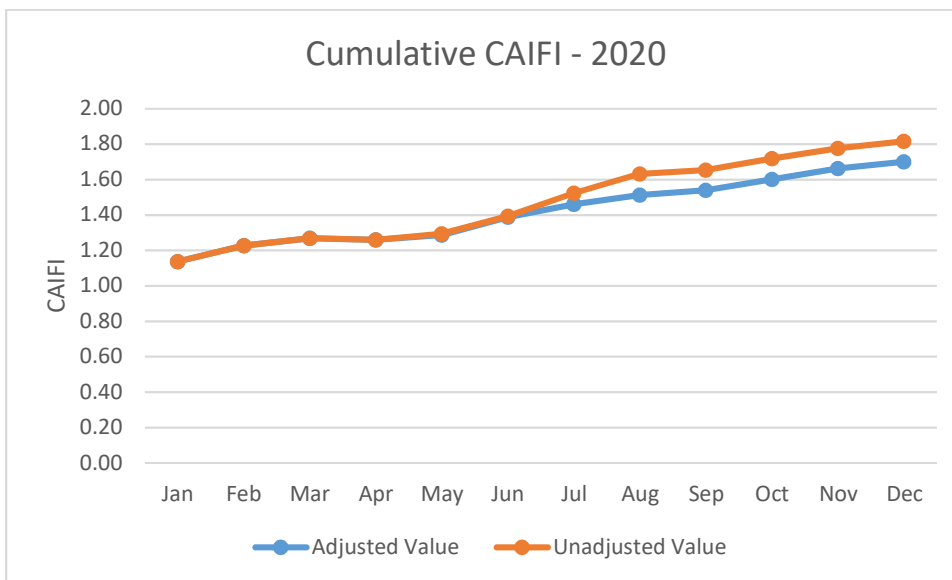
CAIFI:

MONTH	Adjusted Value	Unadjusted Value
Jan	1.14	1.14
Feb	1.23	1.23
Mar	1.27	1.27
Apr	1.26	1.26
May	1.29	1.29
Jun	1.39	1.39
Jul	1.46	1.52
Aug	1.51	1.63
Sep	1.54	1.65
Oct	1.60	1.72
Nov	1.66	1.78
Dec	1.70	1.82

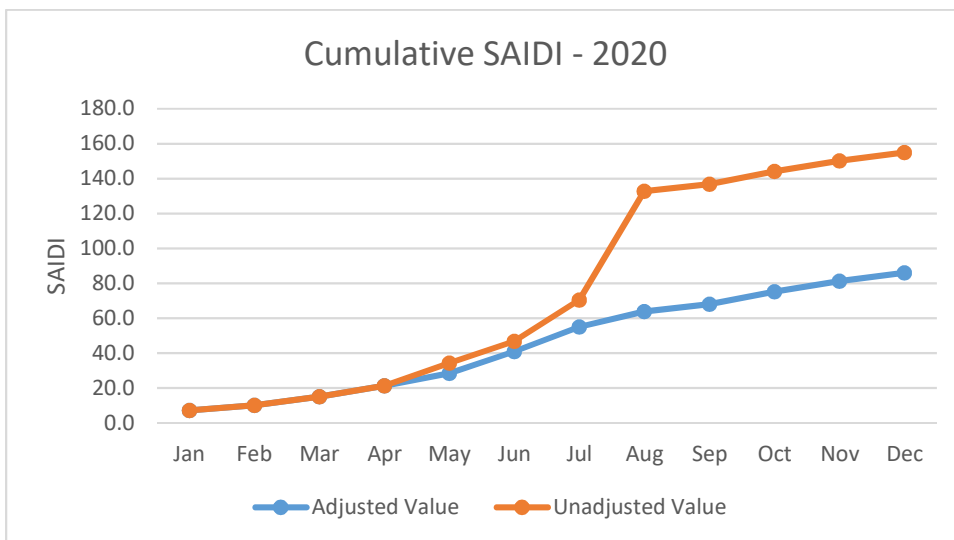
SAIDI:

MONTH	Adjusted Value	Unadjusted Value
Jan	7.2	7.2
Feb	10.2	10.2
Mar	15.1	15.1
Apr	21.4	21.4
May	28.5	34.3
Jun	41.0	46.8
Jul	55.1	70.4
Aug	63.9	132.7
Sep	68.0	136.9
Oct	75.2	144.1
Nov	81.3	150.2
Dec	86.1	155.0

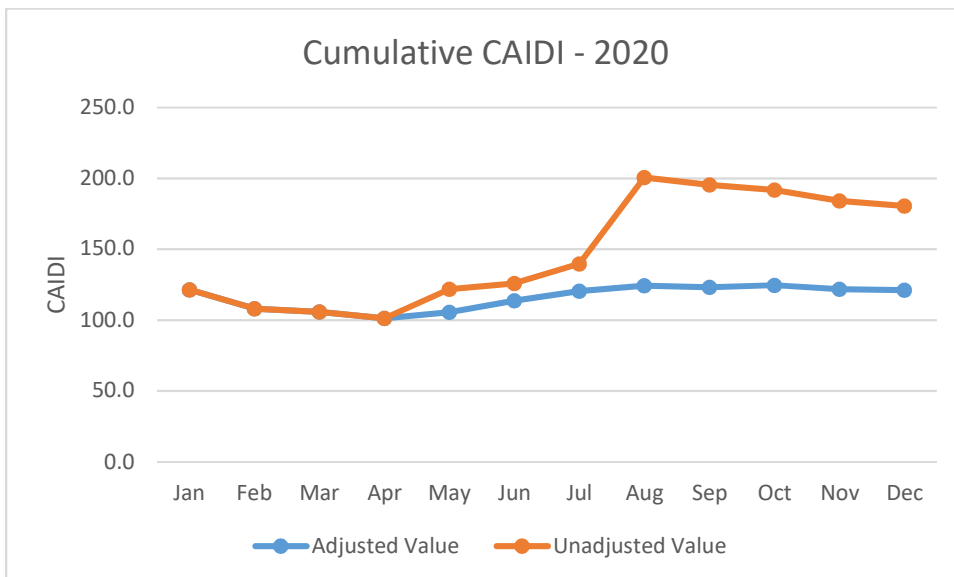
CAIDI:

MONTH	Adjusted Value	Unadjusted Value
Jan	121.4	121.4
Feb	108.0	108.0
Mar	105.7	105.7
Apr	101.2	101.2
May	105.5	121.9
Jun	113.8	126.0
Jul	120.4	139.6
Aug	124.4	200.6
Sep	123.1	195.4
Oct	124.6	191.7
Nov	121.8	184.2
Dec	121.2	180.6
