Ameren Missouri 4 CSR 240-23.010 Electric Utility System Reliability Monitoring and Reporting Submission Requirements – Annual Reliability Report

This report details Union Electric (dba Ameren Missouri) Company's annual reliability metrics and worst performing circuits for calendar year 2013 as required by Missouri Public Service Commission Rule 4 CSR 240-23.010, Electric Utility System Reliability Monitoring and Reporting Submission Requirements (referred to in the remainder of this document as "the Rule"). This report is required by Sections (2), (7), and (8) of the Rule which state, *"The information required by section (1) shall be filed annually by the last business day of April of the calendar year following the calendar year for which the information was accumulated.... The information developed in accordance with section (6) shall be reported as part of the annual report required by section (2).... If on or after the time the annual report required by section (7) for calendar year 2011 is filled, a circuit has been on the worst performing circuit list for two (2) of the three (3) most recent consecutive calendar years the electrical corporation shall include detailed plans

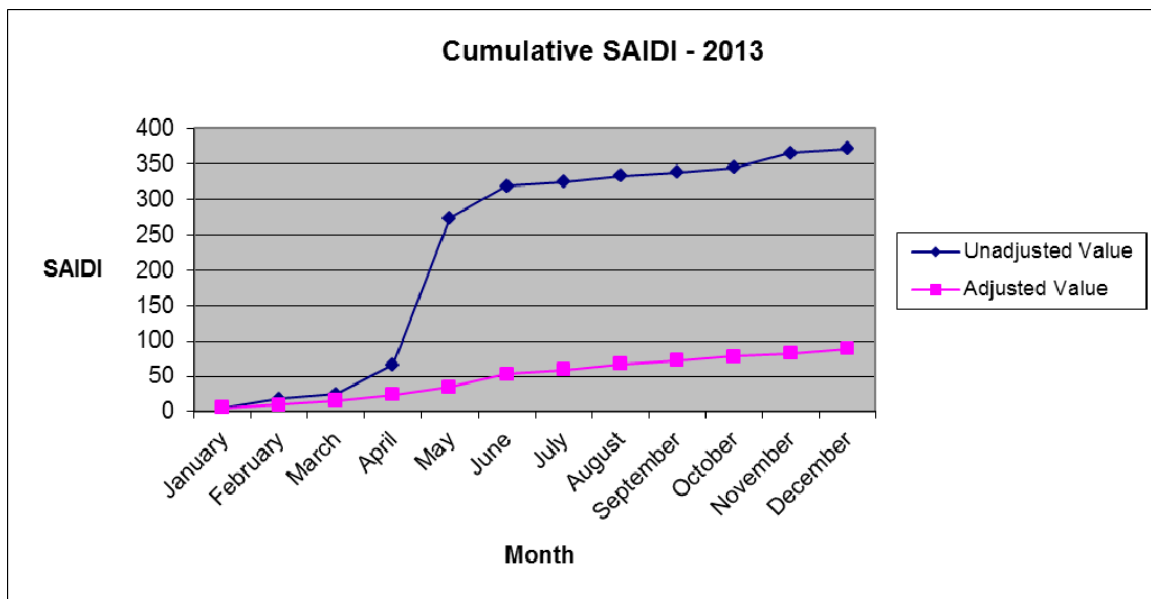
SAIDI:

Month	Unadjusted Value	Adjusted Value
January	6	6
February	18	10
March	24	16
April	66	24
May	273	35
June	318	53
July	324	59
August	333	67
September	338	72
October	344	78
November	365	82
December	371	88
