Ameren Missouri 4 CSR 240-23.010 Electric Utility System Reliability Monitoring and Reporting Submission Requirements – Annual Reliability Report

This report details Union Electric (dba Ameren Missouri) Company's annual reliability metrics and worst performing circuits for calendar year 2019 as required by Missouri Public Service Commission Rule 4 CSR 240-23.010, Electric Utility System Reliability Monitoring and Reporting Submission Requirements (referred to in the remainder of this document as "the Rule"). This report is required by Sections (2), (7), and (8) of the Rule which state, *"The information required by section (1) shall be filed annually by the last business day of April of the calendar year following the calendar year for which the information was accumulated.... The information developed in accordance with section (6) shall be reported as part of the annual report required by section (2).... If on or after the time the annual report required by section (7) for calendar year 2011 is filed, a circuit has been on the worst performing circuit list for two (2) of the three (3) most recent consecutive calendar years the electrical corporation shall include detailed plans

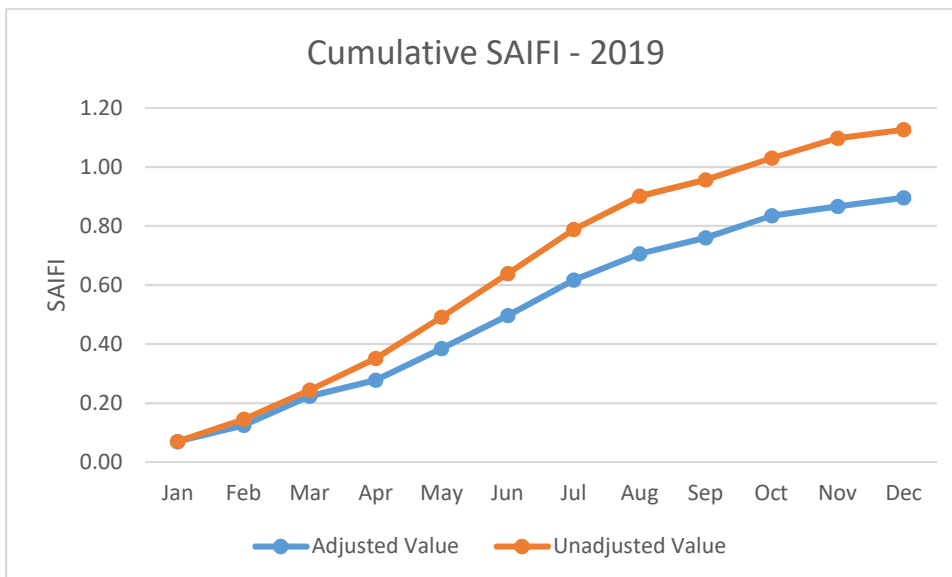
SAIFI:

MONTH	Adjusted Value	Unadjusted Value
Jan	0.07	0.07
Feb	0.13	0.15
Mar	0.22	0.24
Apr	0.28	0.35
May	0.39	0.49
Jun	0.50	0.64
Jul	0.62	0.79
Aug	0.71	0.90
Sep	0.76	0.96
Oct	0.84	1.03
Nov	0.87	1.10
Dec	0.90	1.13

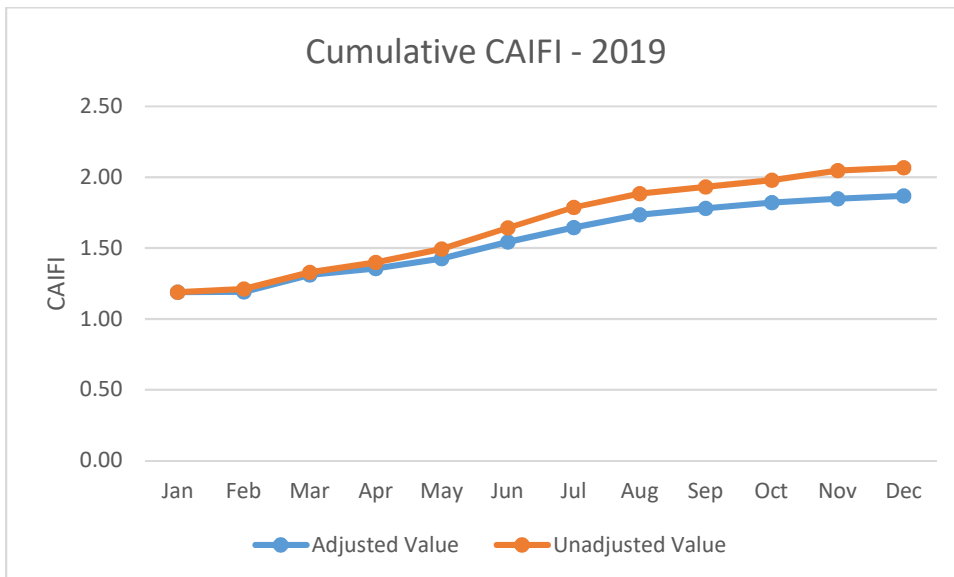
CAIFI:

MONTH	Adjusted Value	Unadjusted Value
Jan	1.19	1.19
Feb	1.19	1.21
Mar	1.31	1.33
Apr	1.36	1.40
May	1.43	1.49
Jun	1.54	1.64
Jul	1.65	1.79
Aug	1.74	1.88
Sep	1.78	1.93
Oct	1.82	1.98
Nov	1.85	2.05
Dec	1.87	2.07

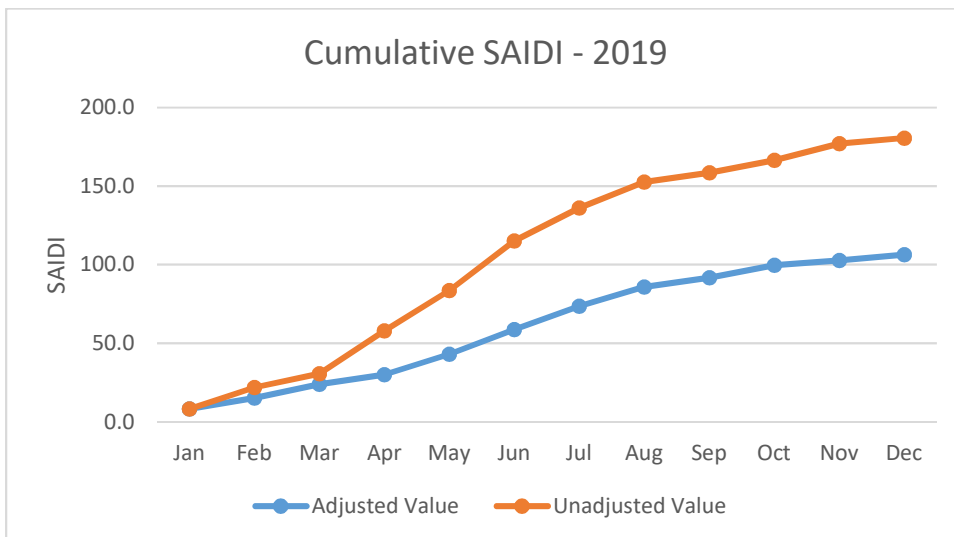
SAIDI:

MONTH	Adjusted Value	Unadjusted Value
Jan	8.2	8.2
Feb	15.2	21.9
Mar	24.0	30.7
Apr	30.0	57.9
May	43.0	83.6
Jun	58.8	115.1
Jul	73.7	136.1
Aug	85.9	152.6
Sep	91.8	158.6
Oct	99.7	166.5
Nov	102.7	177.0
Dec	106.4	180.6

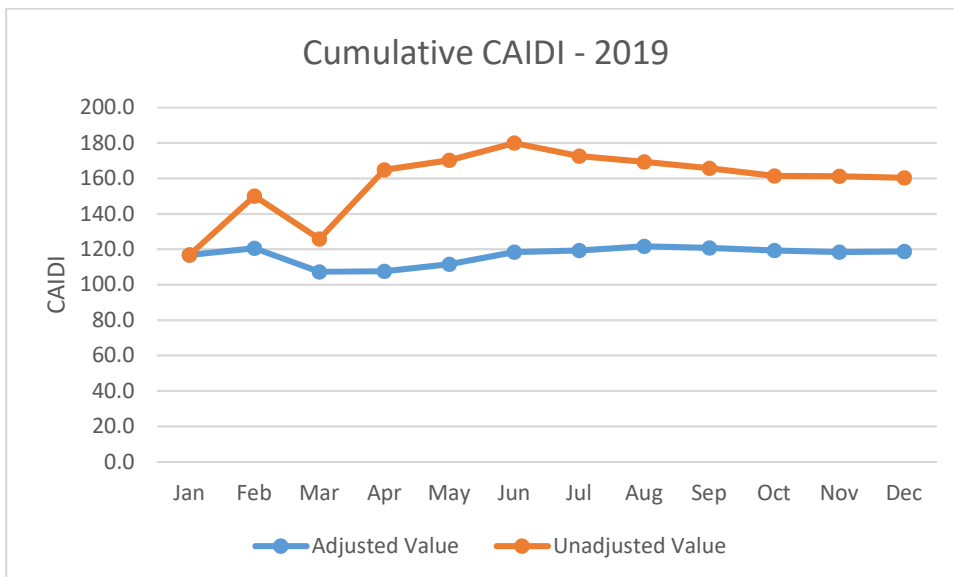
CAIDI:

MONTH	Adjusted Value	Unadjusted Value
Jan	116.8	116.8
Feb	120.7	150.0
Mar	107.3	125.9
Apr	107.6	164.9
May	111.6	170.2
Jun	118.4	180.0
Jul	119.3	172.6
Aug	121.6	169.3
Sep	120.7	165.8
Oct	119.4	161.5
Nov	118.5	161.3
Dec	118.7	160.4
