# Grain Belt Express HVDC System Impact Study

Final Report for  
Southwest Power Pool

Prepared by:  
Excel Engineering, Inc.

September 6, 2013

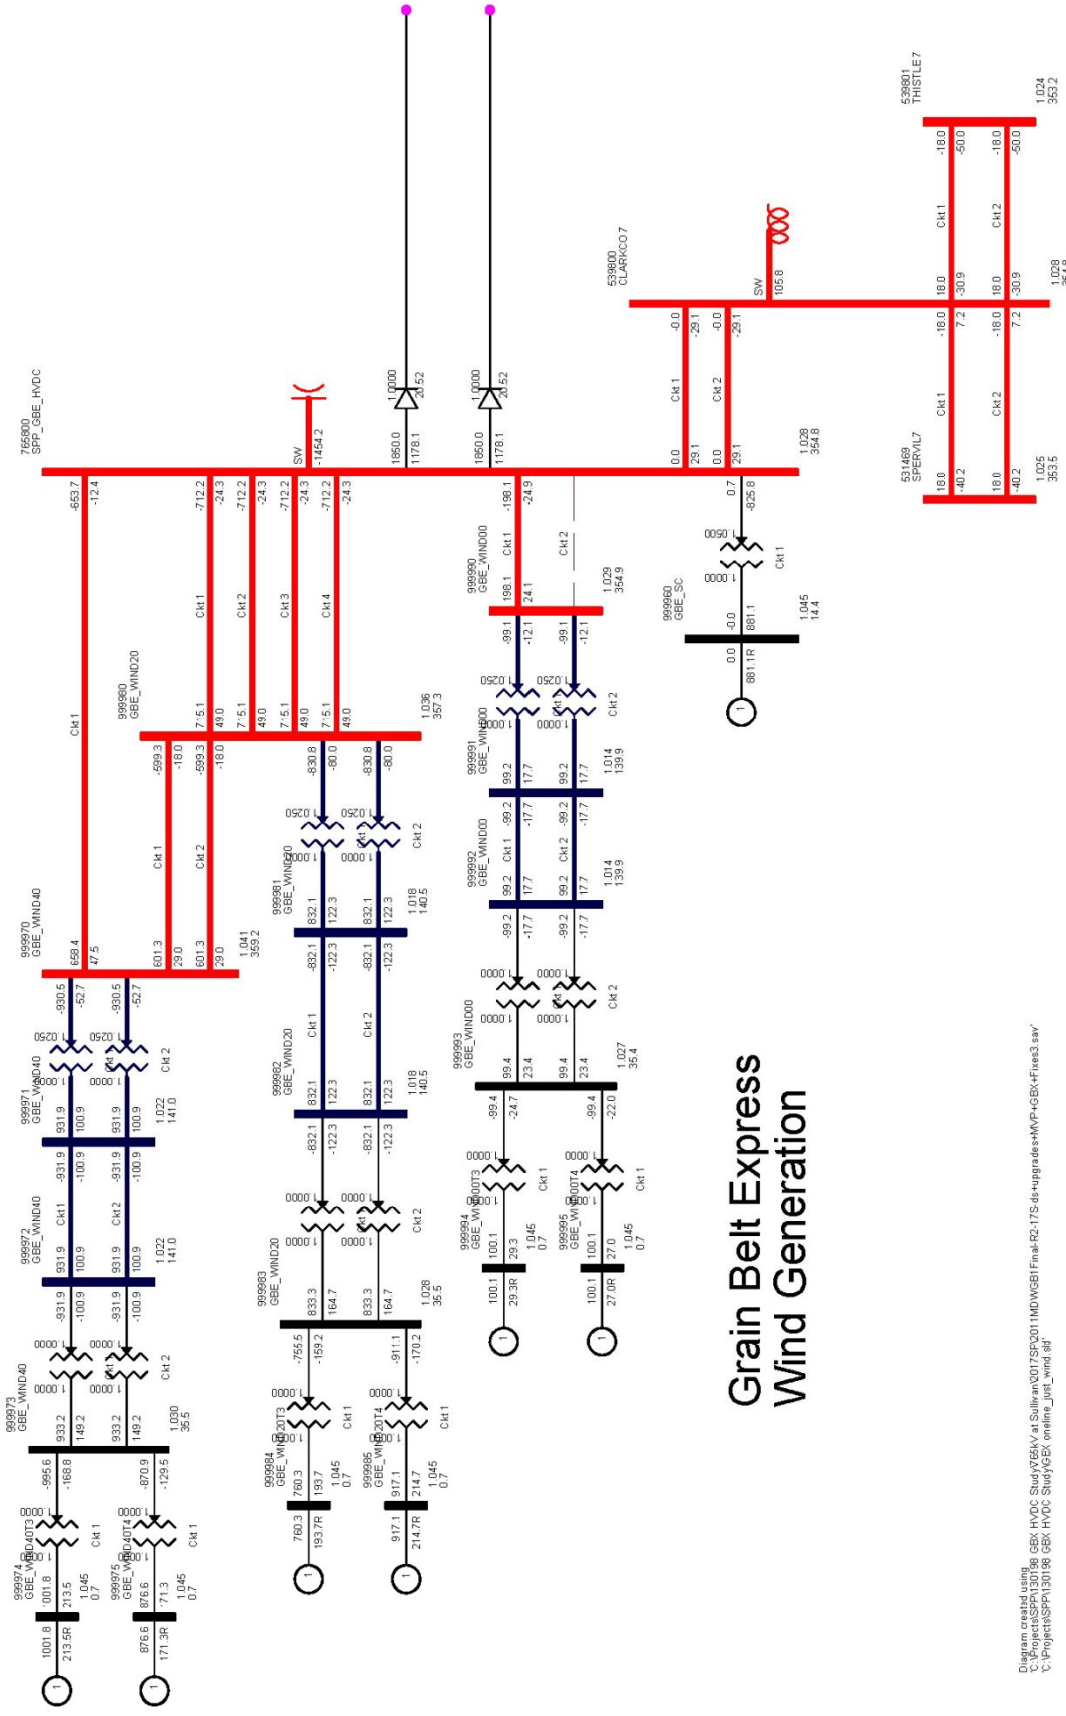
Figure 3-2. Power Flow One-line of GBX Wind Generation – 2017 Summer Peak

Figure 3-1 and Figure 3-2 show power flow one-lines for the 2017 Summer Peak case with the 345 kV option at Sullivan and the GBX wind generation model, respectively. One-line diagrams of GBX and the full SPP 345 kV system for all three seasons are provided in Appendix E.

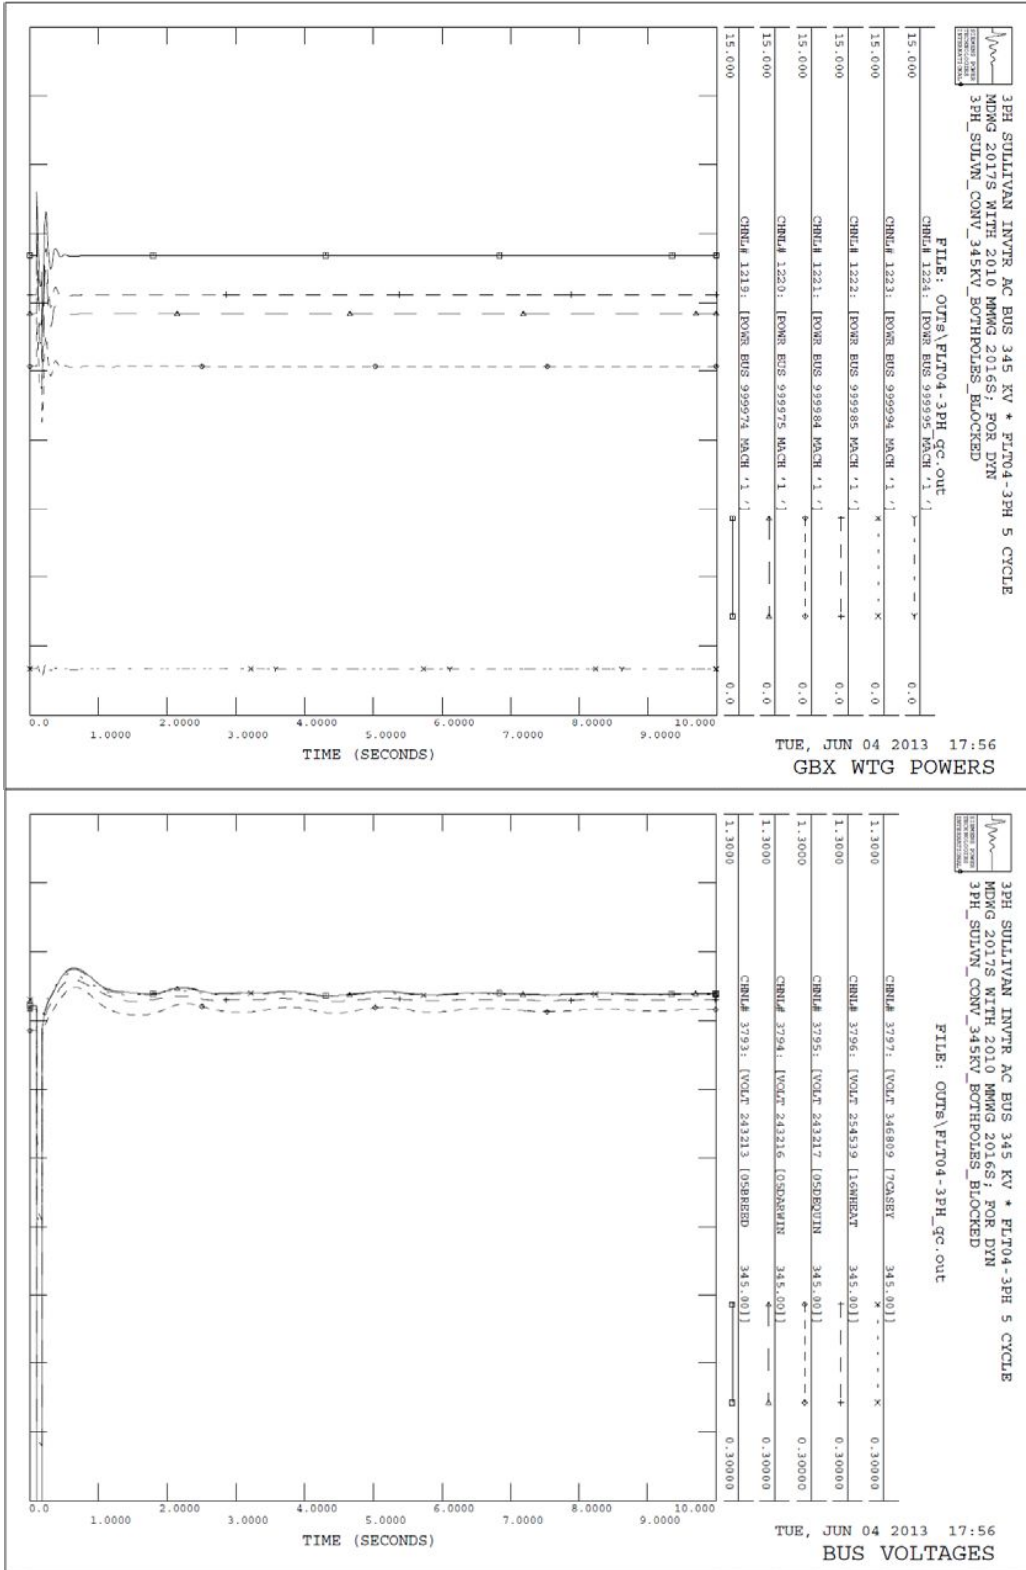
Figure 4-10. GBX Wind Power and Bus Voltages for FLT04, 3ph fault at GBX AEP converter AC bus, tripping both GBX HVDC poles

For faults at the AEP Sullivan and AMMO Palmyra converters resulting in loss of both HVDC poles, simulation results were also stable (Figure 4-10, Figure 4-11).
