## Ameren Missouri 4 CSR 240-23.010 Electric Utility System Reliability Monitoring and Reporting Submission Requirements – Annual Reliability Report

This report details Union Electric (dba Ameren Missouri) Company's annual reliability metrics and worst performing circuits for calendar year 2015 as required by Missouri Public Service Commission Rule 4 CSR 240-23.010, Electric Utility System Reliability Monitoring and Reporting Submission Requirements (referred to in the remainder of this document as "the Rule"). This report is required by Sections (2), (7), and (8) of the Rule which state, *"The information required by section (1) shall be filed annually by the last business day of April of the calendar year following the calendar year for which the information was accumulated.... The information developed in accordance with section (6) shall be reported as part of the annual report required by section (2).... If on or after the time the annual report required by section (7) for calendar year 2011 is filled, a circuit has been on the worst performing circuit list for two (2) of the three (3) most recent consecutive calendar years the electrical corporation shall include detailed pl

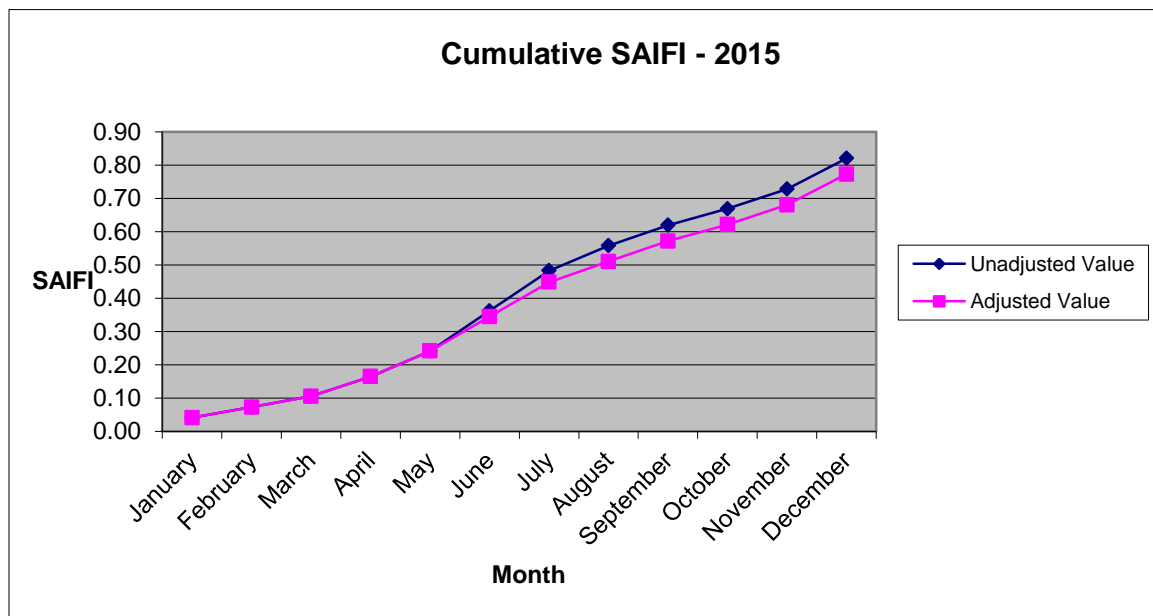
SAIFI:

Month	Unadjusted Value	Adjusted Value
January	0.04	0.04
February	0.07	0.07
March	0.11	0.11
April	0.16	0.16
May	0.24	0.24
June	0.36	0.35
July	0.48	0.45
August	0.56	0.51
September	0.62	0.57
October	0.67	0.62
November	0.73	0.68
December	0.82	0.77

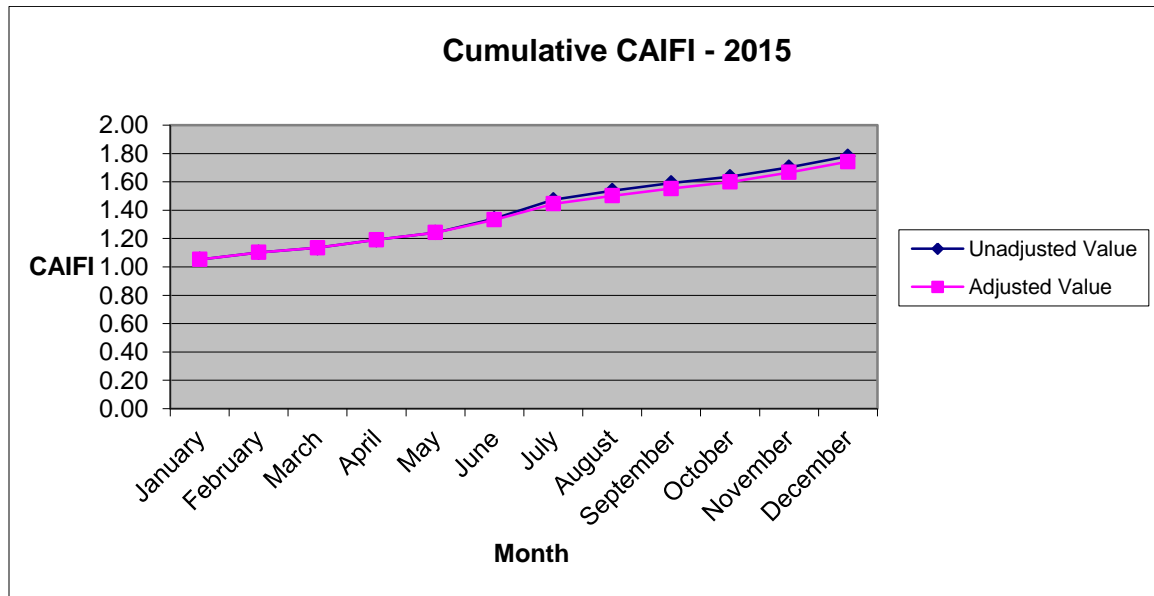
CAIFI:

Month	Unadjusted Value	Adjusted Value
January	1.05	1.05
February	1.10	1.10
March	1.14	1.14
April	1.19	1.19
May	1.24	1.24
June	1.34	1.33
July	1.47	1.45
August	1.54	1.50
September	1.59	1.55
October	1.64	1.60
November	1.70	1.67
December	1.78	1.74

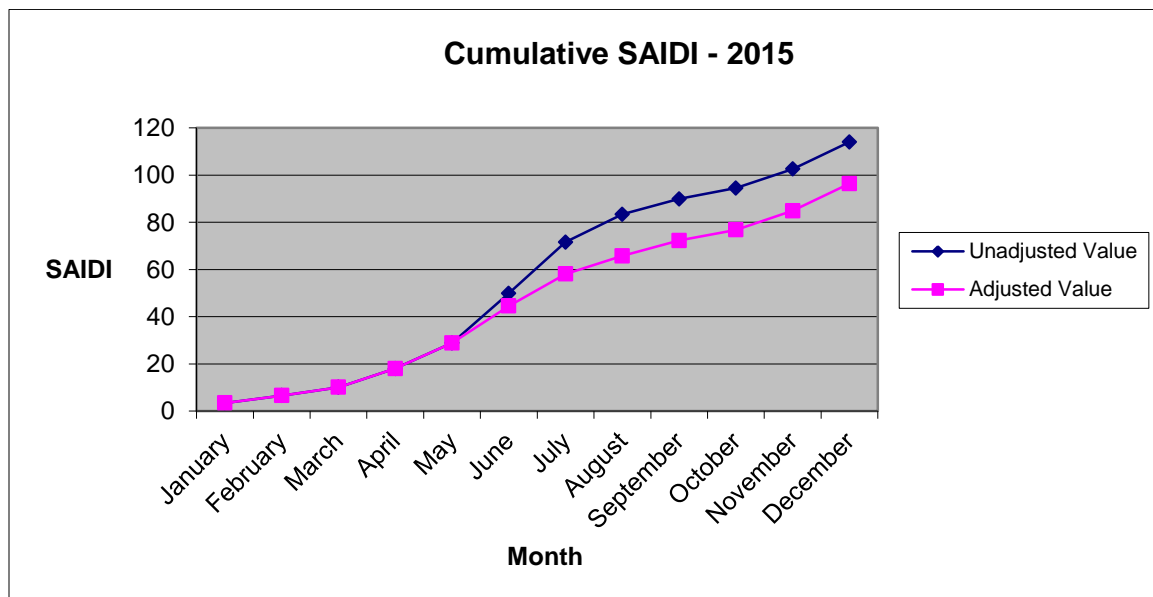
SAIDI:

Month	Unadjusted Value	Adjusted Value
January	3	3
February	7	7
March	10	10
April	18	18
May	29	29
June	50	45
July	72	58
August	83	66
September	90	72
October	95	77
November	103	85
December	114	96

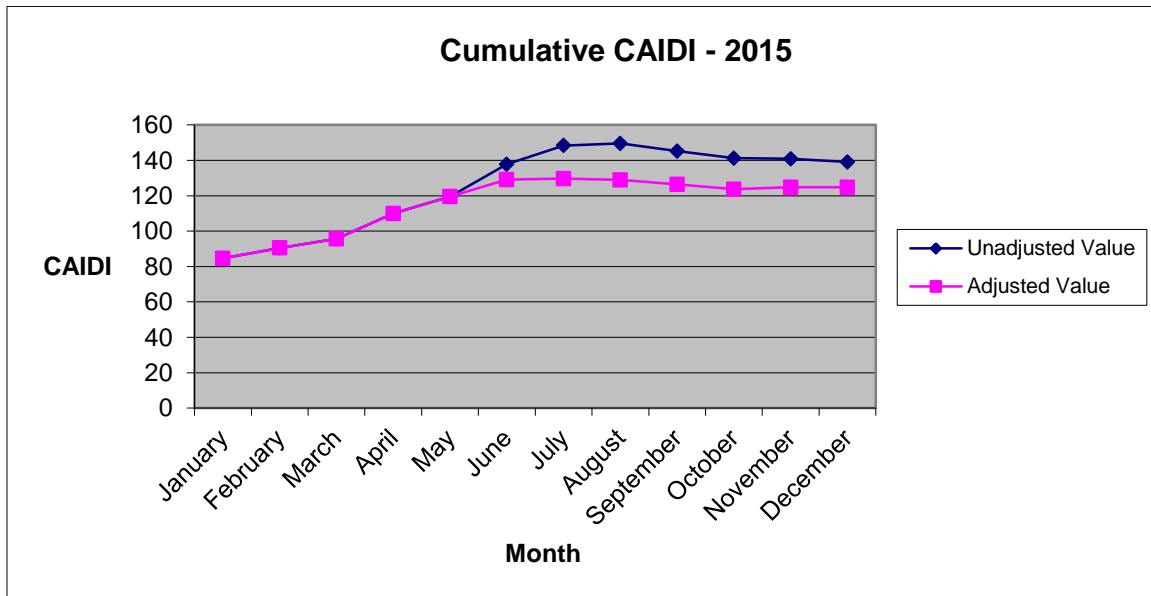
CAIDI:

Month	Unadjusted Value	Adjusted Value
January	85	85
February	91	91
March	96	96
April	110	110
May	120	120
June	138	129
July	148	130
August	150	129
September	145	126
October	141	124
November	141	125
December	139	125
