***Merchant Transmission Interconnection
PJM Impact Study Report***

***PJM Merchant Transmission Request
Queue Position X3-028***

Breed 345 kV

System Impact Study
Breed 345 kV Merchant Transmission Project

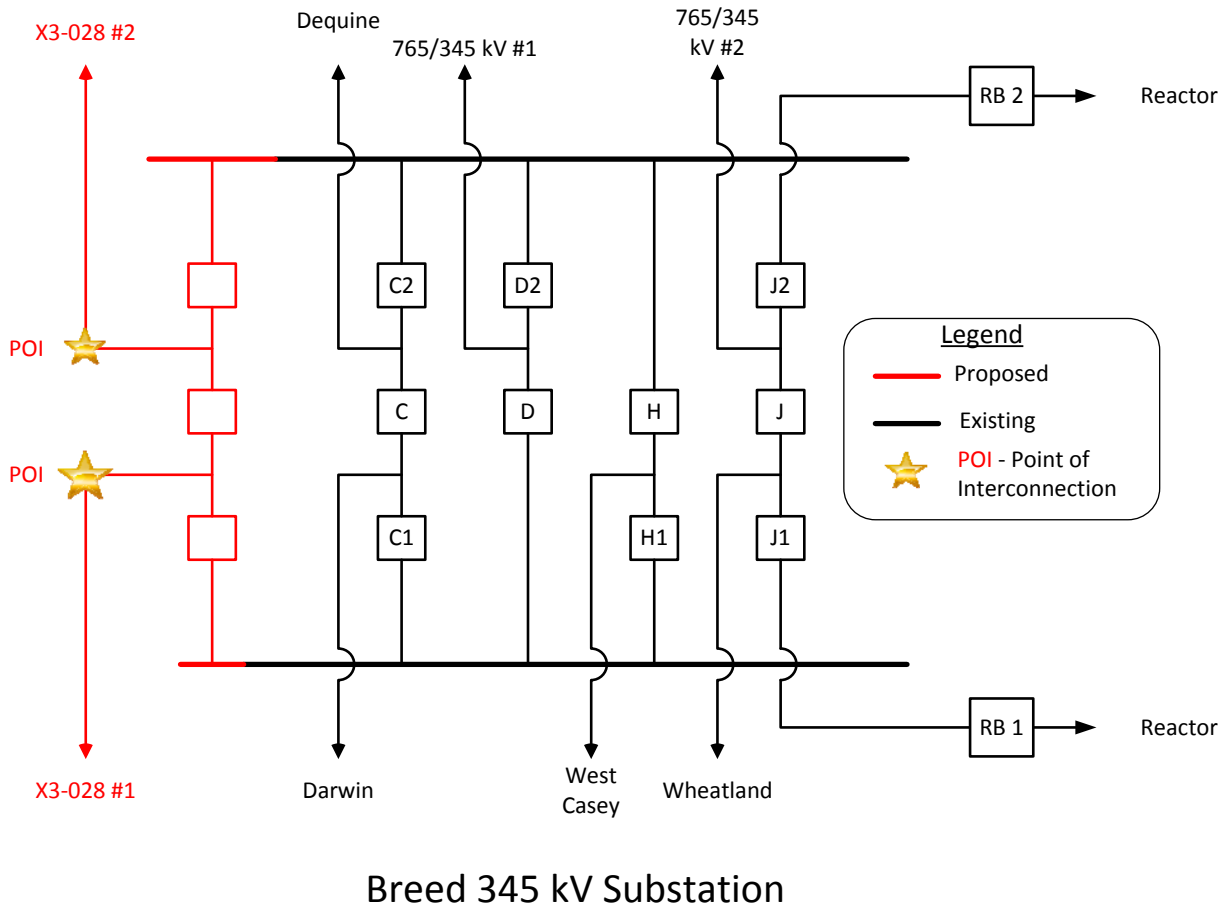
A new breaker string consisting of three (3) new 345 kV breakers and dual 345 kV revenue metering will be required to attach Queue Project #X3-028 to the Breed 345 kV Substation see Figure 1 for details, and Table 1 for estimated costs. Figure 2 shows the physical location of Breed 345 kV Substation.

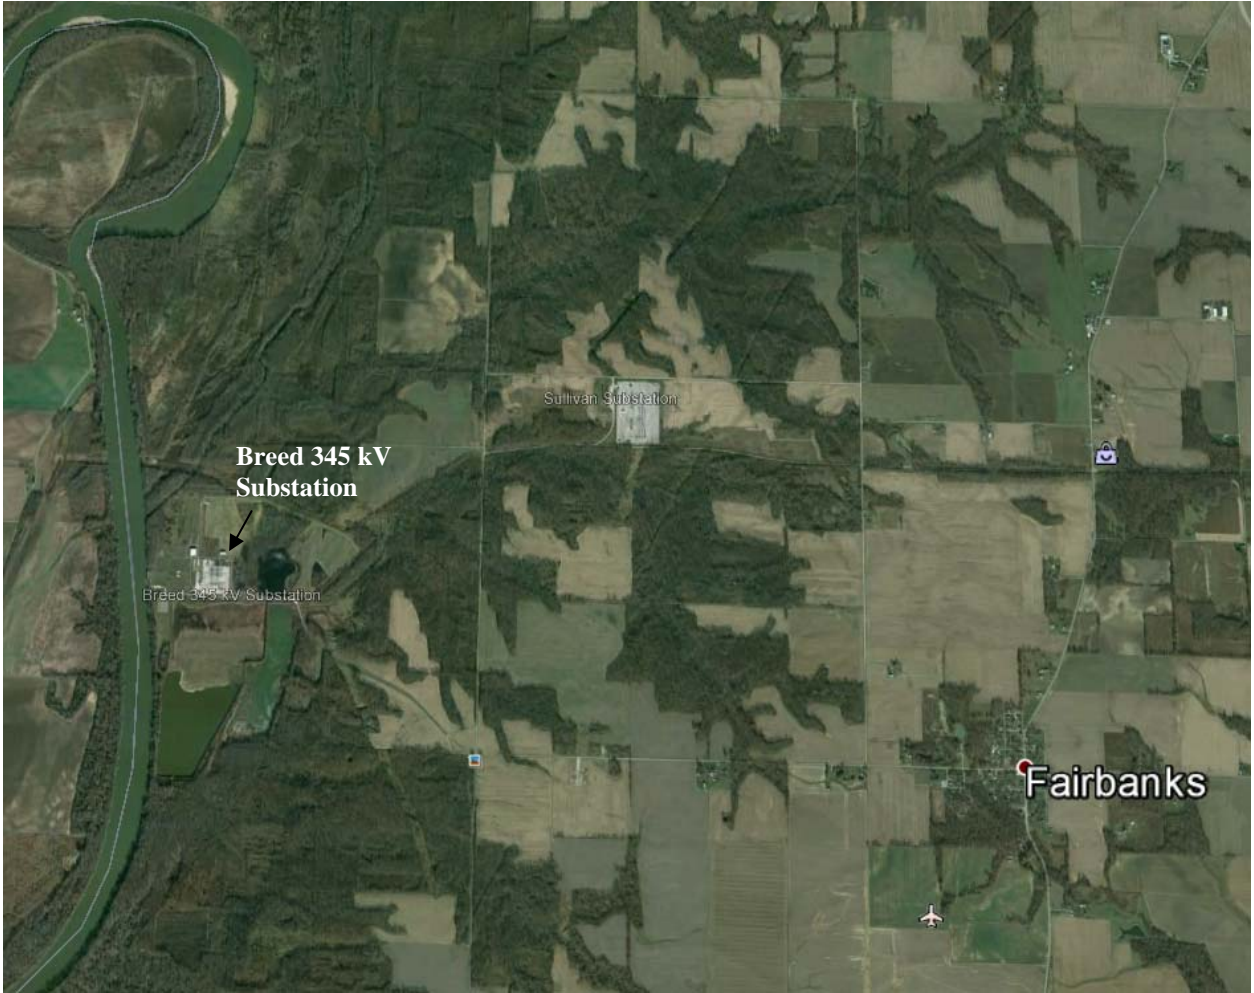
Figure 2 –Location of Breed 345 kV Substation near Fairbanks Indiana
