Ameren Missouri 4 CSR 240-23.010 Electric Utility System Reliability Monitoring and Reporting Submission Requirements – Annual Reliability Report

This report details Union Electric (dba Ameren Missouri) Company's annual reliability metrics and worst performing circuits for calendar year 2018 as required by Missouri Public Service Commission Rule 4 CSR 240-23.010, Electric Utility System Reliability Monitoring and Reporting Submission Requirements (referred to in the remainder of this document as "the Rule"). This report is required by Sections (2), (7), and (8) of the Rule which state, *"The information required by section (1) shall be filed annually by the last business day of April of the calendar year following the calendar year for which the information was accumulated.... The information developed in accordance with section (6) shall be reported as part of the annual report required by section (2).... If on or after the time the annual report required by section (7) for calendar year 2011 is filled, a circuit has been on the worst performing circuit list for two (2) of the three (3) most recent consecutive calendar years the electrical corporation shall include detailed plans

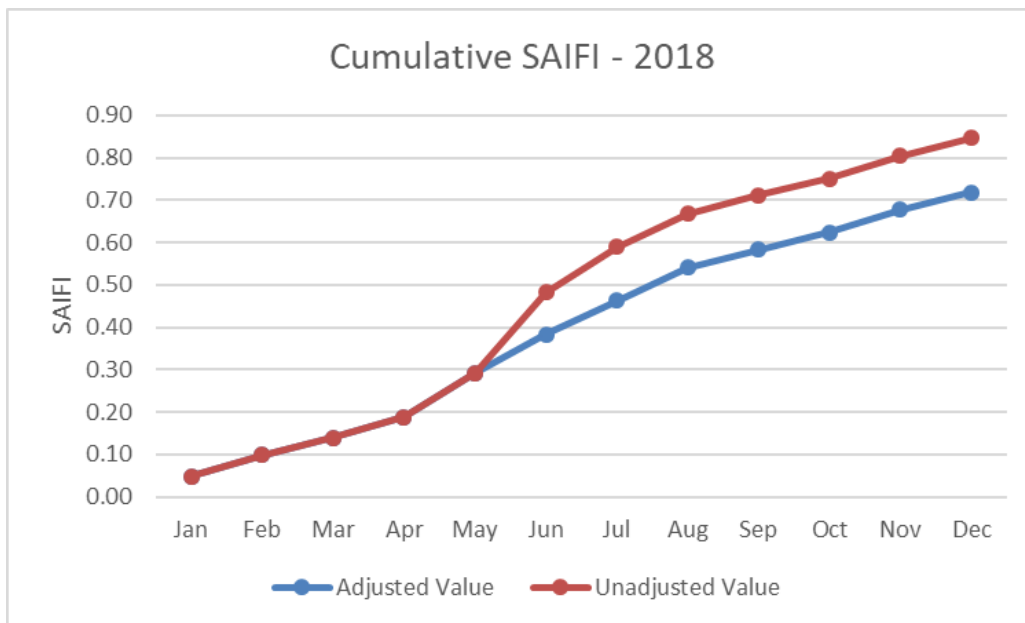
SAIFI:

MONTH	Adjusted Value	Unadjusted Value
Jan	0.05	0.05
Feb	0.10	0.10
Mar	0.14	0.14
Apr	0.19	0.19
May	0.29	0.29
Jun	0.38	0.48
Jul	0.46	0.59
Aug	0.54	0.67
Sep	0.58	0.71
Oct	0.62	0.75
Nov	0.68	0.80
Dec	0.72	0.85

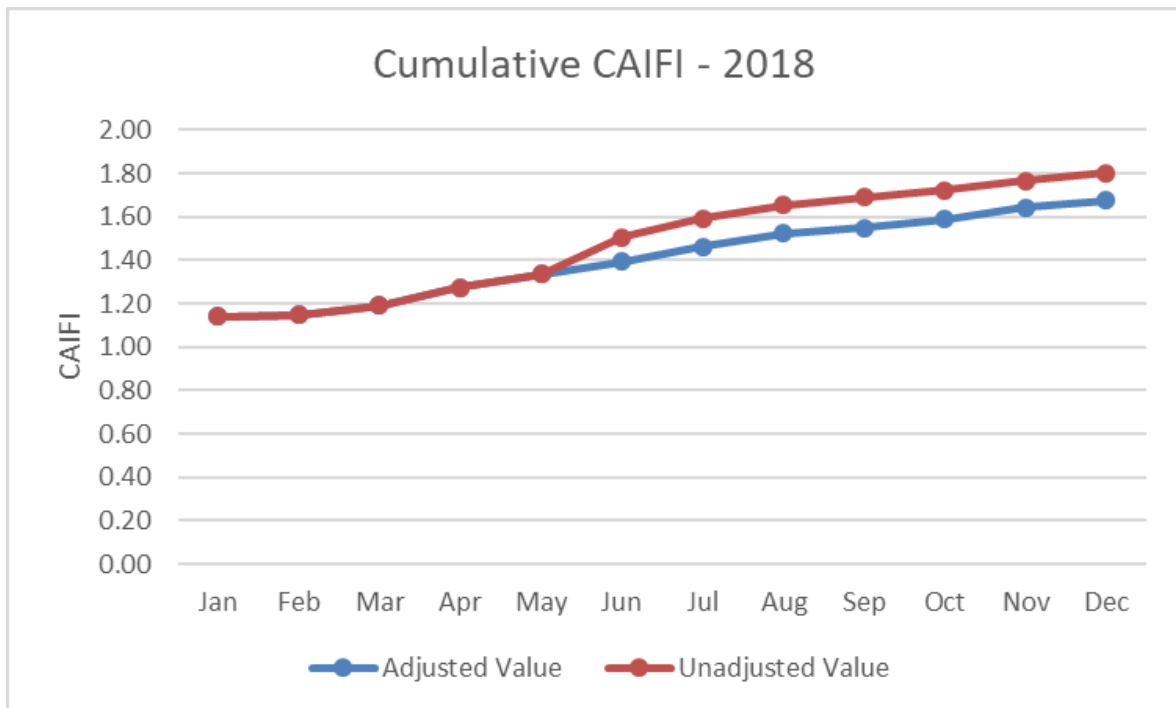
CAIFI:

MONTH	Adjusted Value	Unadjusted Value
Jan	1.14	1.14
Feb	1.15	1.15
Mar	1.19	1.19
Apr	1.27	1.27
May	1.34	1.34
Jun	1.39	1.50
Jul	1.46	1.59
Aug	1.52	1.65
Sep	1.55	1.69
Oct	1.59	1.72
Nov	1.64	1.77
Dec	1.68	1.80

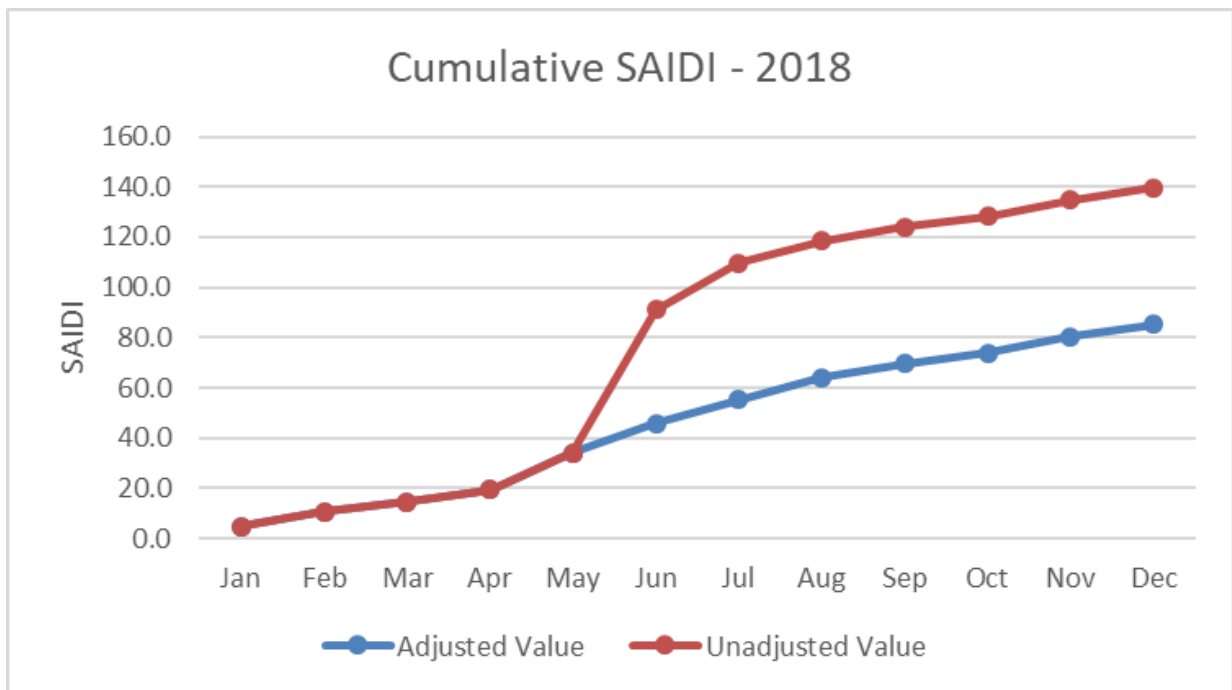
SAIDI:

MONTH	Adjusted Value	Unadjusted Value
Jan	4.8	4.8
Feb	10.5	10.5
Mar	14.6	14.6
Apr	19.3	19.3
May	34.1	34.1
Jun	46.0	91.0
Jul	55.3	109.8
Aug	64.0	118.5
Sep	69.5	124.0
Oct	73.8	128.3
Nov	80.3	134.8
Dec	85.3	139.8

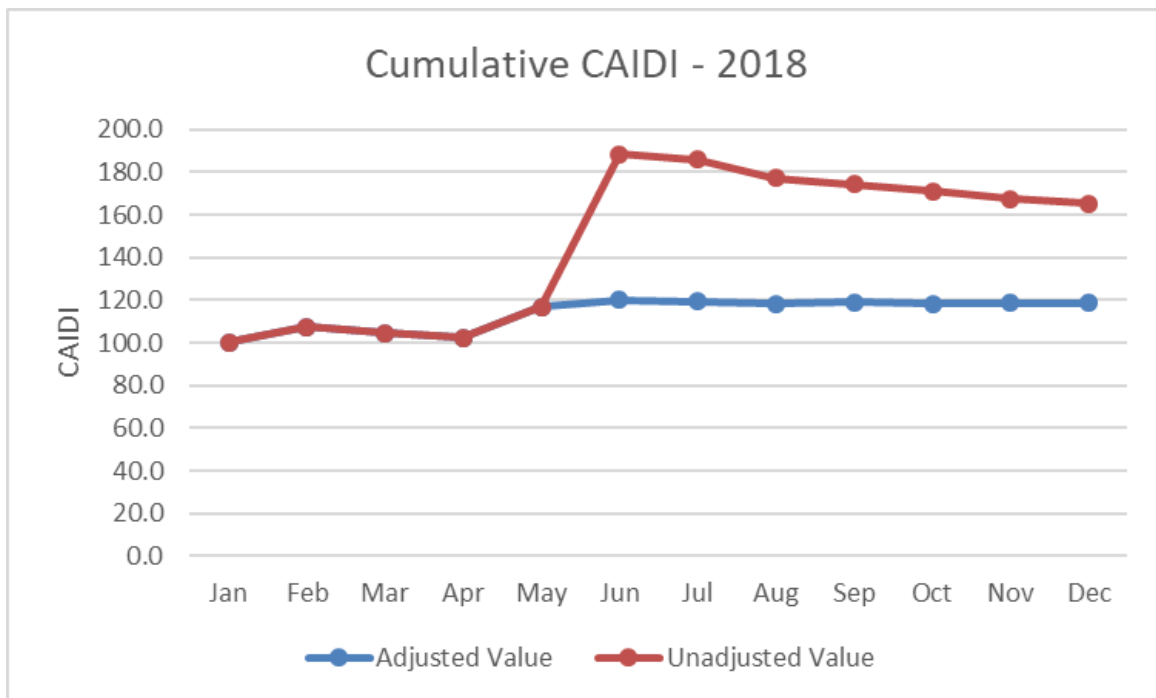
CAIDI:

MONTH	Adjusted Value	Unadjusted Value
Jan	100.1	100.1
Feb	107.6	107.6
Mar	104.6	104.6
Apr	102.4	102.4
May	116.8	116.8
Jun	120.2	188.6
Jul	119.6	186.1
Aug	118.4	177.3
Sep	119.0	174.3
Oct	118.5	171.0
Nov	118.7	167.6
Dec	118.7	165.2
