The Arizona Battery Explosion Is Changing Conventional Wisdom on Safety

Six months later, GTM gets an exclusive update from APS and Fluence on an event that's forcing a new look at grid battery engineering.

OCTOBER 10, 2019

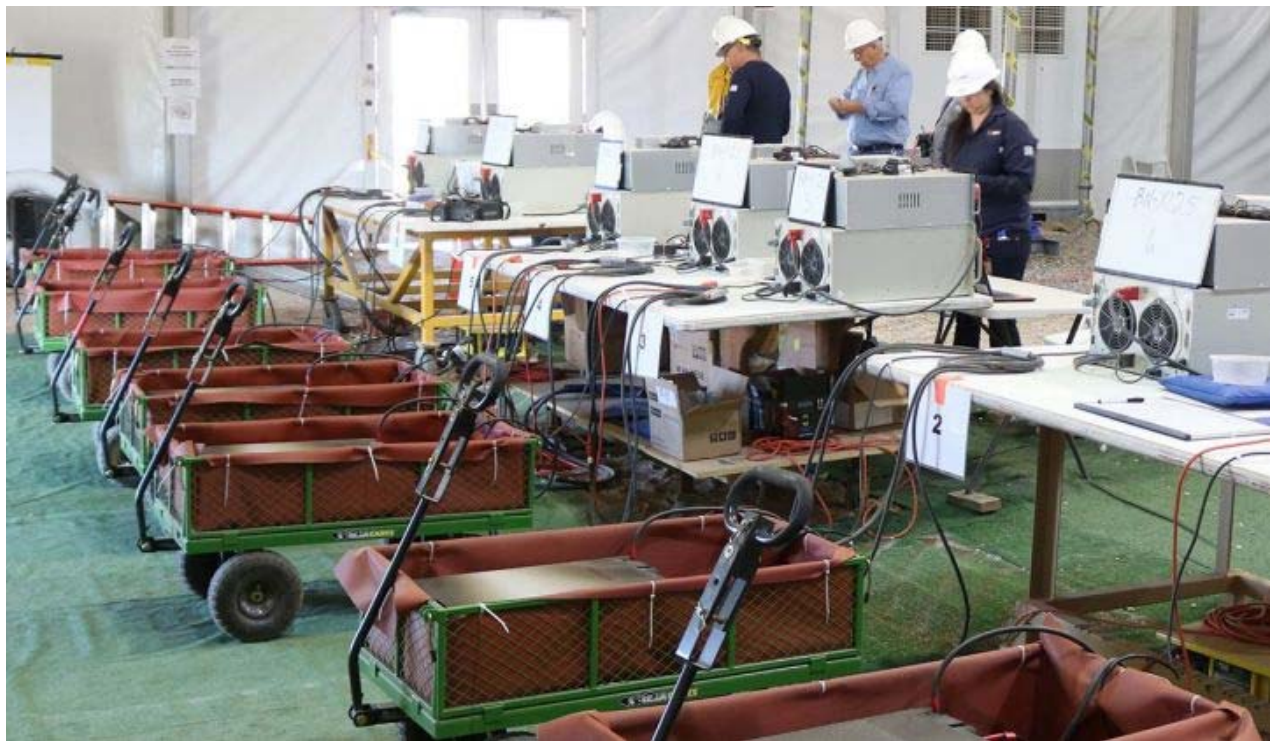
Technicians emptying out the battery modules they removed from the site of the fire. (Credit: APS)

The crews approached each rack and removed the wiring, then walked the modules out of the container, hooked them up to a thermal bank and discharged them. Monsoon season hit during this effort, so APS erected a giant tent to protect the site from the elements.

After about nine weeks of labor and 364 modules being removed, the crew extracted the problem rack, which had "pretty much melted itself all together" into a column of aluminum, Bordenkircher said. The rack has been disassembled and shipped to the forensic lab in Michigan, where it began undergoing a series of tests this week.
