Staff from the Missouri Department of Natural Resources (Department) conducted an inspection on August 9, 2017, of the Reflections Condos public water system (system). The system operates under the public water system identification number MO3071337. Compliance with Safe Drinking Water Law was evaluated.

**Missouri Department of Natural Resources  
Southwest Regional Office/Public Drinking Water Branch  
Report of Inspection  
Reflections Condos  
Camden County, Missouri  
Public Water System ID Number MO3071337  
August 29, 2017**

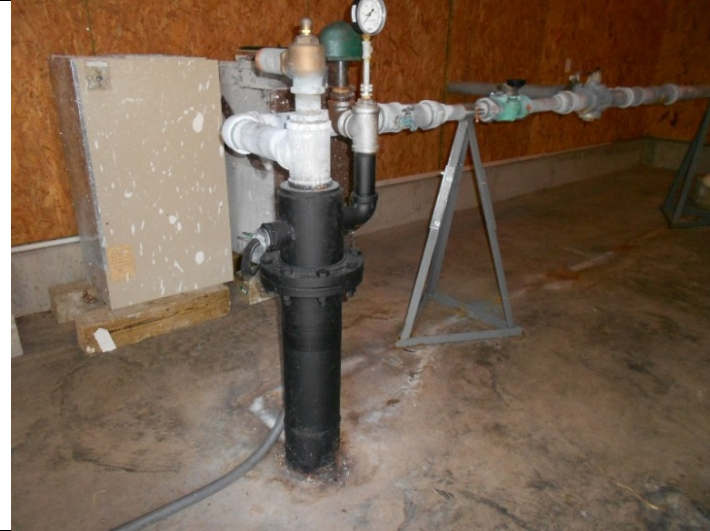
PHOTOGRAPH# 1  
TAKEN BY: Darrell Barber  
ENTITY: Reflections Condos  
PERMIT: MO3071337  
LOCATION: Inside well house  
DESCRIPTION: Well #1 and related discharge piping.  
DATE TAKEN: August 9, 2017  
PROGRAM: Public Drinking Water Branch

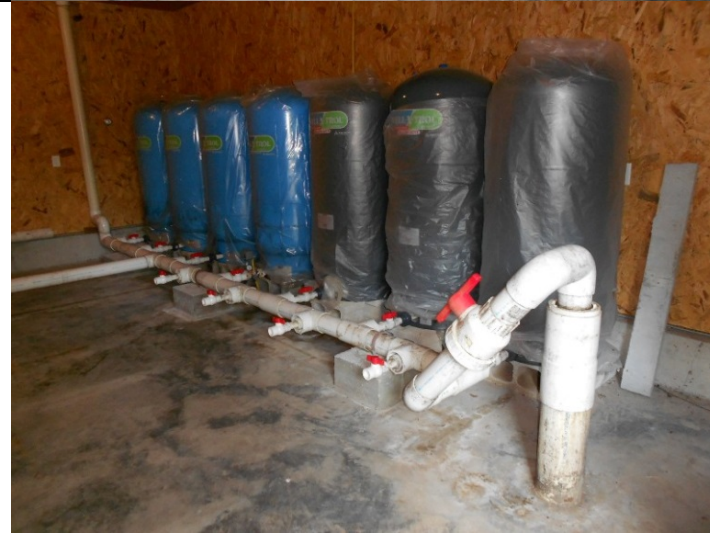
2. The public water system failed to construct the public water system in accordance with approved plans and specifications in violation of Safe Drinking Water Regulation 10 CSR60-10.010(4). Specifically, the water system failed to construct the standpipe storage tank as proposed and approved by the Department's August 6, 2009, construction authorization (project number 54556-09). Additionally, the water system failed to reconstruct the water main as proposed and approved by the Department's November 28, 2007, construction authorization (project number 54327-07).

1. The hydropneumatic (pressure) tanks do not provide adequate storage volume. Also, the use of hydropneumatic storage as the only source of storage is not appropriate for the size of the water system.

2. The water system has piping components that do not comply with AWWA standards. Specifically, the piping in the well house includes sections of four-inch solvent-welded plastic pipe.

AWWA standards require all piping larger than two inches to be bolted-flanged mechanical joint, threaded or fusion welded pipe. Plastic piping is more susceptible to failure over time and should be replaced.

PHOTOGRAPH# 2  
TAKEN BY: Darrell Barber  
ENTITY: Reflections Condos  
PERMIT: MO3071337  
LOCATION: Inside well house  
DESCRIPTION: Seven (7) 119-gallon bladder tanks. Piping in well house includes four inch solvent-welded PVC piping, which is not recommended. Storage was not constructed per the approved plans and specifications.  
DATE TAKEN: August 9, 2017  
PROGRAM: Public Drinking Water Branch

Within 90 calendar days of the date of this report, the public water system shall submit two copies each of the previously-approved engineering report, plans, and specifications along with an application for a new construction permit to the Missouri Department of Natural Resources, Public Drinking Water Branch, P.O. Box 176, Jefferson City, Missouri 65102, 573-751-5331, for construction/completion of the public water system in accordance with the previously-approved engineering report, plans, and specifications. Specifically, the water system shall construct the previously approved standpipe storage tank and reconstruct the water main.

Continued use of hydropneumatic storage as the only means of storage is not recommended. There may be other options that are more appropriate for this system. Please consult your engineer to determine a more specific solution to address your storage needs. A construction permit must be obtained to construct the additional storage needed for this public water system. To obtain this construction permit, submit two copies of an engineering report, plans, and specifications each bearing the seal of a professional engineer registered in Missouri along with an application for a construction permit to Missouri Department of Natural Resources, Public Drinking Water Branch, P.O. Box 176, Jefferson City, MO 65102, 573-751-5331.

The Department recommends replacing the plastic piping in the well house.

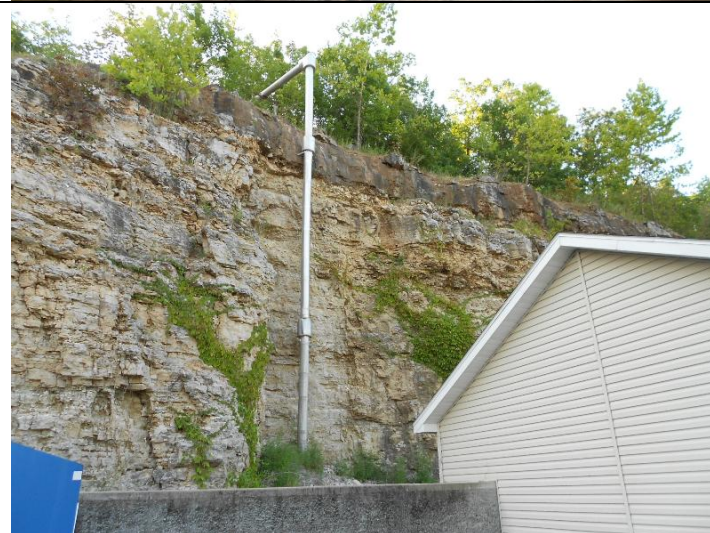
PHOTOGRAPH# 3  
TAKEN BY: Darrell Barber  
ENTITY: Reflections Condos  
PERMIT: MO3071337  
LOCATION: Parking lot by garages and condo buildings.  
DESCRIPTION: Water main is suspended over the side of the rock bluff – was not properly buried as required by the approved plans and specifications.  
DATE TAKEN: August 9, 2017  
PROGRAM: Public Drinking Water Branch

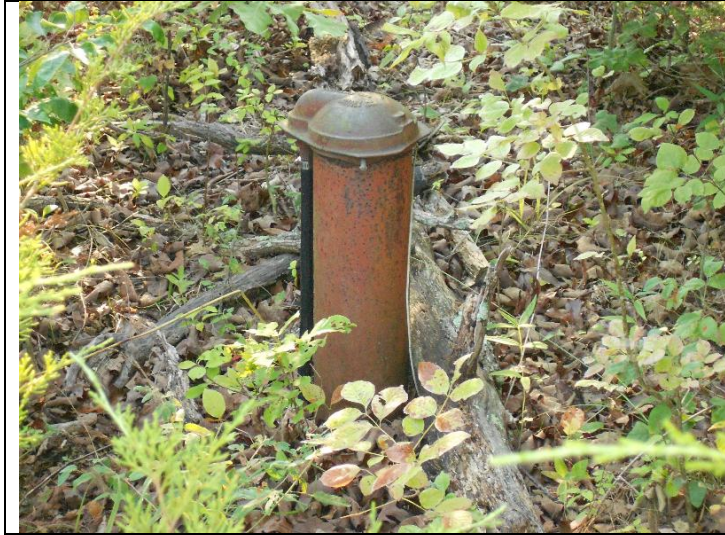
There is an abandoned well located approximately 135 feet from the public water system's well. This well is located on property that is not owned by the public water system or the condominium owner's association. However, due to the potential for the abandoned well to serve

PHOTOGRAPH# 4  
TAKEN BY: Darrell Barber  
ENTITY: Reflections Condos  
PERMIT: MO3071337  
LOCATION: Southeast of well house  
DESCRIPTION: Abandoned well approximately 135 feet from the public water system well for Reflections Condos. The abandoned well is not located on property owned by Great Southern Bank or Reflections Condominium Owners Association, Inc.  
DATE TAKEN: August 9, 2017  
PROGRAM: Public Drinking Water Branch

as a contamination source that could contaminate the public water system's well, the public water system should consider working with the owner of the abandoned well and the Department's Wellhead Protection Program to properly plug the abandoned well. For guidance on properly plugging the well, please contact Ms. Airin Haselwander in the Wellhead Protection Section at 573-368-2196.

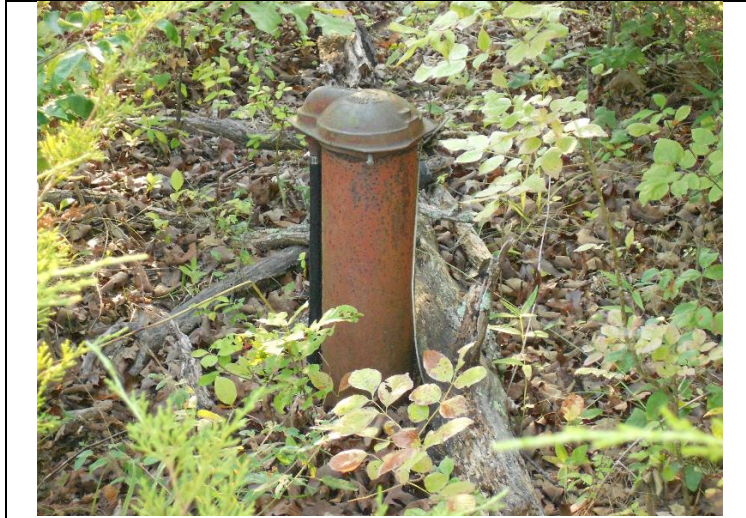
Kathleen Spero  
Abandoned Well Report  
August 9, 2017

Owner and contact information: Kathleen Spero property (adjacent to Reflections Condominiums) near 370 Pershing Dr., Sunrise Beach, MO

Comments: Abandoned private well located on a parcel owned by Kathleen Spero, which is adjacent to a PWS well for Reflections Condominiums (MO3071337).
