Electric Incident Report

AmerenUE Case No. ES-2001-359

> Venice Plant Turbine #1 Fire Venice, Illinois August 10, 2000

Operations Division... Electric Department... Engineering Section

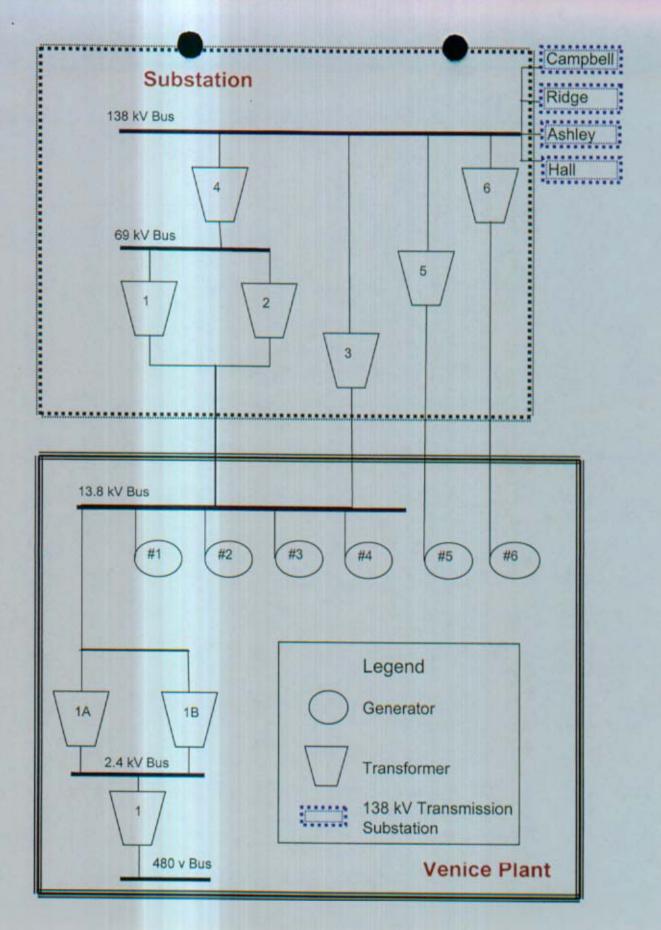
Electrical Diagram

Simple electrical diagram of Venice Plant and Venice Substation.

Station service transformers (13.8 / 2.4 kV) 1A and 1B plus a 480-volt transformer (2.4 kV / 480 V) were damaged by the electrical fault and fire, as were step-up transformers #1, #2 (13.8 / 69 kV), #3 (13.8 / 138 kV) and #4 (69 / 138 kV). (See diagram in

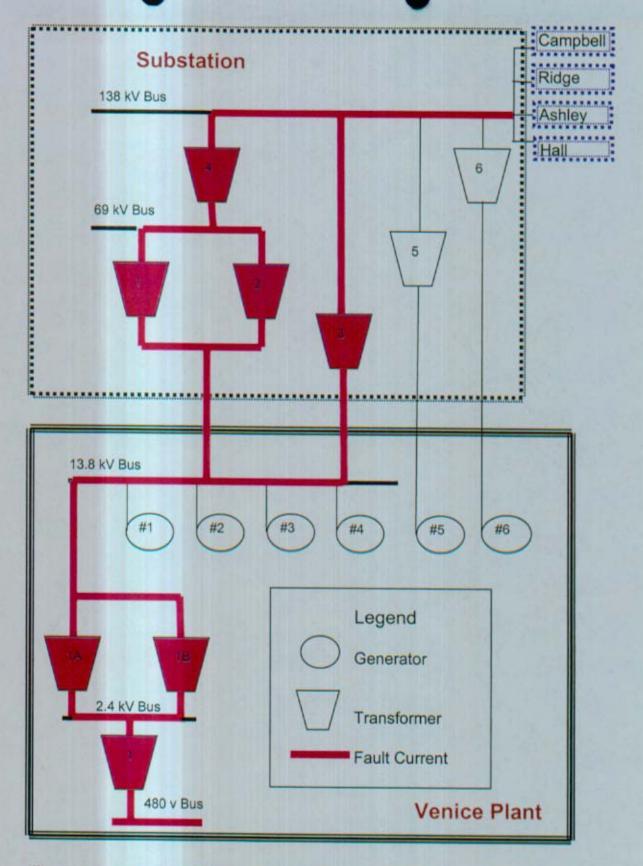
Electrical current available from the 138 kV system sought the ground fault in the plant

continued to feed the electrical ground fault¹ at Venice. AmerenUE personnel were unable to trip breakers at Venice because the D.C. control system also experienced an electrical ground fault and the batteries were quickly discharged. The timeline of events shows that the last substation was manually disconnected from the 138 kV system at 19:51:33. Following this breaker operation at the Hall Street Substation to isolate the fault, firefighters were able to extinguish the fire by 02:00 on August 11, 2000.

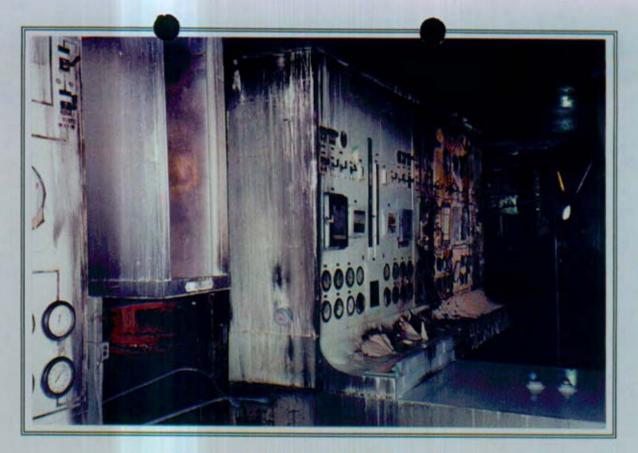
Equipment below Turbine #1 damaged by the fire

Unit #1 sustained extensive damage in the area of the fire. Damage to structural steel supporting the turbine floor was evident as the floor dropped approximately ten (10) to twelve (12) inches. The fire caused damage to electrical cables and ensuing electrical faults caused extensive damage to the 480-volt electrical bus² and to the 2400-volt internal station bus. The fire damaged the 125-volt D.C. circuits and the storage batteries quickly discharged, leaving no power to operate the breakers or to activate the fire control systems.

- 4. D. C. cables that were routed through the area under turbine #1 were damaged by the flames and caused the D. C. system to experience a ground fault and consequently, loss of control of electrical breakers and fire control systems.

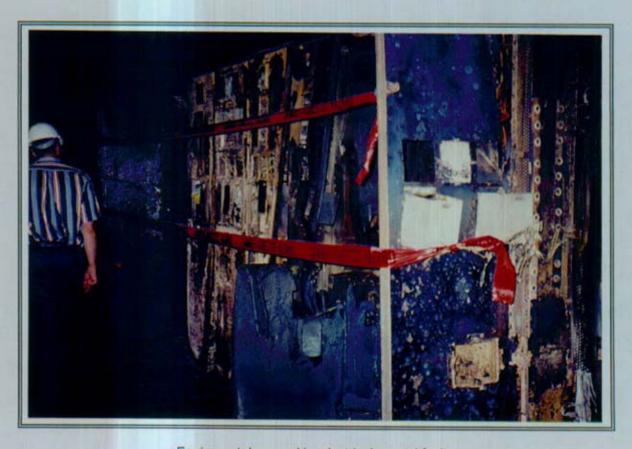
Equipment damaged by electrical ground fault

- 5. The fire on Unit #1 damaged electrical cables that caused a ground fault on the 2.4 kV bus that was fed through the substation from the 138 kV transmission system, which caused major damage to electric facilities.

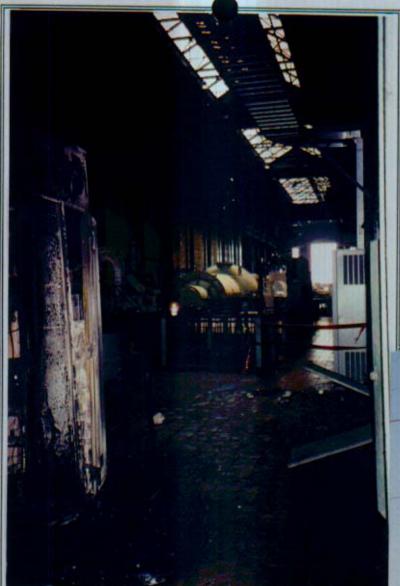
View Of Turbine Floor, Looking South Unit #1 on Immediate Left

Structural repair of the turbine floor has been completed. Damaged cabinets and equipment have been removed. The batteries for the 125-volt D.C. system have been replaced. Installation of new cable to the substation, transformer repair and replacement are underway.

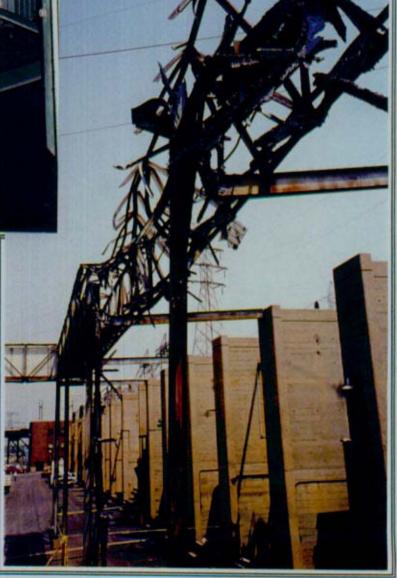
Overhead 13.8 kV Bus Outside Of Plant That Was Damaged By The Fault Current

Appendix A) Electrical buses and switches between the plant and the substation were also damaged. Most of the damaged equipment in and around the plant was original equipment.

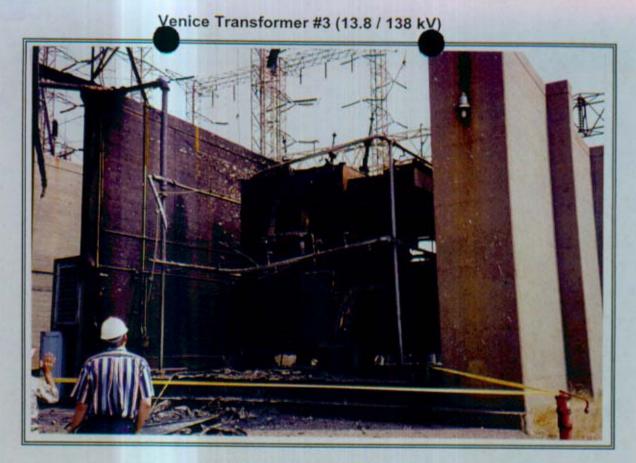
Substation towers in background

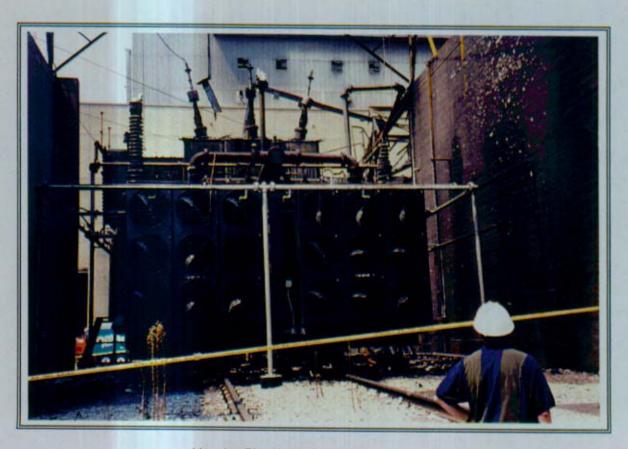
Vennice Plant in background
