Exhibit No.:  
Issues: Capital Investment Program,  
Description of Plant Additions, Water  
Storage Tank Rehabilitation, Risk  
Associated with Providing Public  
Water and Wastewater Services  
Witness: Rebecca B. Losli  
Exhibit Type: Direct  
Sponsoring Party: Missouri-American Water Company  
Case No.: WR-2022-0303  
SR-2022-0304  
Date: July 1, 2022

**CASE NO. WR-2022-0303**

**DIRECT TESTIMONY**

**REBECCA B. LOSLI**

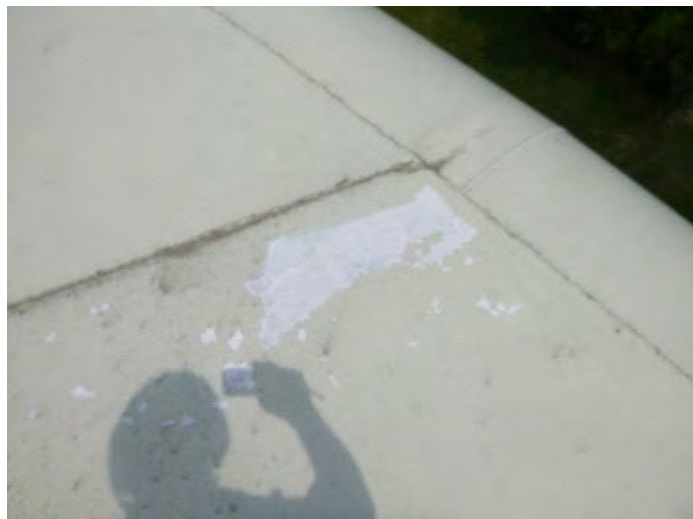
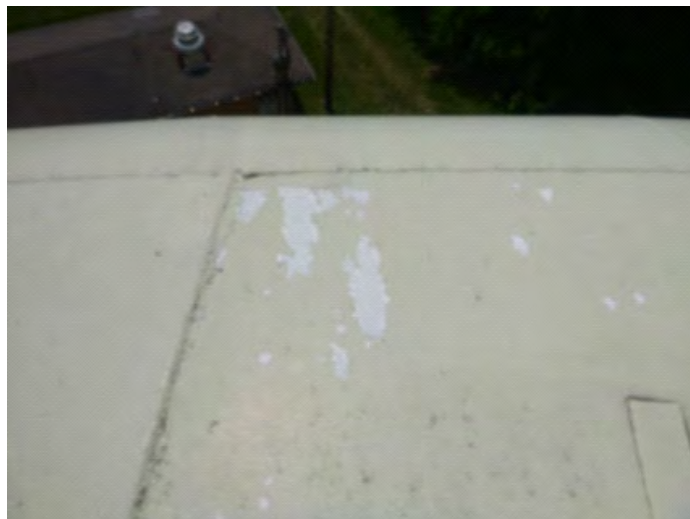
**Exterior coating condition:** Coatings are in good condition with an average of 9.0-13.0 mils DFT. Top coat delamination along edges of upper knuckle and roof connection. Surface rust around weld seam of roof patch. Minor mold and mildew streaking on sidewalls.

Rust on weld seam at roof patch. Coat rusted area before streaking of wall plates.

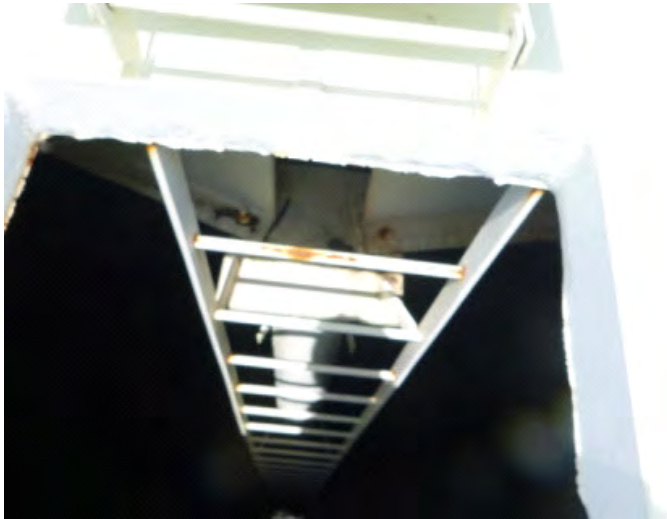
**Interior Coating Condition:** Overall good condition with some minimal spot rusting on walls and ceilings. Tops of roof beams corrosion due to contact with roof plates and condensation.

Rusting on tops of roof beams  
due to roof plates contacting  
tops of roof plates

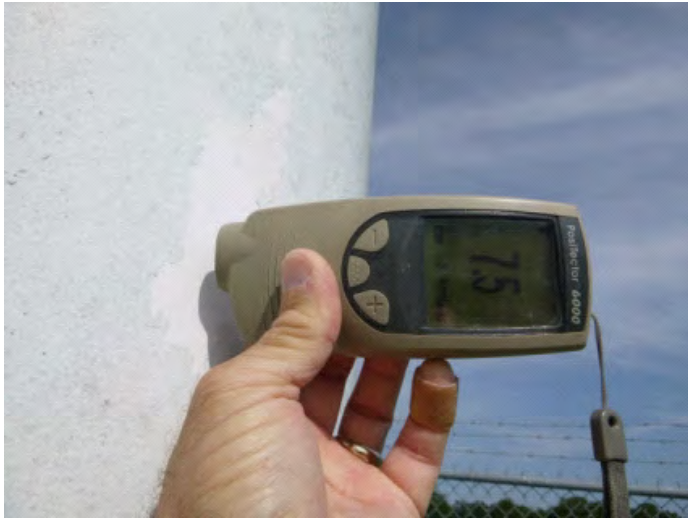
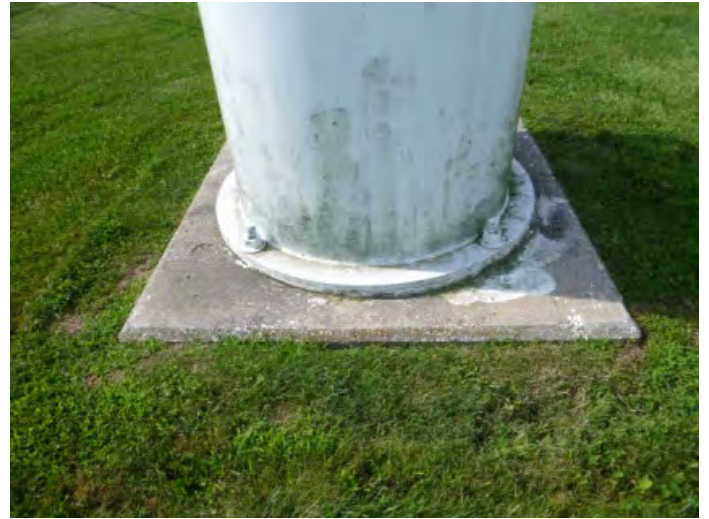
Spot failures with rust

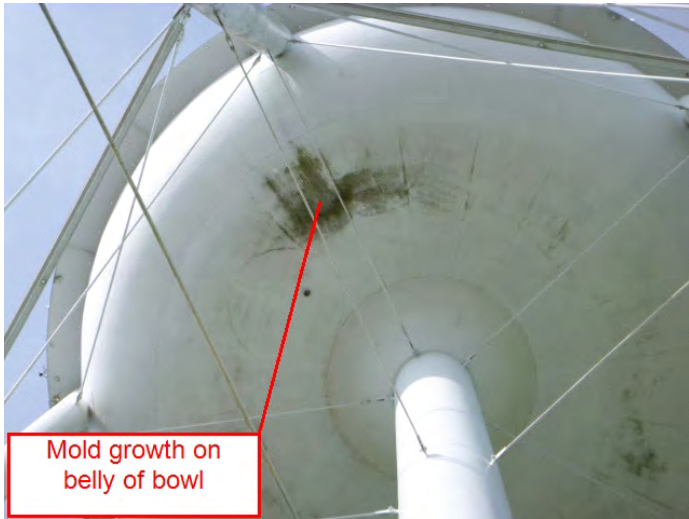
Mold growth on belly of bowl

- Relocate coax cables from ladder standoffs.
- Lower grade to 6" below top of foundation.
- Pressure wash tank to remove mold and mildew growth.
- Plug old electrical junction box on roof.

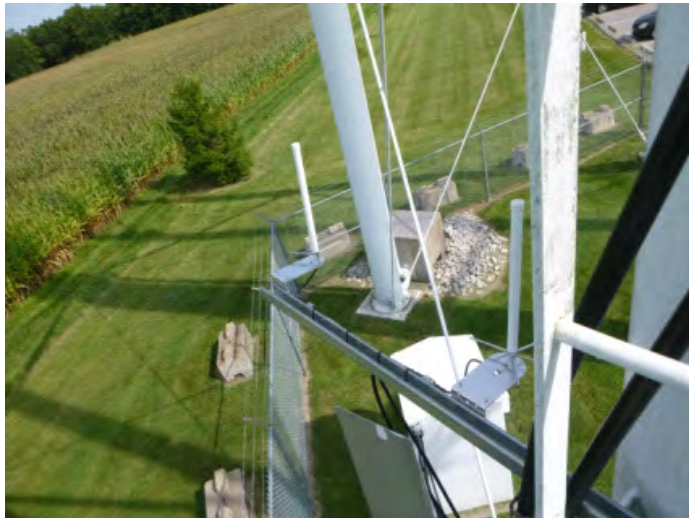
Top coat delamination on leg

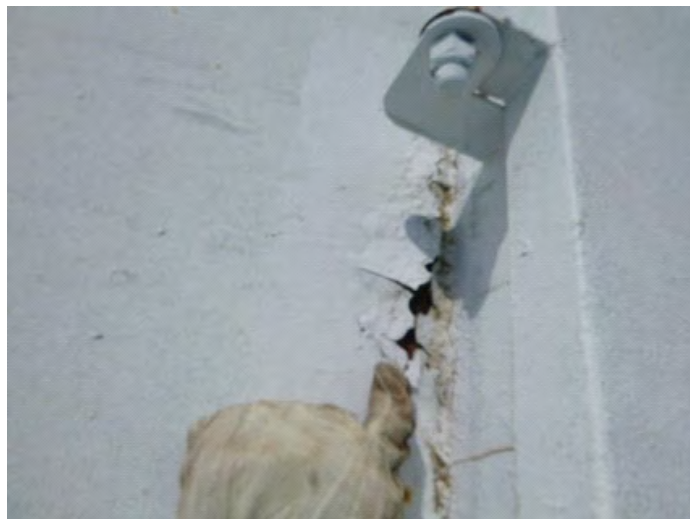
Rusting on roof hatch curb

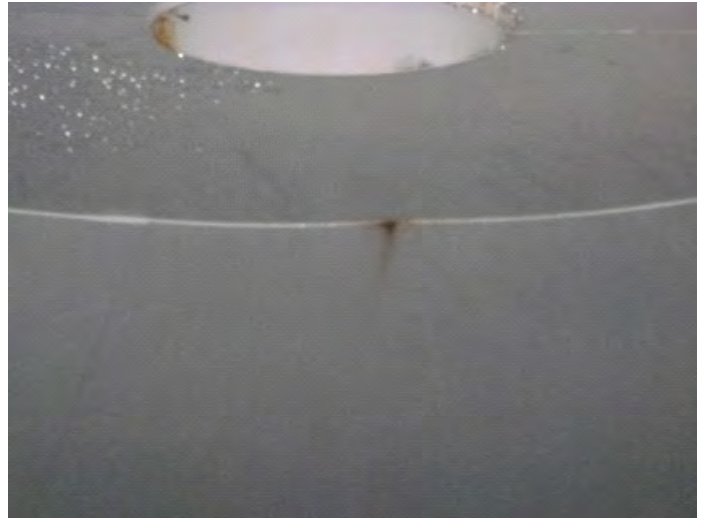
Rust streaking  
on bowl  
sidewalls
