Exhibit No.:
Issues: Water Storage Tank Rehabilitation,
Risks of Providing Water & Sewer
Service
Witness: Matthew A. Lueders
Exhibit Type: Direct
Sponsoring Party: Missouri-American Water Company
Case No.: WR-2024-0320
SR-2024-0321
Date: July 1, 2024

DIRECT TESTIMONY

MATTHEW A. LUEDERS

3 Schedule MAL-2 – Sample water storage tank inspection reports

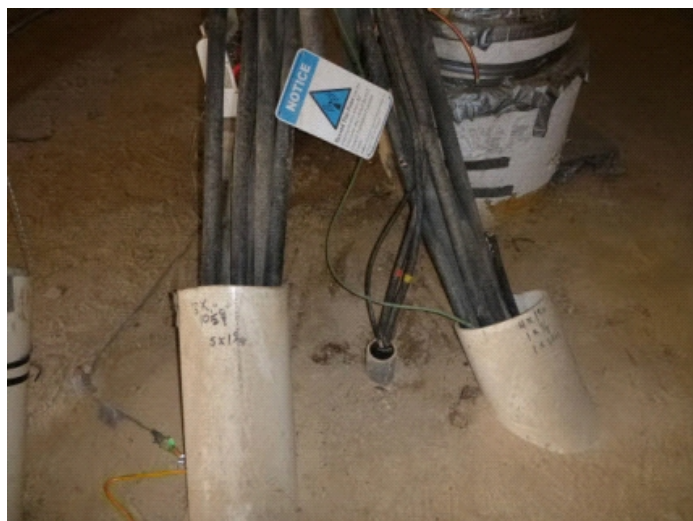
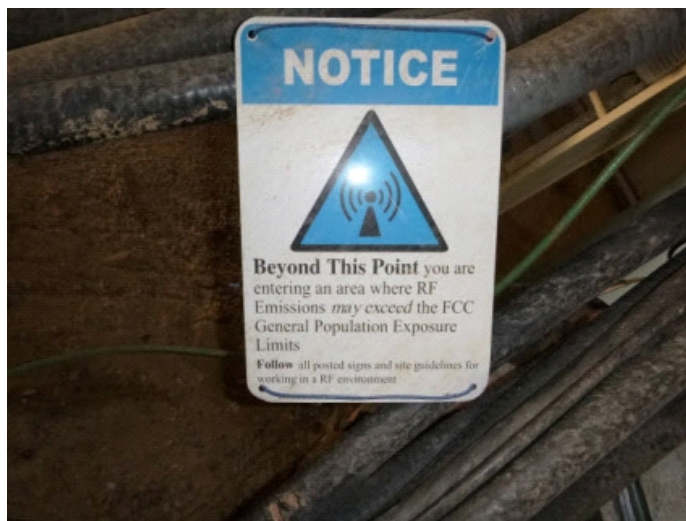
Cellular cables

- Replace bowl ladder at next renovation.
- Lower grade on south side of foundation.
- Seal pipe chases in dry tube for cellular and coax cables closed.
- Relocate cables mounted to ladder in dry tube.
- Consider interior wet and dry riser complete renovation in the next year.

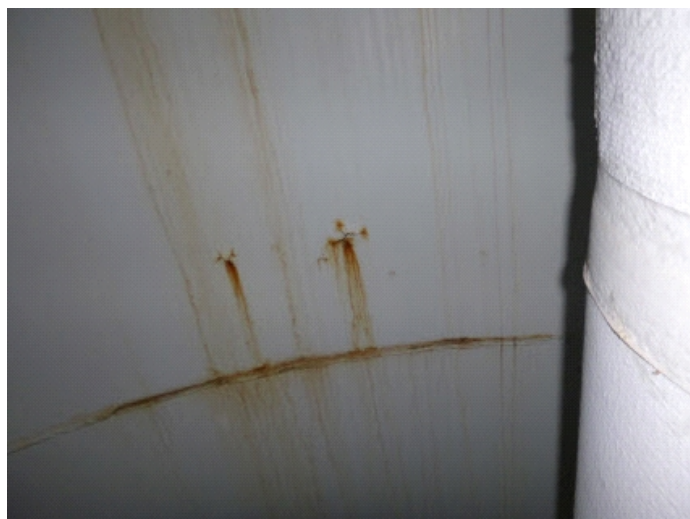
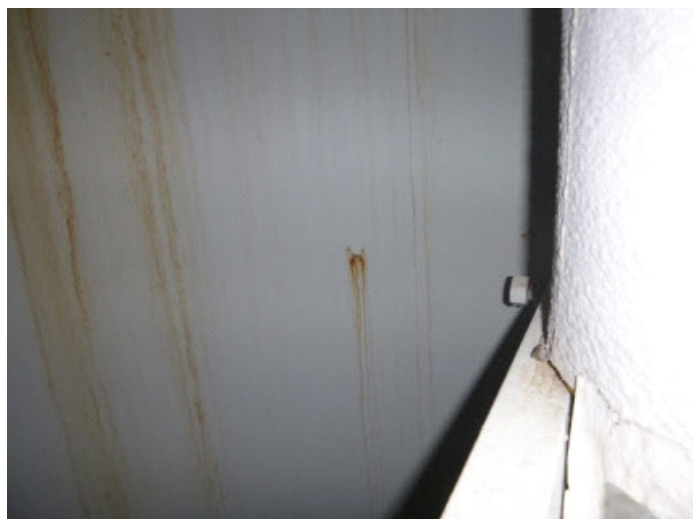
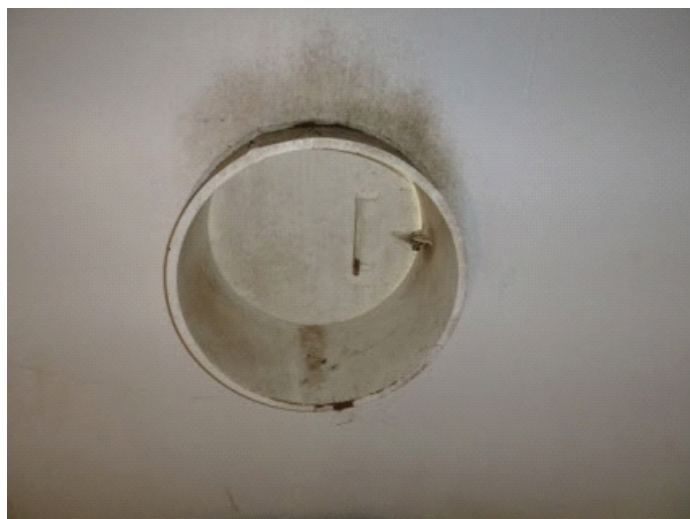
Spot failures in dry rides

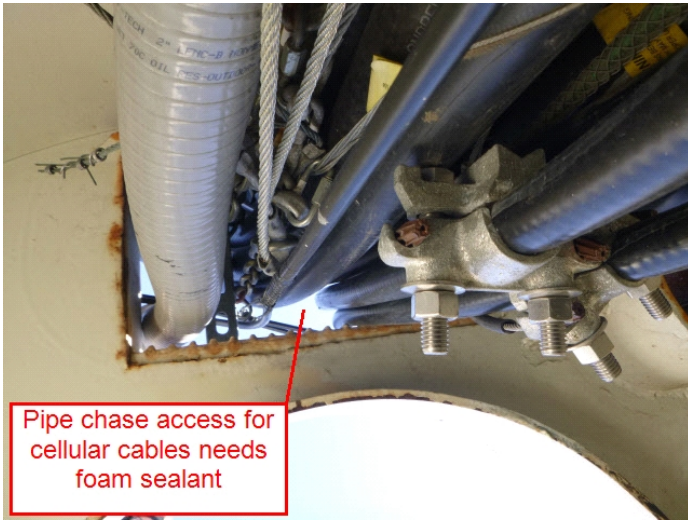
Pipe chase access for cellular cables needs foam sealant

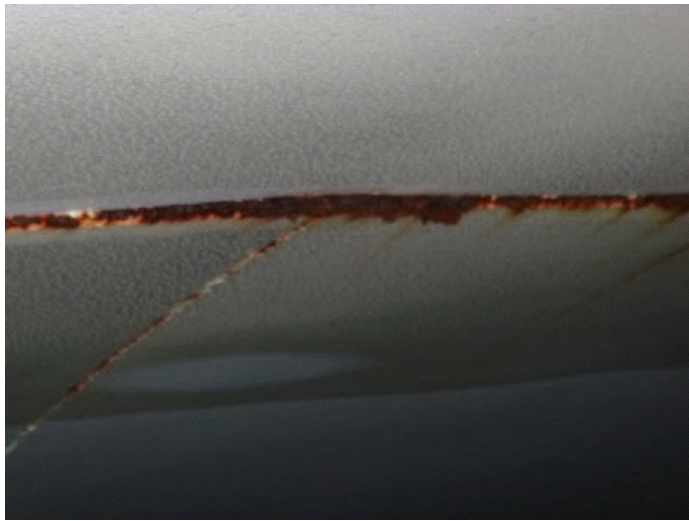
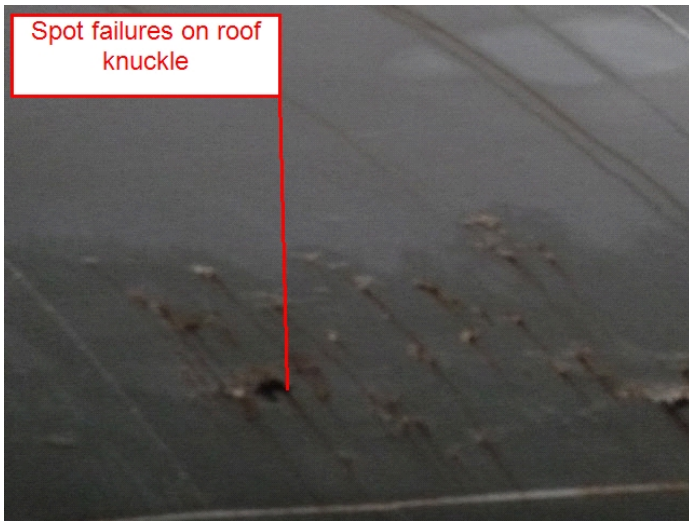
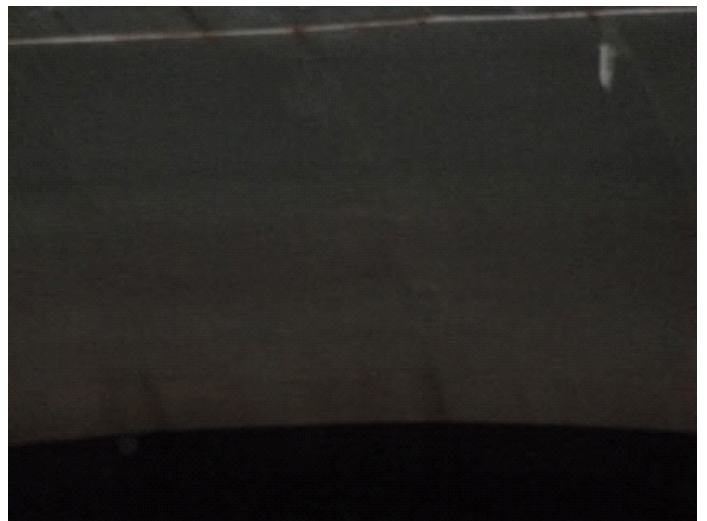
Rusting along overlapping roof plates

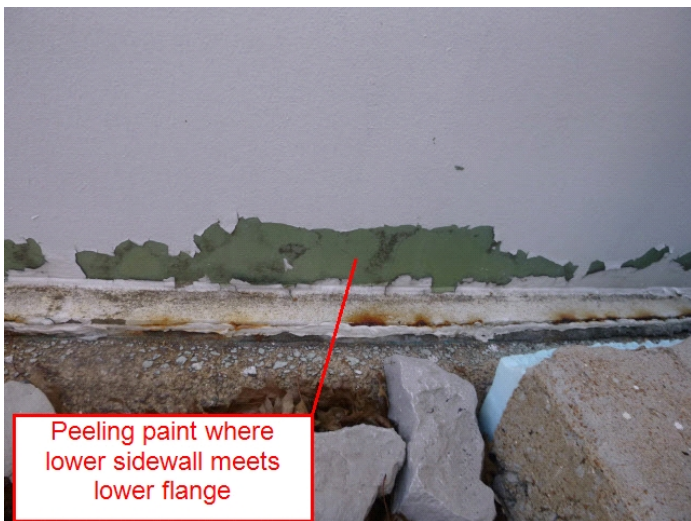
Exterior coating condition: Coatings are in fair condition with an average of 15.0-17.0 mils DFT. Isolated spots of top coat delamination where sidewalls meet lower flange. Spot failures with rust on top of wind girder.

Peeling paint where lower sidewall meets lower flange

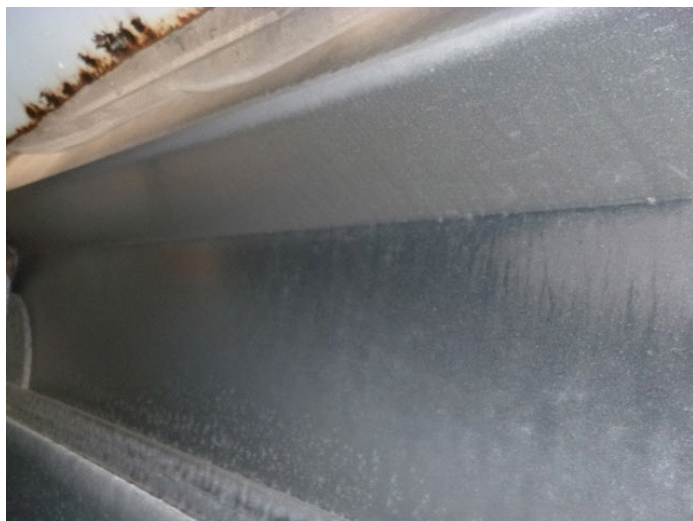
Interior Coating Condition: Coatings are in fair condition with heavy rusting on overflow box and around dome mounts. Rusting on top edge of sidewall. Surface rusting visible on overflow pipe. Isolated spot failures on sidewalls. Minimal sediment visible on tank floor.

Surface rusting on overflow pipe

- Install additional 30" manway during next tank renovation.
- Replace main ladder or install anti skid compound on ladder rungs.
- Install safety cable on main ladder.
- Pressure wash tank to remove mold and mildew.
- Consider complete interior and exterior renovation in the next two years, remove outer dome panels to access rusted dome mounts and top edge of sidewalls.
