Exhibit No.:
Issues: Capital Investment Program,
Description of Plant Additions, Water
Storage Tank Rehabilitation, Risk
Associated with Providing Public
Water and Wastewater Services
Witness: Rebecca B. Losli
Exhibit Type: Direct
Sponsoring Party: Missouri-American Water Company
Case No.: WR-2022-0303
SR-2022-0304
Date: July 1, 2022

DIRECT TESTIMONY

REBECCA B. LOSLI

MISSOURI-AMERICAN WATER COMPANY

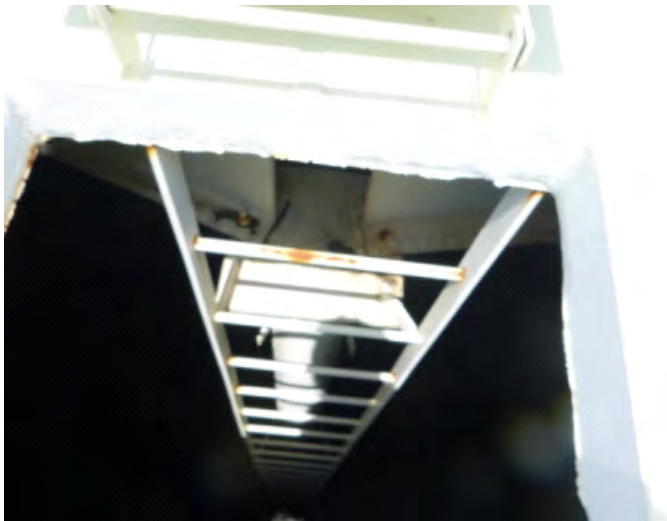
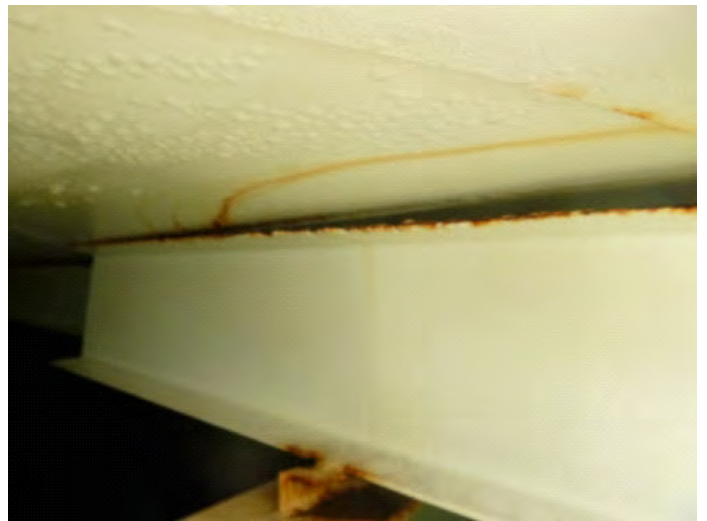
Rusting on tops of roof beams
due to roof plates contacting
tops of roof plates

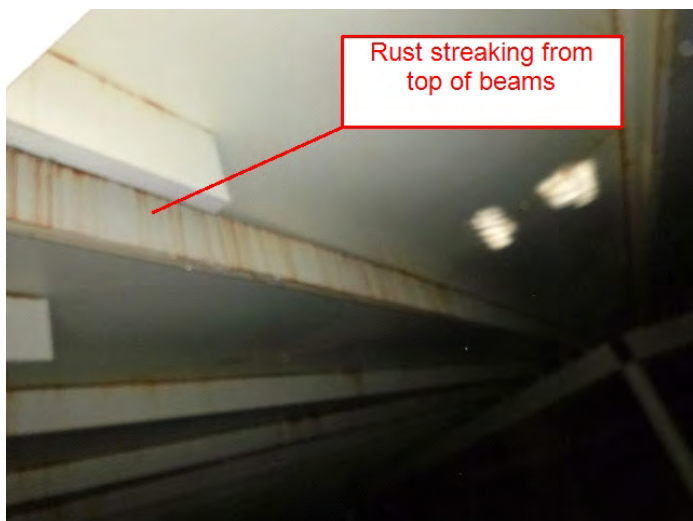
Rust streaking from top of beams
