Exhibit No. \_\_\_\_\_  
Issues: System Condition and Improvements  
Witness: Jacob Freeman  
Type of Exhibit: Direct Testimony  
Sponsoring Party: Confluence Rivers Utility  
Operating Company, Inc  
File Nos.: WR-2023-0006 / SR-2023-0007  
Date: December 21, 2022

**Missouri Public Service Commission**

**Direct Testimony**

**Confluence Rivers Utility Operating Company, Inc**

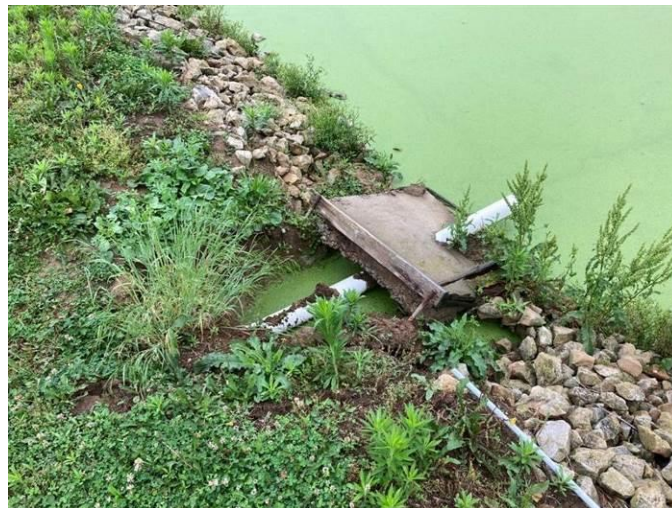
There were also erosion issues at the transfer pipes between the cells as well as at the lagoon outlet. This erosion allowed wastewater flow around the transfer structure and scouring out soil instead of flowing through the transfer and outlet pipes. Thus, such erosion can result in sanitary sewage overflows (“SSO”) releasing untreated or partially treated wastewater into the environment.

*Erosion behind transfer pipe*

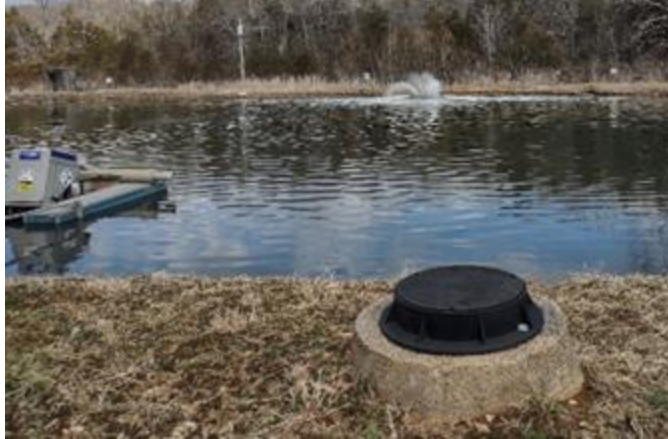
As described in the section previously, the aeration systems in the Terre du Lac three-cell lagoon were in failed or poor condition, with the aerator in the first cell not functioning and the aerator in the second cell functioning poorly. The Company has replaced both aerators with more powerful “Airmaster” aerators which achieve a higher level of treatment than the ones previously installed. Furthermore, Confluence Rivers has moved both aerators to the first cell of the lagoon. This is a temporary reconfiguration until the I&I repairs in the collection system can be completed. As long as the flows are elevated due to the I&I, it is better not to aerate in the second cell, as aeration processes stir up sludge in the water. If the facility was only receiving flows consistent with design levels, the third cell would provide adequate settling time for these stirred up solids to settle out prior to discharge. With the elevated flows caused by I&I, the system needs to use both of the second two cells to provide adequate settling time without aeration causing solids to be stirred up again.

*New Airmaster aerators installed in first cell of the lagoon system*

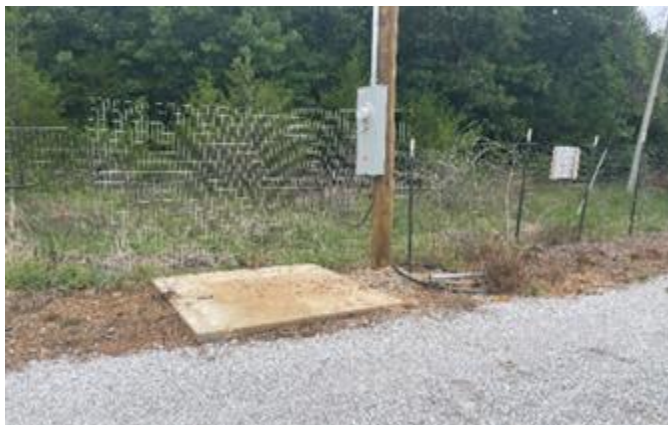
1  
2  
3           The failed power and control structure has been torn down and a new power pole  
4 added to ensure reliable power is present to operate not only the new aerators, but also  
5 the additional treatment processes to be installed as improvements continue at the  
6 facility. New control systems were also installed to operate the new aerators. The area  
7 where the control structure was located has been graded to prepare for the equipment that  
8 will be installed as part of the remaining process improvements still to be implemented.

*Site of old control shack and new power service to site*

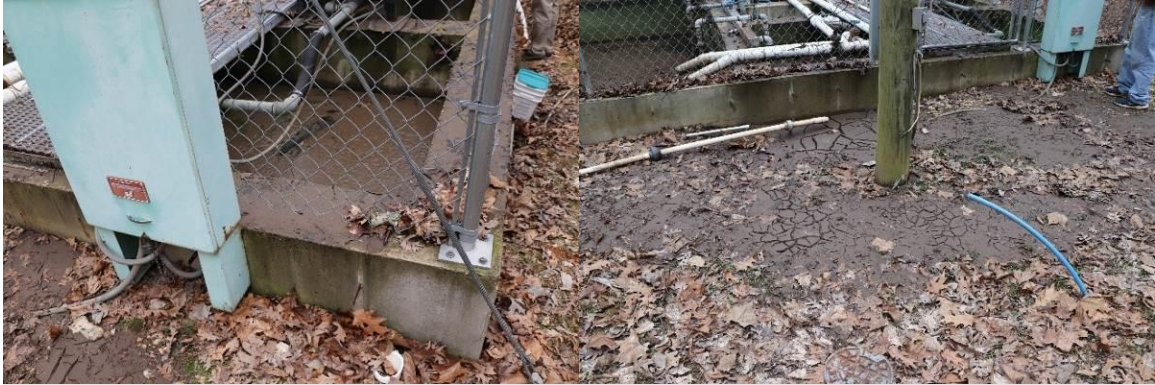
1  
2 *Large amounts of sludge deposited on the ground around the facility from past overflow, signs of recent*  
3 *overflow with wet sludge on the top edges of the facility tankage. Also note poor piping practices with flex*  
4 *hoses attached with hose clamps on sludge return lines rather than proper plumbing returns*  
5

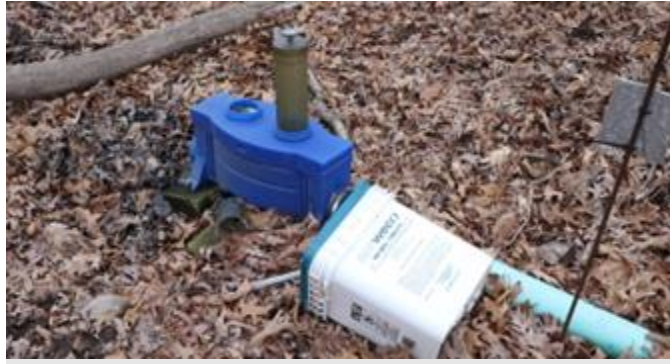
9  
10  
11 With the aeration system and proper treatment restored at the facility, Confluence  
12 Rivers secured permission from the DNR to formally return the discharge point to its  
13 original location and made improvements to the outfall structure. Improvements were  
14 also made to the disinfection system with the addition of feeders for both chlorine tablets  
15 and dechlorination tablets.

*New dechlorination tablet feeder*

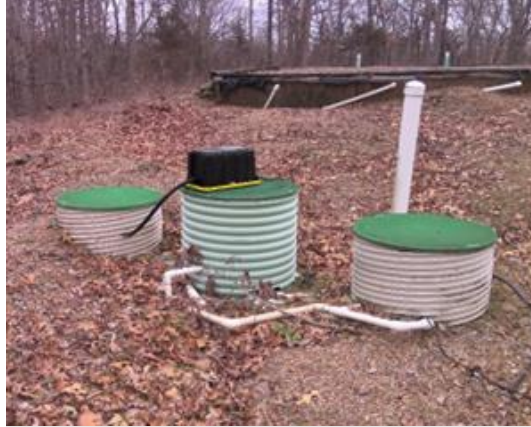
8 Finally, as described with regard to Cedar Glen, Confluence Rivers has  
9 implemented a process improvement to address compliance with ammonia limits.  
10 Specifically, rather than incurring the capital cost of additional tankage for the  
11 installation of a traditional MBBR, Confluence Rivers has instead installed micro  
12 MBBRs in existing tankage. Specifically, micro MBBRs were placed in two existing  
13 recirculation tanks (one in each tank). By utilizing this modified installation, Confluence  
14 Rivers not only avoided the cost of additional tankage, but also allowed for the  
15 installation of smaller, quieter, less expensive blowers than in a more traditional MBBR  
16 setup. This improvement now allows the facility to treat to permitted limits at a much-  
17 reduced cost as compared to more traditional approaches.

*Micro MBBR in Recirculation tank and small blower running MBBR at Cimarron Bay*

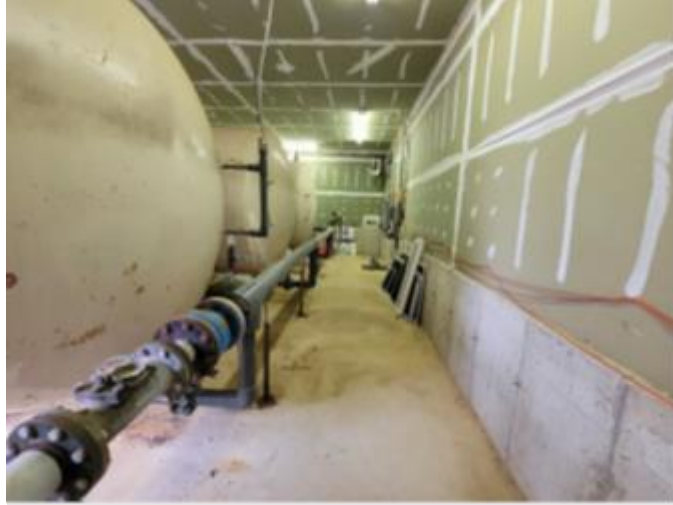
*Hydropneumatic storage tank building (note violations associated with dependence on hydropneumatic storage only and use of 2” pvc piping)*

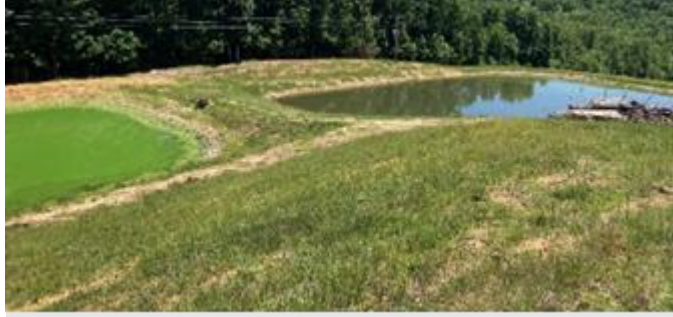
*Lagoon cells cleared of trees after acquisition at Port Perry*

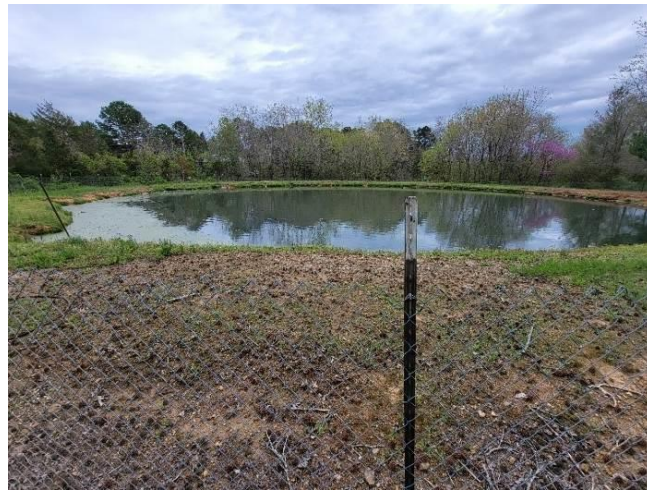
*Deguire after duckweed remediation*

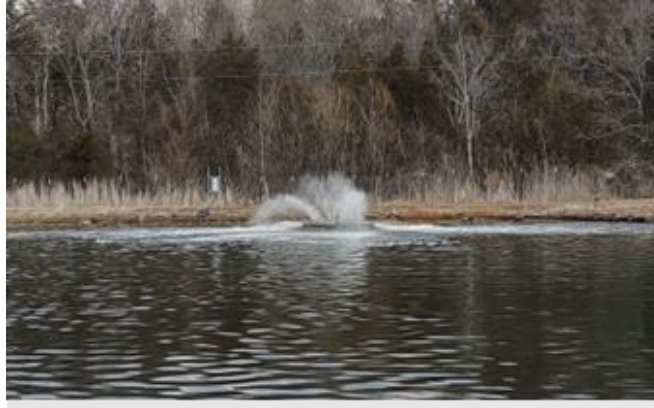
*New aeration at Terre du Lac three-cell lagoon*

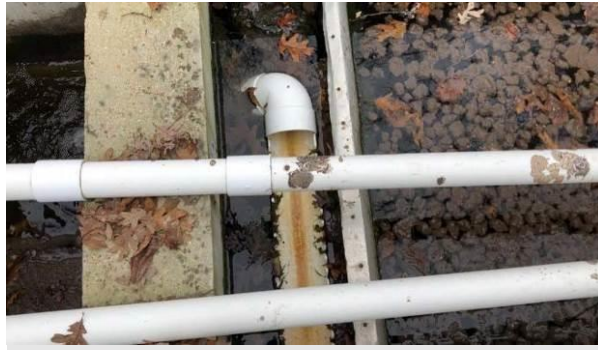
*Poor condition of clarifier at Chelsea Rose*

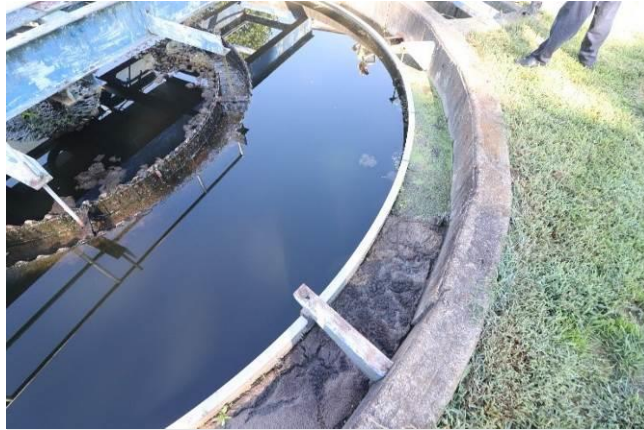
*Mechanical failure at Terre du Lac Oxidation Ditch clarifier*

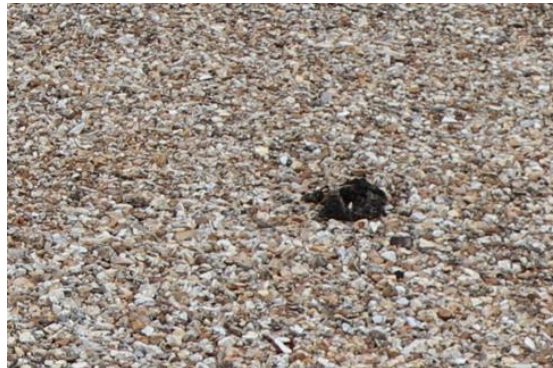
*Visible sludge breaking the surface of the Cedar Glen sand filter beds.*

20 Confluence Rivers does several things to resolve these issues where they are  
21 discovered and take steps to prevent this sort of sludge accumulation from recurring.  
22 First, where sludge has clogged filter media, the media is raked out to break up sludge  
23 blocks; sludge is removed from the septic and recirculation tanks; and in some cases

1 where sludge impact is too severe, portions of the media are hauled off and replaced.  
2 Should issues be identified with pump configuration pulling sludge from the bottom of  
3 the septic tank, pumps are reconfigured to reduce solids flow. The final and perhaps  
4 most significant improvement that reduces these issues and prevents recurrence are  
5 improved process improvements including either the installation of an MBBR alongside  
6 the facility or installation of drop in micro MBBR units in the facility recirculation tanks.  
7 While the primary purpose of these improvements is to allow facility to meet permit  
8 limits (especially ammonia limits), a secondary effect is generally improved  
9 microbiology in the facility improving the breakdown of the organic components in  
10 wastewater solids and reducing sludge volume. The reduced volume is more easily  
11 washed out of the filters becoming less likely to accumulate again in the future.

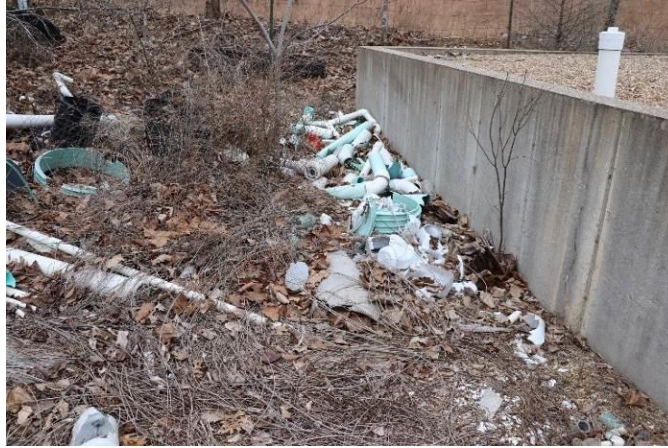
14 facility. Additionally, several of these facilities had piles of damaged materials and  
15 equipment that were simply dumped on site rather than being properly disposed. This is  
16 evidence of general neglect in the operations and maintenance of the facilities and in  
17 some cases would qualify as illegal dumping or disposal of material. In such cases,  
18 Confluence Rivers immediately seeks to remove any trash and debris from the utility  
19 sites. Finally, some facilities have had issues related to untended vegetation around the  
20 site. This can cause a number of issues including damage to fencing; debris falling onto  
21 filter beds; adverse effects on the treatment process; portions of the facility being  
22 rendered inaccessible for regular operations and maintenance activities.

*Piles of trash and debris on the Eagle Woods site*
